ASBESTOS MANAGEMENT SURVEY REPORT FOR WELLINGTON SCOTTISH ATHLETICS CLUB SALISBURY TERRACE, MOUNT COOK, WELLINGTON

Reference Details: STMCW-0

Document Issue Date: 16/05/2023

Survey/Inspection Date(s): 5/05/2023

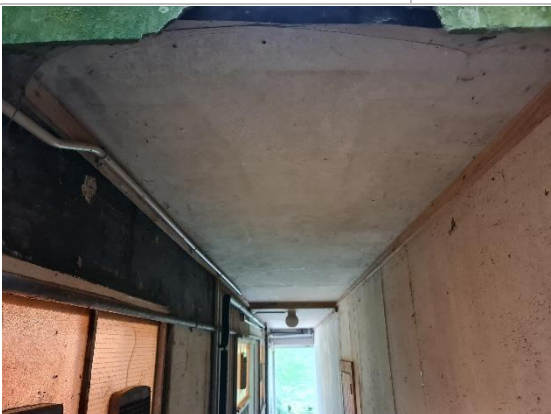
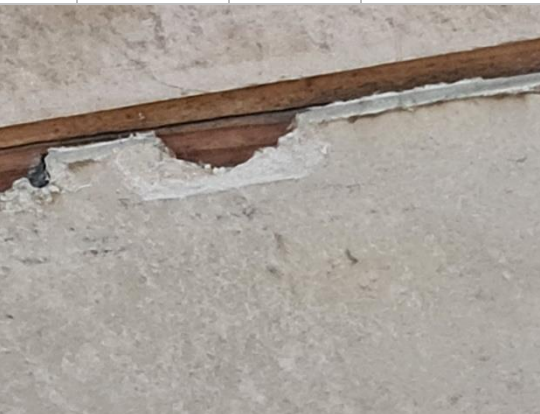
Survey Date: 5/05/2023	Building/structure	Sample No:	Level	Area/Location	Item/Position	Material	Result/Material Risk	Recommended Action
Lead Surveyor: Supry Sos	Main Building	S003	Ground	Southeast	Ceiling	Cement Product	ASBESTOS DETECTED MAS: 4\geq (Very Low)	Manage & Label

Survey Technique:	<i>Sampled</i>		
					Sample Type:	<i>Bulk</i>		
					Accessibility:	<i>Easy</i>		
					Material Assessment Score (MAS)			
					Product Type:	<i>Composite - Cement Product</i>	1	
					Asbestos Type:	<i>Chrysotile</i>	1	
					Material Condition:	<i>Good</i>	1	
					Surface Treatment:	<i>Good</i>	1	
					Material Extent:	<i>~12m²</i>		
					Removal Class:	<i>B Class Licensed Removal Work</i>		
					Comments:	<i>None.</i>

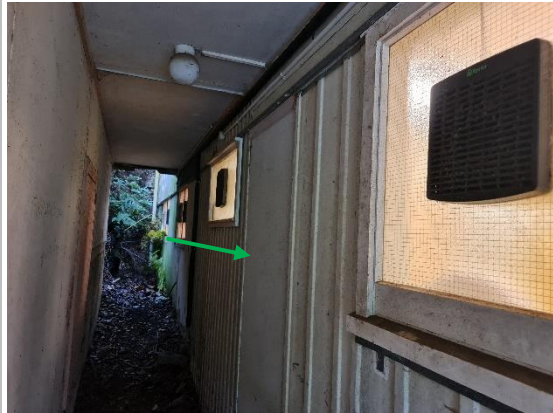
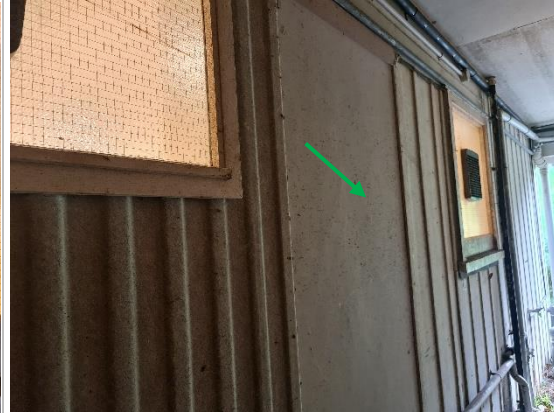
Survey Date: 5/05/2023	Building/structure	Sample No:	Level	Area/Location	Item/Position	Material	Result/Material Risk	Recommended Action
Lead Surveyor: Supry Sos	Main Building	S004	Ground	Northeast	Cladding	Cement Product	NO ASBESTOS DETECTED MAS: 0 (Unlikely)	No Action Required

Survey Technique:	Sampled
Sample Type:	Bulk
Accessibility:	Easy
Material Assessment Score (MAS)	
Product Type:	Composite - Cement Product
Asbestos Type:	No Asbestos Detected
Material Condition:	Not applicable
Surface Treatment:	Not applicable
Material Extent:	Not Applicable
Removal Class:	Not applicable
Comments:	Old doorway Cladded over.

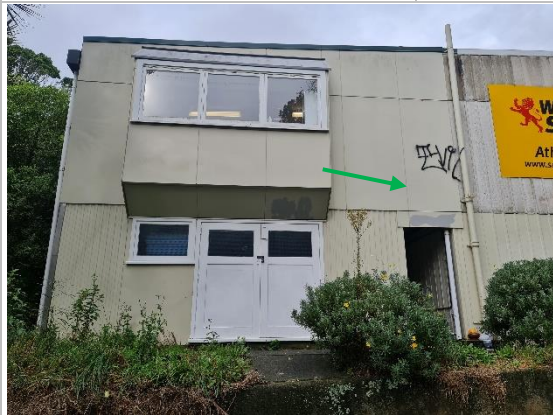
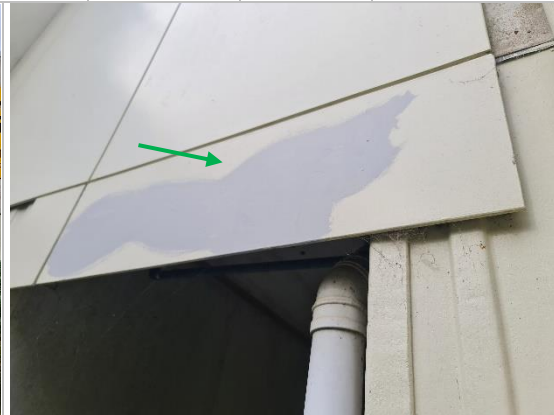
Survey Date: 5/05/2023	Building/structure	Sample No:	Level	Area/Location	Item/Position	Material	Result/Material Risk	Recommended Action
Lead Surveyor: Supry Sos	Main Building	S005	First	Northeast	Cladding	Cement Product	NO ASBESTOS DETECTED MAS: 0 (Unlikely)	No Action Required

Survey Technique:	Sampled
Sample Type:	Bulk
Accessibility:	Easy
Material Assessment Score (MAS)	
Product Type:	Composite - Cement Product
Asbestos Type:	No Asbestos Detected
Material Condition:	Not applicable
Surface Treatment:	Not applicable
Material Extent:	Not Applicable
Removal Class:	Not applicable
Comments:	Asbestos cladding could be concealed beneath this external cladding.

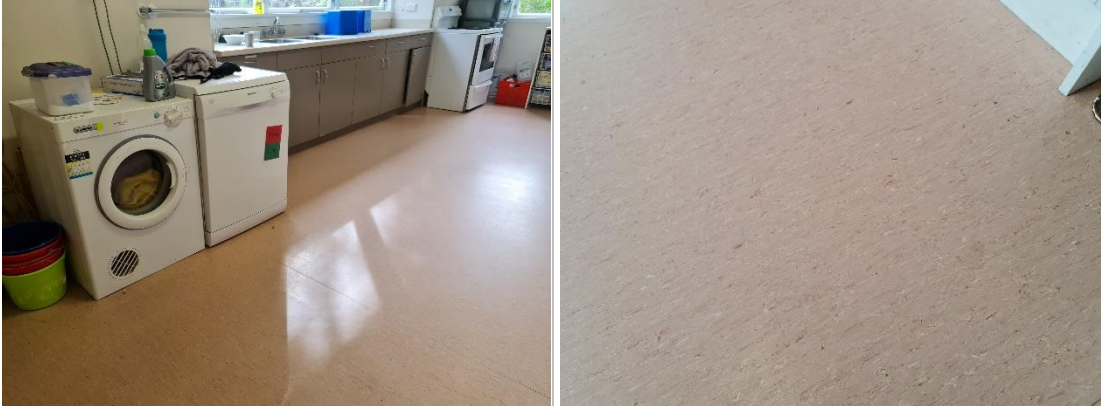
Survey Date: 5/05/2023	Building/structure	Sample No:	Level	Area/Location	Item/Position	Material	Result/Material Risk	Recommended Action
Lead Surveyor: Supry Sos	Main Building	S008	First	Kitchen	Flooring & Lining	Vinyl Product	NO ASBESTOS DETECTED MAS: 0 (Unlikely)	No Action Required

Survey Technique:	Sampled		
					Sample Type:	Bulk		
					Accessibility:	Easy		
					Material Assessment Score (MAS)			
					Product Type:	Composite - Vinyl product		
					Asbestos Type:	No Asbestos Detected		
					Material Condition:	Not applicable		
					Surface Treatment:	Not applicable		
					Material Extent:	Not Applicable		
					Removal Class:	Not applicable		
Comments:	None.

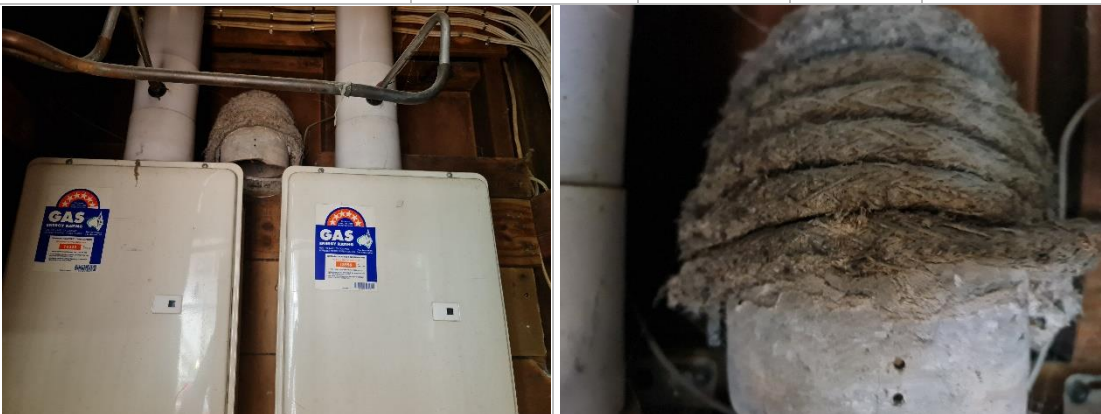
Survey Date: 5/05/2023	Building/structure	Sample No:	Level	Area/Location	Item/Position	Material	Result/Material Risk	Recommended Action	
Lead Surveyor: Supry Sos	Main Building	S009	First	Staiwell Cupboard	Rope Insulation	Insulation Product	ASBESTOS DETECTED MAS: 10≤ (High)	Remove

Survey Technique:	Sampled			
					Sample Type:	Bulk			
					Accessibility:	Easy			
					Material Assessment Score (MAS)				
					Product Type:	Friable - Asbestos Rope			3
					Asbestos Type:	Chrysotile			1
					Material Condition:	Poor			3
					Surface Treatment:	Poor/Unsealed			3
					Material Extent:	<.25m ²			
					Removal Class:	A Class Licensed Removal Work			
Comments:	All surfaces need to be cleaned and sealed in this cupboard.

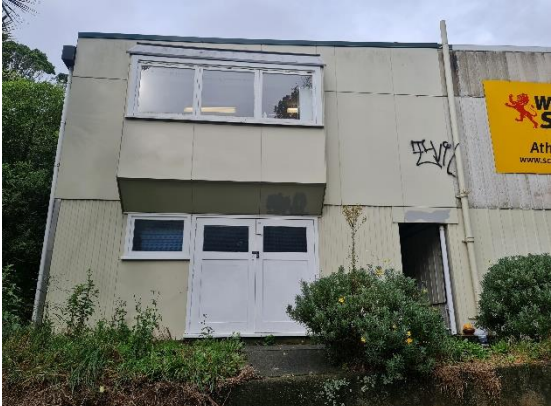
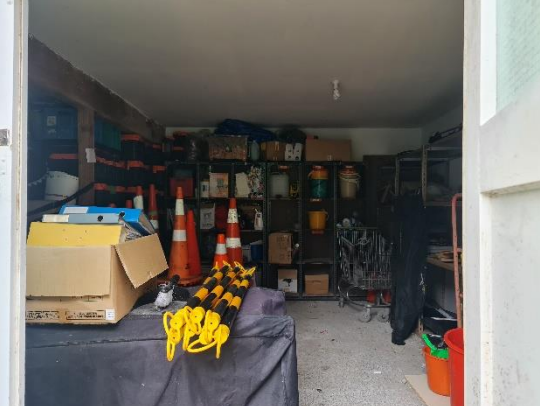
Survey Date: 5/05/2023	Building/structure	Sample No:	Level	Area/Location	Item/Position	Material	Result/Material Risk	Recommended Action
Lead Surveyor: Supry Sos	Main Building	Not Applicable	Ground	Storage	Internal Walls	No Suspect Materials	Not Applicable	No Action Required

Survey Technique: Visual Inspection - No Suspicious Materials Identified Sample Type: Visual Assessment Accessibility: Easy Material Assessment Score (MAS) Product Type: Not Applicable Asbestos Type: Not applicable Material Condition: Not applicable Surface Treatment: Not applicable Material Extent: Not Applicable Removal Class: Not applicable Comments: None.

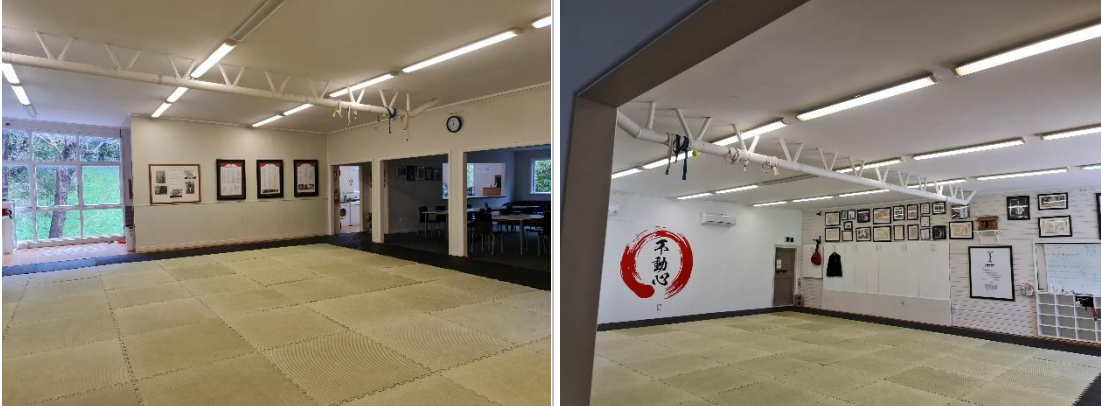
Survey Date: 5/05/2023	Building/structure	Sample No:	Level	Area/Location	Item/Position	Material	Result/Material Risk	Recommended Action
Lead Surveyor: Supry Sos	Main Building	Not Applicable	First	All	Internal Walls	No Suspect Materials	Not Applicable	No Action Required

Survey Technique:	<i>Visual Inspection - No Suspicious Materials Identified</i>		
					Sample Type:	<i>Visual Assessment</i>		
					Accessibility:	<i>Easy</i>		
					Material Assessment Score (MAS)			
					Product Type:	<i>Not Applicable</i>		
					Asbestos Type:	<i>Not applicable</i>		
					Material Condition:	<i>Not applicable</i>		
					Surface Treatment:	<i>Not applicable</i>		
					Material Extent:	<i>Not Applicable</i>		
					Removal Class:	<i>Not applicable</i>		
Comments:	<i>None.</i>
