Maintenance Plan Report

WELLINGTON SCOTTISH ATHLETICS
CLUB

Prince of Wales Park, Salisbury Terrace,
Mt Cook, Wellington 6021

17/01/2023
WSA22-01

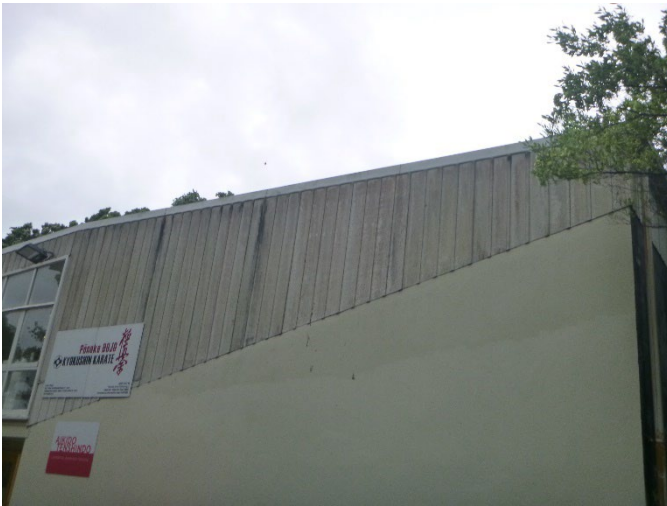
Photograph 2

Partial view of front elevation. Note possible asbestos cladding to high level area. Minor staining to decorative finishes.

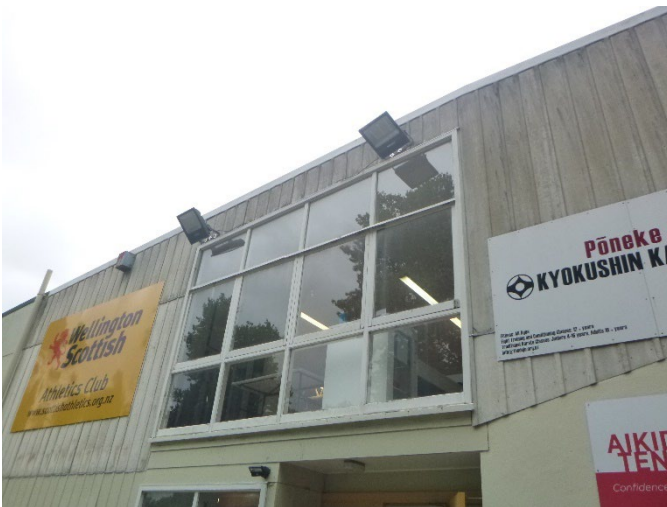
Photograph 3

Large window to first floor hall area, note discolouration and deterioration of painted finish.

2.4.3		External Walls	Concrete and cement sheet areas.	Generally in fair / poor condition with deterioration noted to painted finishes and significant moss growth to isolated/sheltered areas.	Undertake redecoration of all previously painted external walls.	P	510m2	35	17850	5 years		17,850					17,850					35,700

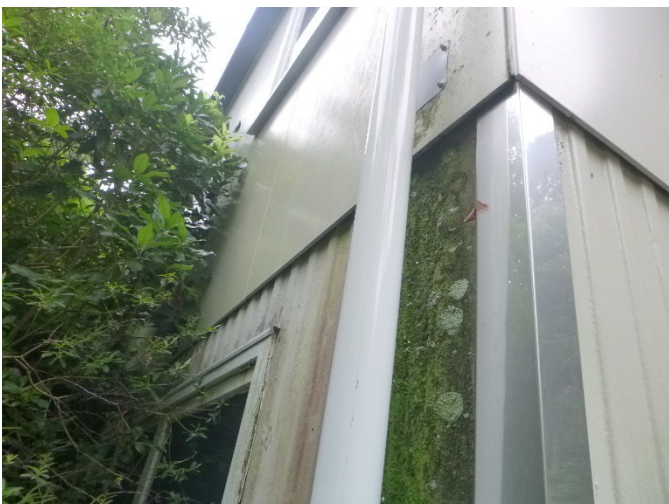
Photograph 6

Partial view of northeast elevation.
Access largely obscured by overgrown vegetation.

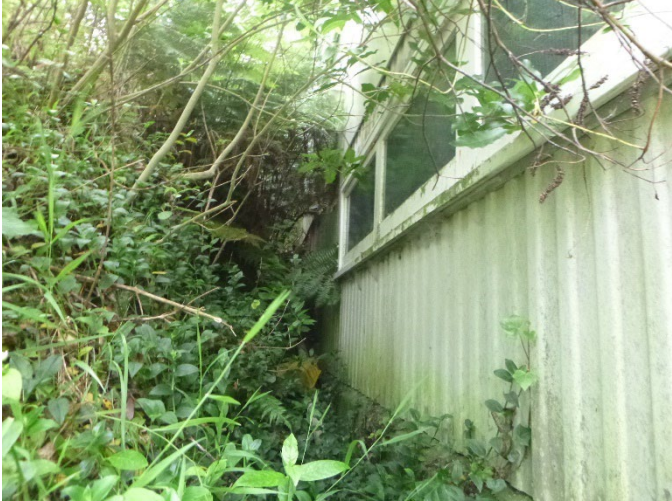
Photograph 7

Partial view of northeast elevation. Access largely obscured by overgrown vegetation.

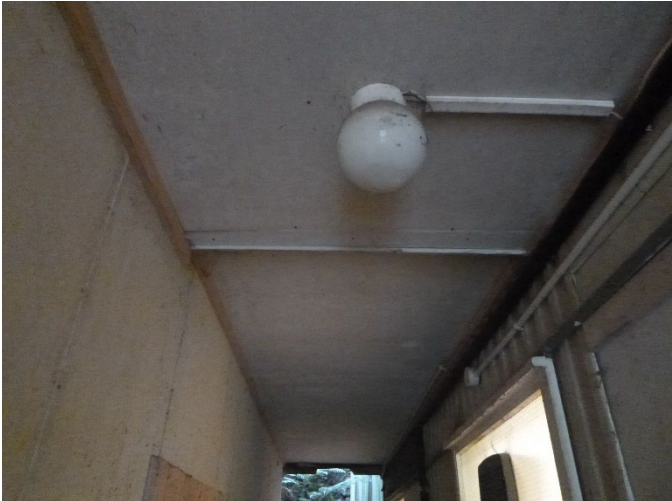
Photograph 8

Alleyway between the old and new building. Generally, in poor decorative condition.

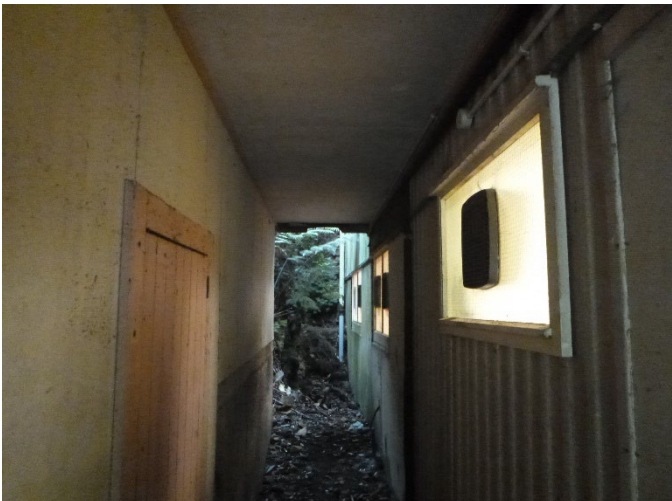
Photograph 9

Alleyway between the old and new building. Generally, in poor decorative condition. Note unsealed floor area.

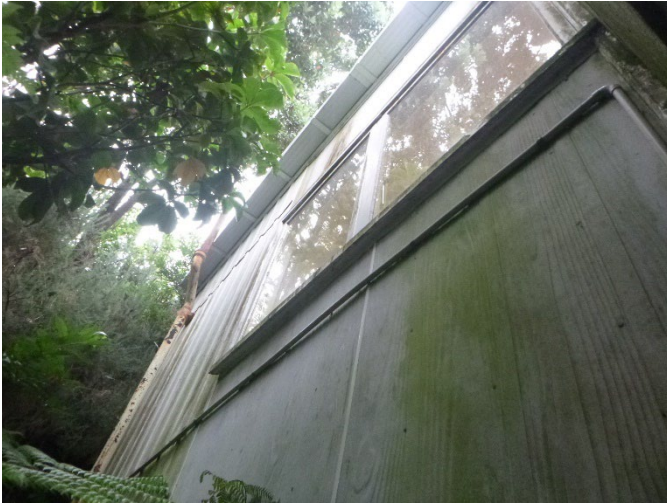
Photograph 10

Partial view of rear elevation beyond the alleyway. Note staining and discolouration to cladding.

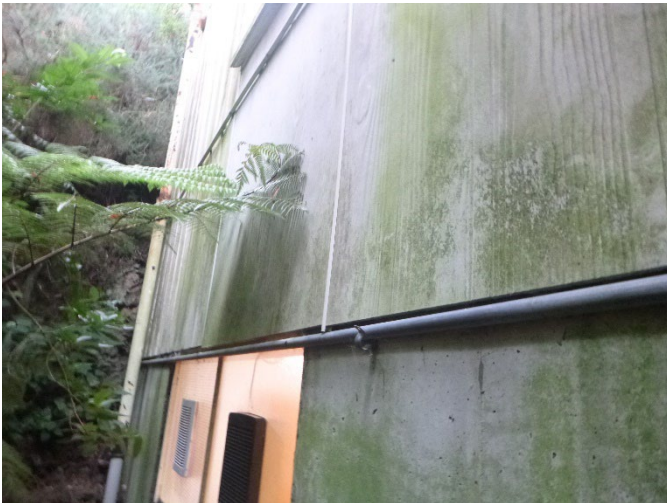
Photograph 11

Partial view of rear elevation beyond the alleyway. Note staining and discolouration to cladding.

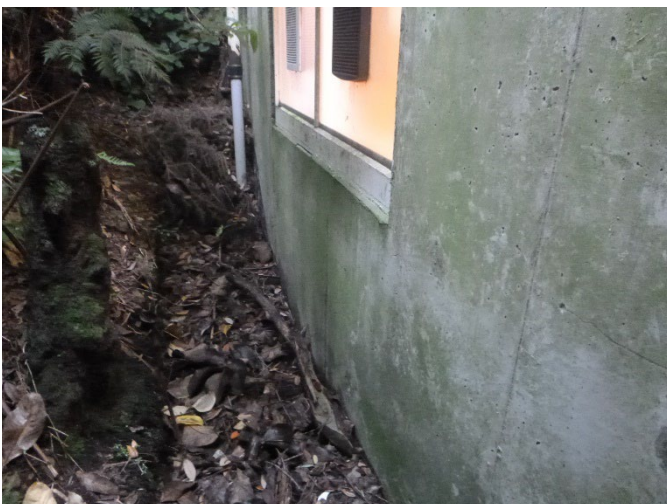
Photograph 12

Partial view of rear elevation beyond the alleyway. Note staining and discolouration to cladding as well as raised ground level.

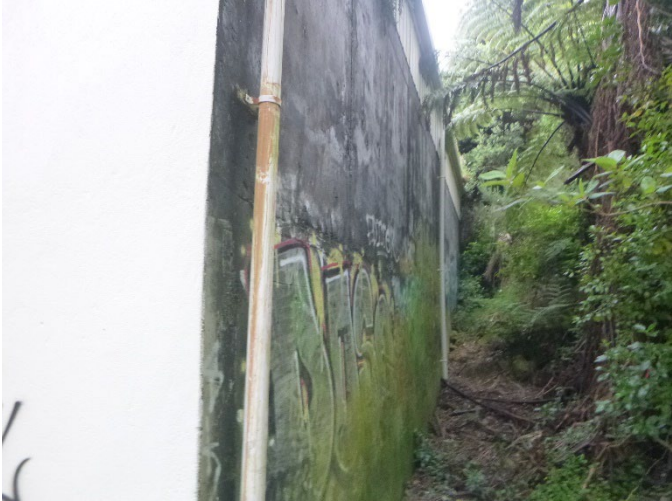
Photograph 13

Partial view of southwest (side) elevation. Graffiti to concrete and overgrown vegetation.

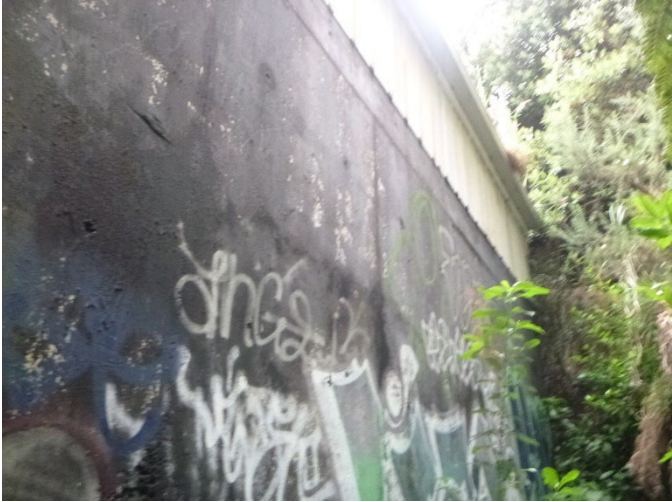
Photograph 14

Partial view of southwest (side) elevation. Graffiti to concrete and overgrown vegetation.

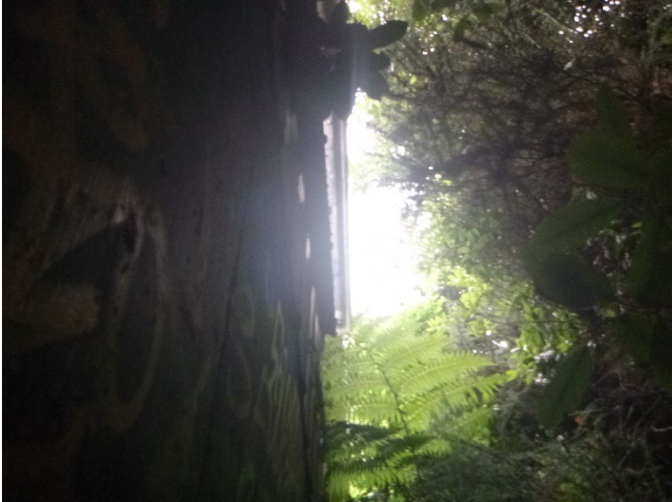
Photograph 15

- 2.2.2 The external fire escape route from the fire door mentioned above is in poor condition (likely a consequence of an historic landslip behind the building). The escape route is uneven/sloping over rough ground which is heavily overgrown with vegetation. There is a significant gap between the external door threshold and the ground level, which poses a potential trip hazard when exiting the building. The current contracted user of the building (a holiday club) advised that their staff had used the exit recently in practice and whilst they managed to get around the building, but it was reportedly difficult. This route would not be considered a suitable route for the 20+ young children using the building as part of the holiday club and is considered unsafe. Clarification should be sought as to whether this is still a designated escape route and if so, appropriate measures should be taken to maintain the alternative means of escape from the building.

Partial view of southeast (rear) elevation. Note overgrown vegetation and location of a recent landslip.

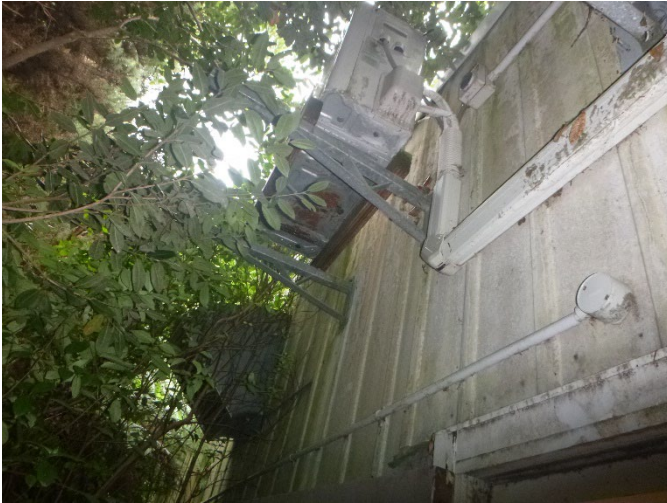
Photograph 16

Partial view of southeast (rear) elevation as viewed from beyond the first floor fire door. Note corrosion to heat pump condenser unit and possible asbestos cladding.

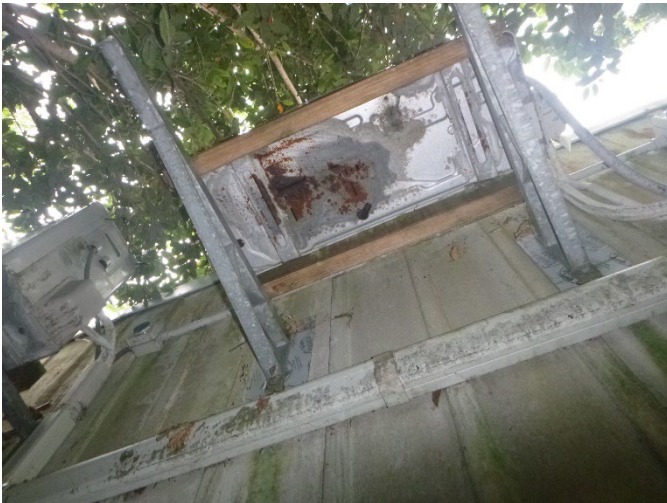
Photograph 17

Partial view of southeast (rear) elevation as viewed from beyond the first floor fire door. Note corrosion to heat pump condenser unit and possible asbestos cladding.

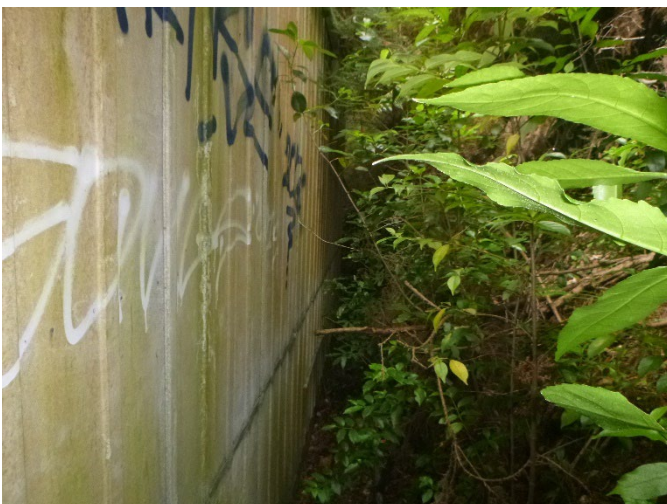
Photograph 18

Partial view of southeast (rear) elevation as viewed from beyond the first floor fire door. Note discoloured cladding.

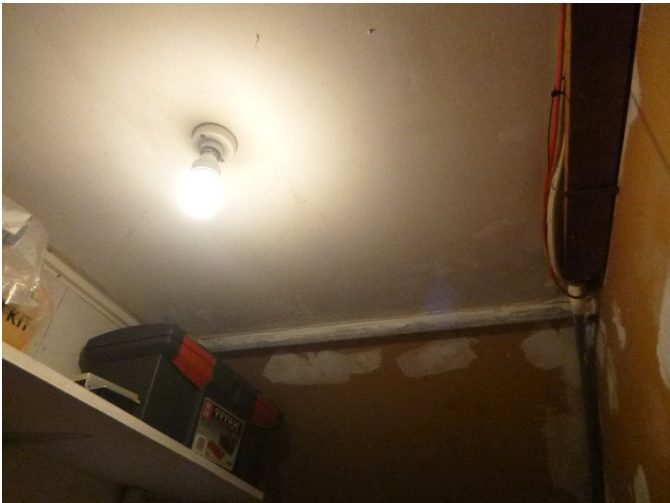
Photograph 23

Ground floor store cupboard, note unfinished decorations.

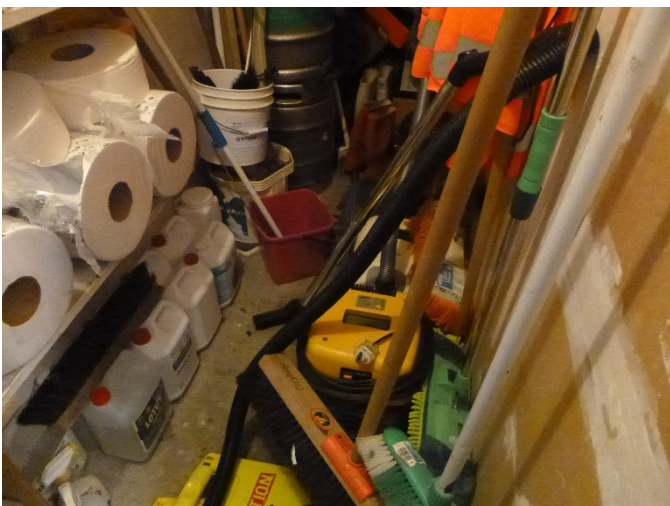
Photograph 24

Ground floor store cupboard, note unfinished decorations.

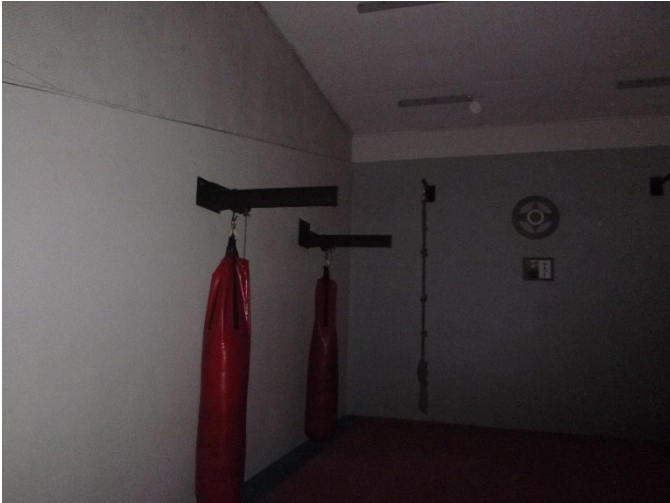
Photograph 25

- 2.2.4 The lights to the front squash court, (now) were not operational at the time of our inspection. There was broken light switch in the entrance hall that may have operated these lights, but as the switch has been pushed into the wall it was not possible to operate. The switch will require replacement.

Partial view of dojo (former squash court)
no lighting affected quality of photographs.

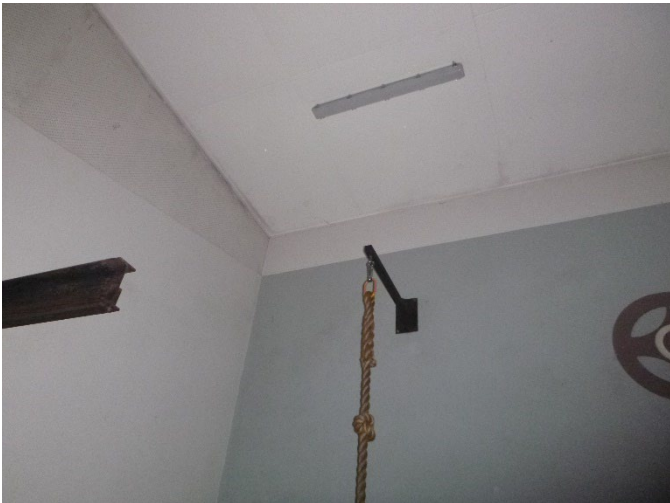
Photograph 26

Partial view of dojo (former squash court)
no lighting affected quality of photographs.

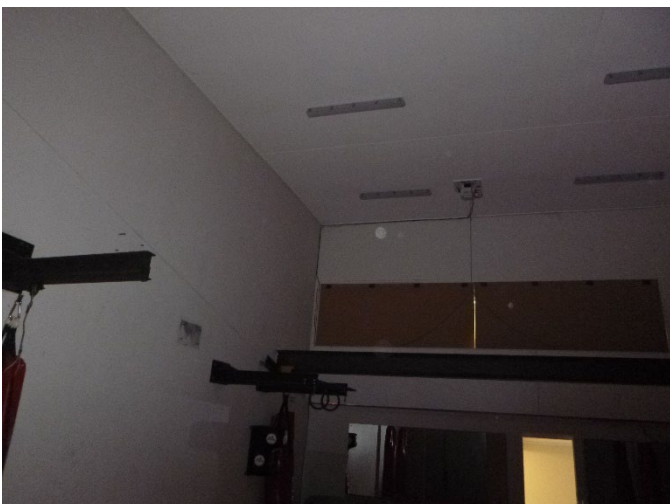
Photograph 27

Partial view of dojo (former squash court)
no lighting affected quality of photographs.

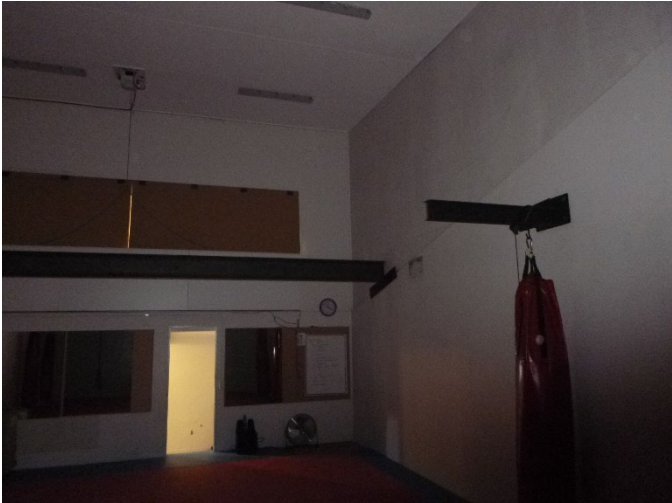
Photograph 28

Partial view of dojo (former squash court) no lighting affected quality of photographs.

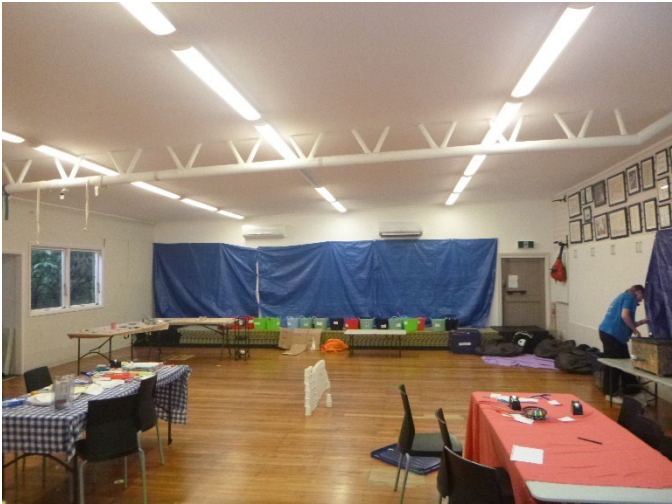
Photograph 54

- 2.2.1 During our inspection we observed the rear fire/emergency escape door from the first floor open plan area is partially blocked by stored floor matting. We understand that this escape door is still considered a designated escape route from the building, which should therefore be unobstructed. Reconfiguring the storage of the matts to a different location would resolve this issue.

Overview of the first floor hall. Note stored floor matting obscures the fire escape route.

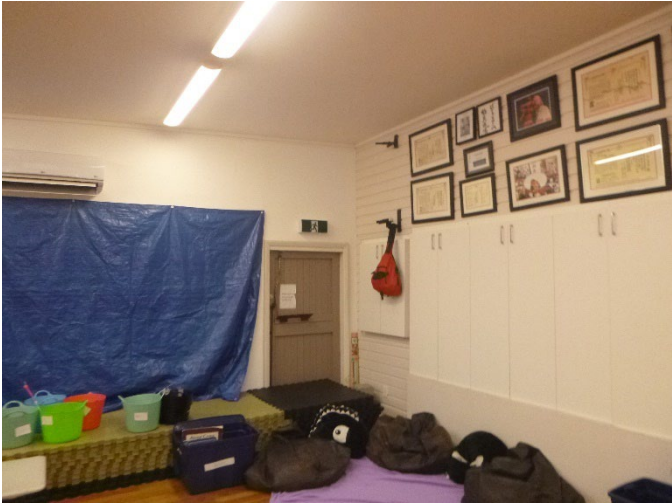
Photograph 55

Close up of the obscured fire escape door.

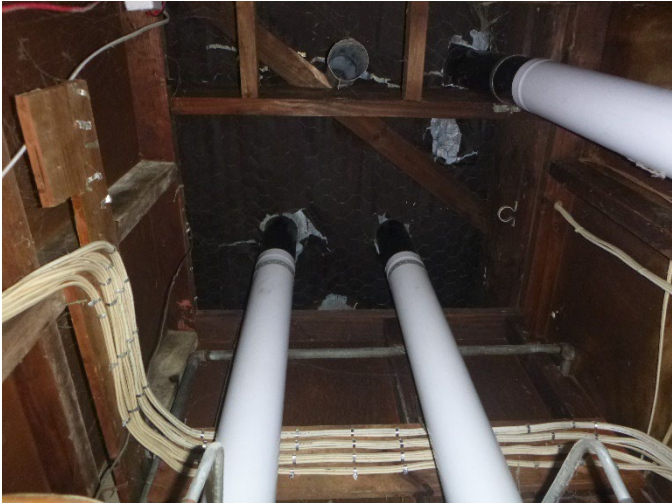
Photograph 59

- 2.2.3 We have not had sight of an asbestos survey or asbestos management plan for the building. Based upon our inspection there is the potential for asbestos to be present in the older external cement sheet wall cladding. In the first floor water heater cupboard an older redundant asbestos cement flue/pipe is likely to be an asbestos containing material. The cement sheet, products are relatively stable if they are undamaged. A white fibrous rope was noted to be

First floor store cupboard, note old redundant flues are possibly an asbestos contain material.

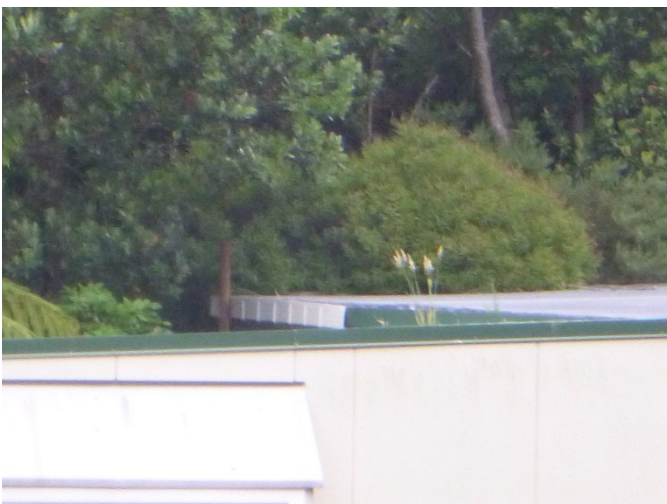
Photograph 69

- 2.1.3 The amount of vegetation around the building has resulted in gutters becoming blocked with notable vegetation growth noted in isolated areas around the building at the time of our inspection.

Close up of photograph 68, note vegetation growth to gutters.

2.2	Rainwater Goods																							
2.2.1		High Level perimeter of roof	Profile metal gutters.	Reasonable condition, but visibly blocked and obscured by vegetation.	Allow thorough clean through of gutters and downpipes to be undertaken at least 6 monthly.	R	25 lin.m	10	450	6 monthly	900	900	900	900	900	900	900	900	900	900	9,000

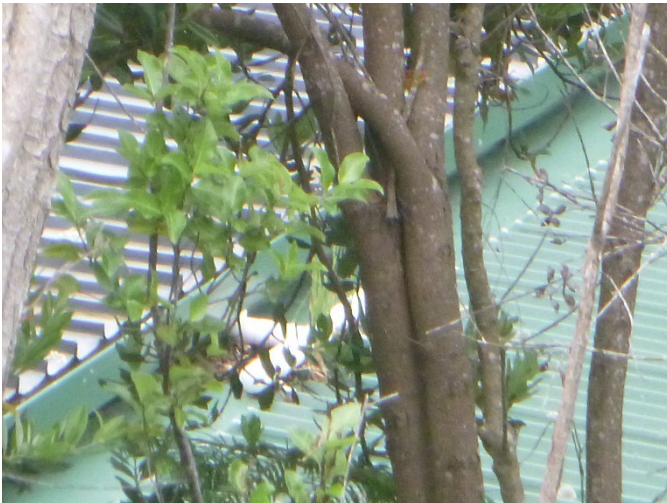
Photograph 71

Partial view of the junction between the original and additional roof area taken from the walkway above and behind the building. Note, some vegetation noted around the rainwater spreader.
