Ref: 8442 L02

23 September 2020

Huddart Parker Sign Steelwork

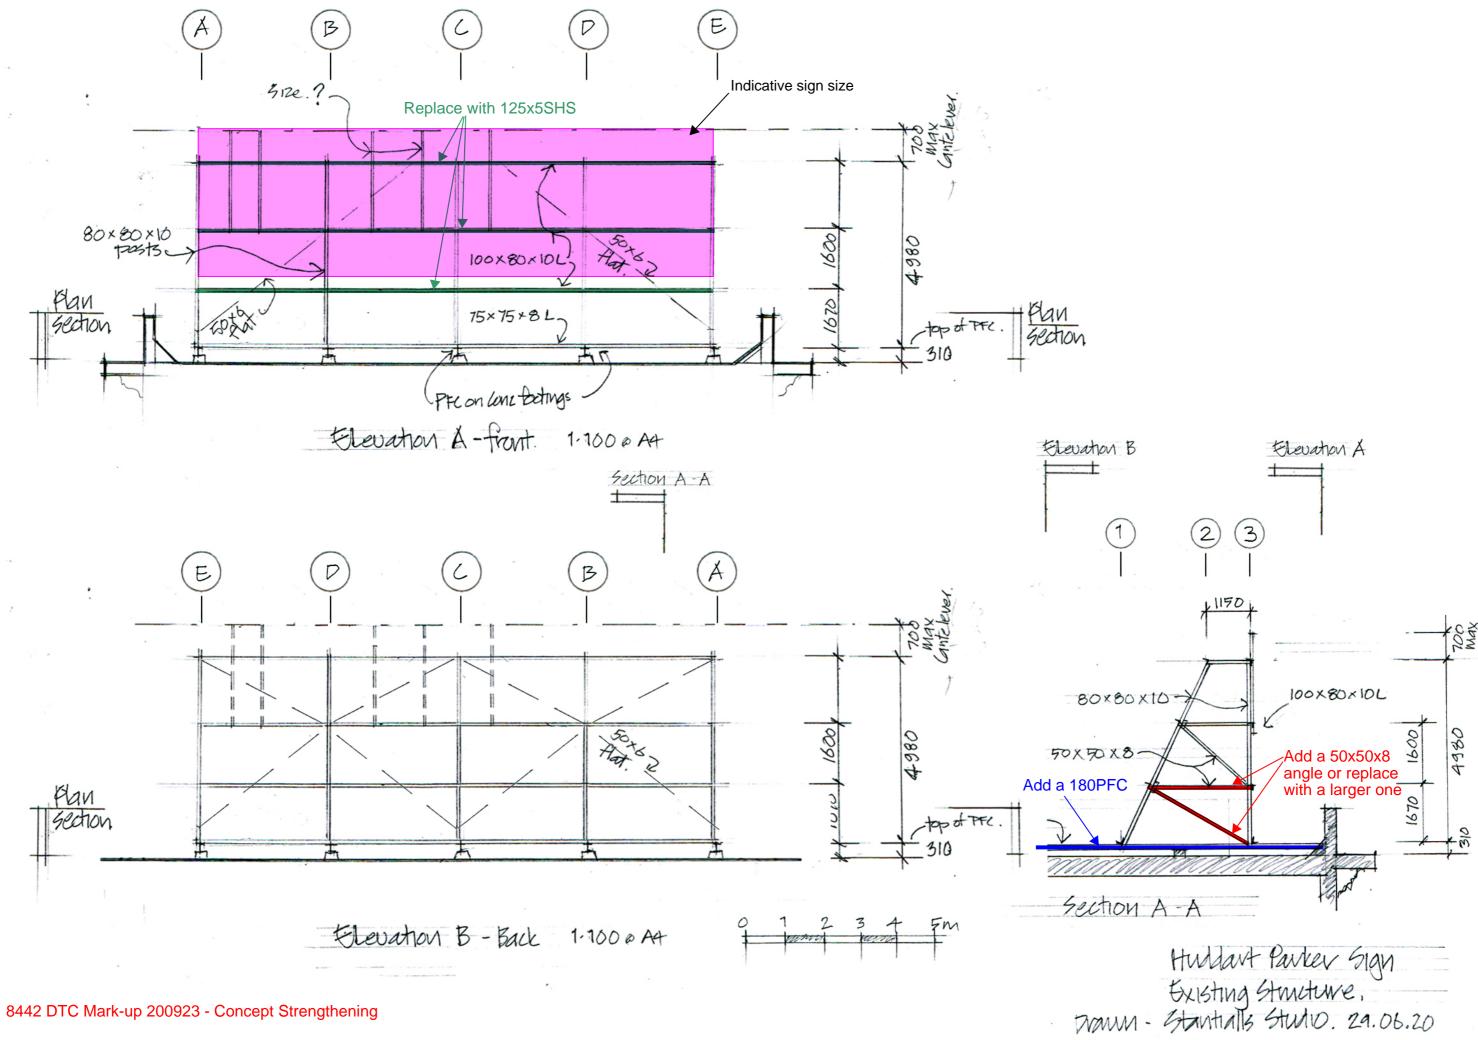
The results are a little mixed with some of the existing members having adequate capacity and some requiring strengthening and/or replacement. The attached concept sketch shows the members that would require attention. We also note that, depending on the make-up of the sign itself, some additional secondary steel members may be required to affix the sign panels to the primary framework.

In addition, and as we observed on site, the steelwork also requires general maintenance (paint-stripping, rust-repair and repainting) and this may identify some other members that require structural repair/strengthening. We also recommend that you should allow to replace say 50% of the existing bolts and to improve connection to the roof deck.
