Seismic Risk Evaluation for Wellington City Council

Embassy Theatre Kent Terrace

July 2025

Kestrel Seismic Risk Evaluation Report on Embassy Theatre 20250728

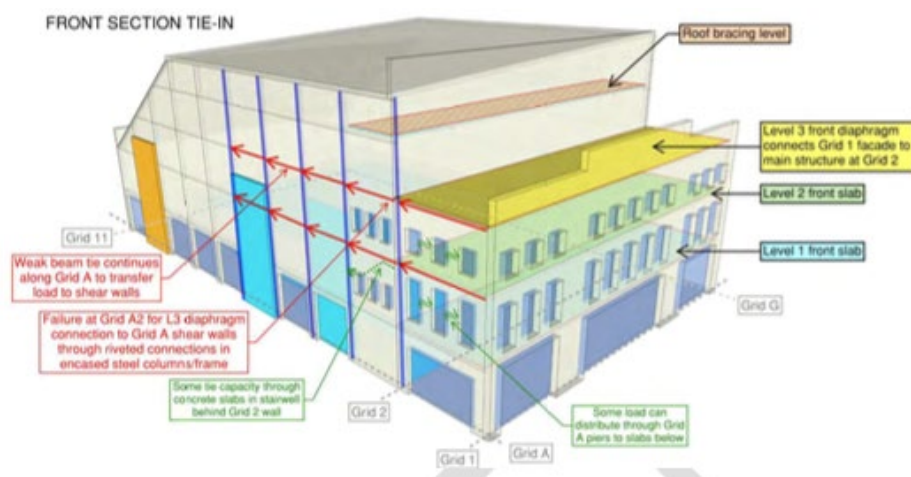
The roof level concrete diaphragm slab (Level 3) between the Kent Terrace frontage and the high level wall to the roof over the main theatre is inadequately connected to the shear wall along Marjoribanks Street. This is primarily due to the weak capacity of the encased steel beam rivet to column connection and lack of bracing capacity due to large window openings. In strong shaking there could be a separation of the elements at this point, leaving the north-west corner of the building vulnerable.

The south wall supporting the high side of the lightweight roof cantilevers 4.3 metres above the steel roof trusses that span the main theatre space. The wall has limited out-of-plane capacity. Possible hingeing immediately above the steel roof trusses could lead to wall collapse into the empty southern lot.

- Improving the connections of the Level 2 and Level 3 diaphragms back to the main shear walls along Marjoribanks Street and the corresponding south side wall is recommended. This may take the form of long tie beams/plates fixed to the face of the shear walls and diaphragm edges. This could more readily be undertaken externally if that was agreed to by the heritage architect.
- The upper roof structure above the main theatre has a sarked timber diaphragm supported on stud frames that sit on top of the main steel roof trusses. The load path from the upper roof diaphragm to the steel trusses could be improved by bracing these stud frames in both orthogonal directions to the trusses below and by enhancing the connection of the south wall to the high-level roof.
