Invasive and Destructive Weathertightness Report

**Karori Community Hall, England Lane,
Karori, Wellington**

Wellington City Council

Date of Report July 2024

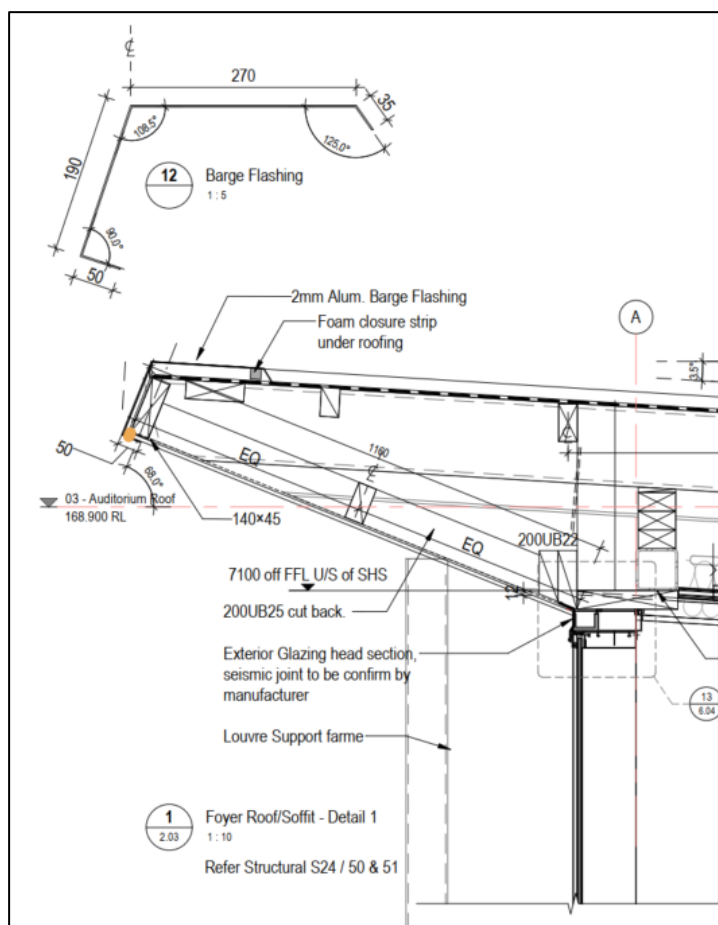
Barge flashing detail in Consent number SR334503-1:

Adjoining the reverse slope eaves above the north and west elevations, the barge flashing at the perimeter of the upper metal sheet roof laps vertically down and returns over the Villaboard compressed sheet soffit linings. This is as per the Building Consent details provided in the architectural drawings, produced by Shand Shelton (drawing sheet A6.06, Detail 1 – extra shown below).

No drip edge has been provided to deflect water running down the face of the barge flashing away from the building, and instead the 50mm horizontal return directs water back onto the soffit linings. This has caused accelerated deterioration of the flush stopped joints between the Villaboard soffit panels, nearly all of which are visibly delaminating and damaged, with open gaps visible.

Closer observation revealed water droplets holding at the junction between the lowest edges of the barge flashing return and the soffit linings, which we consider provides a capillary path for moisture to track between the flashing and the soffit back, into the roof void.

Upon destructive testing of a select number of the worst affected soffit joints below the barge flashings, we observed open gaps in the joints of circa 3-10mm and significant degradation of the stopping compound, which

However, due to the ability for moisture to ingress, the current barge and soffit construction has been confirmed as not performing and will, in our view, require redesign and reconstruction.

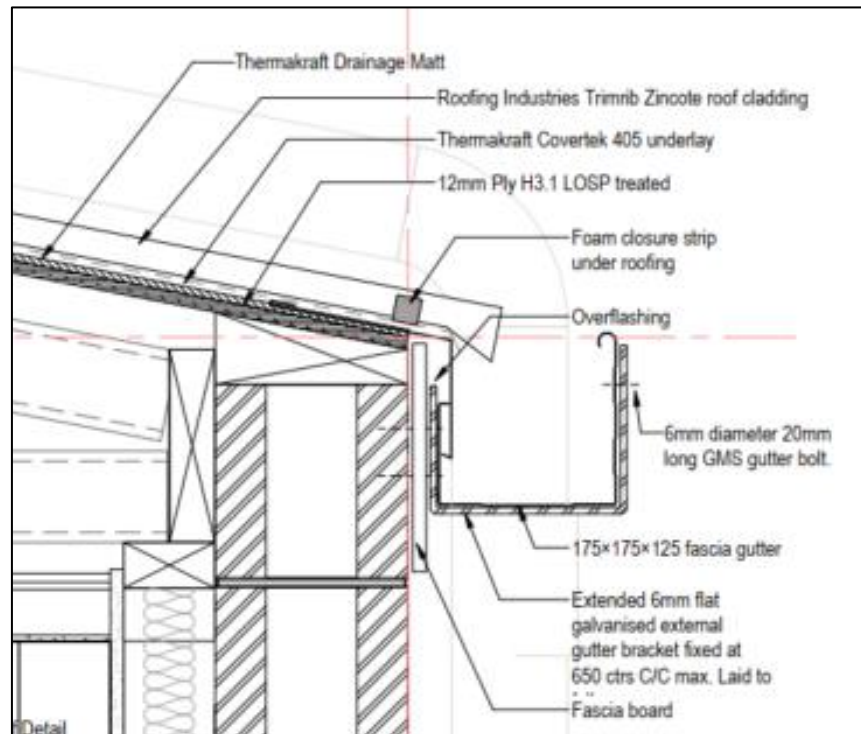
The details on Drawing Sheet A6.02 (snippet below) show a downturn to the eaves flashing which laps down over half the height of the internal side of the box gutter (125 x175 x175mm box gutter, therefore this would have been an approx. 65mm overlap).

Given the walls below are blockwork, mitigating flow of surface run off over these is an important consideration, including provision of correctly detailed eaves flashings on roofing with minimal roofing projection beyond the elevations below.

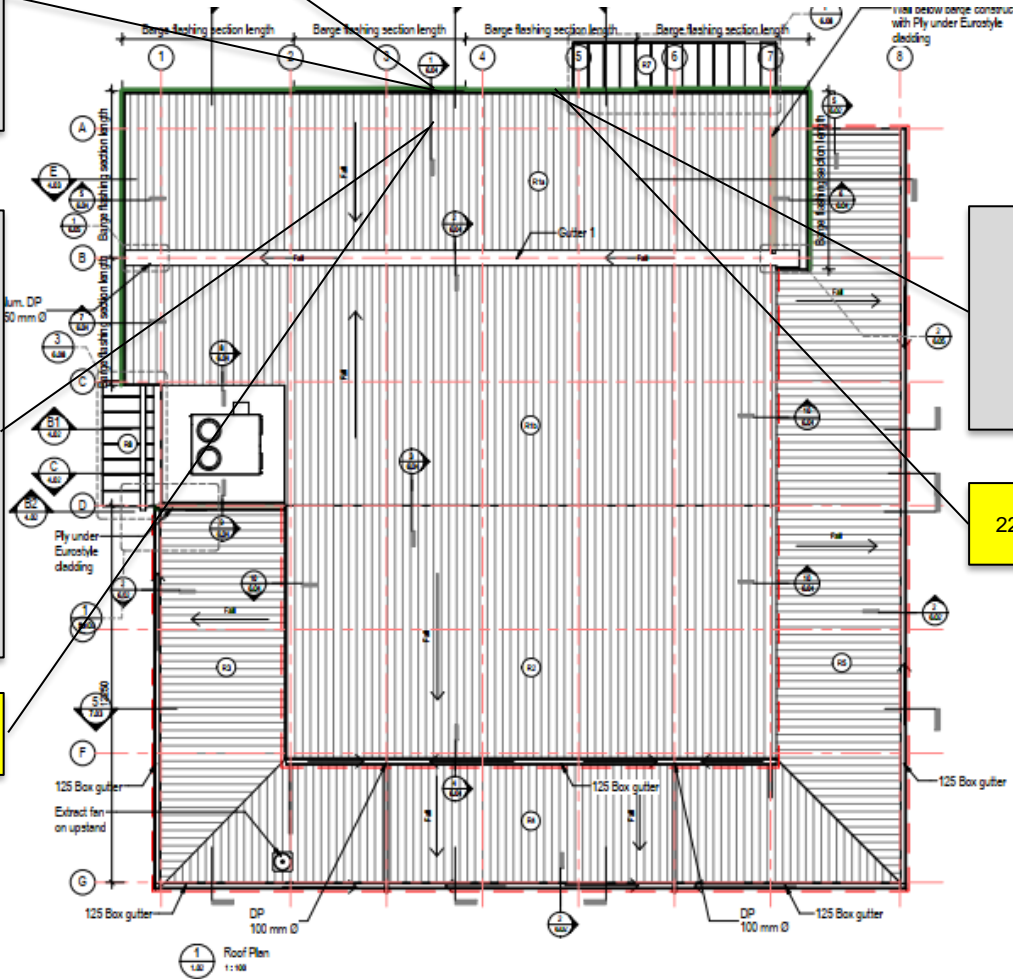
D#4
Decay & Fungal Analysis: No established Decay.
No sample collected.
Observations: 10mm open gap at soffit board junction with stopping compound have completely deteriorated. Reverse slope heave flashing extends approx. 110mm up behind soffit linings and down over the head of the curtain walling below, although the building wrap does not lap over the eave flashing and is instead underlapped.
