Shelly Bay, Shed 8 - Foundation Inspection			Inspection-43 – Rev 1
Date:	22/06/2020	Weather	Fine
Time:	11:15 Am	Job #	1000057
Tide:	Low @ 11:38 am	Inspectors	SELO, JIDE
Monitoring observations			
Void space A, refer attached Figure 1 for void location

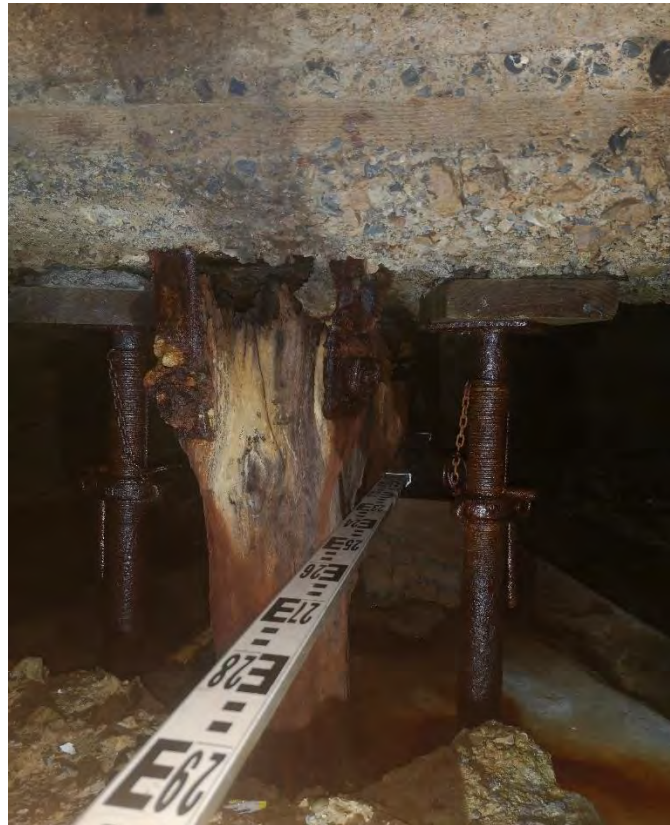
Photograph 1 & 2: Void A left from hatch, above 22/06/2020, 10/10/2019 below.

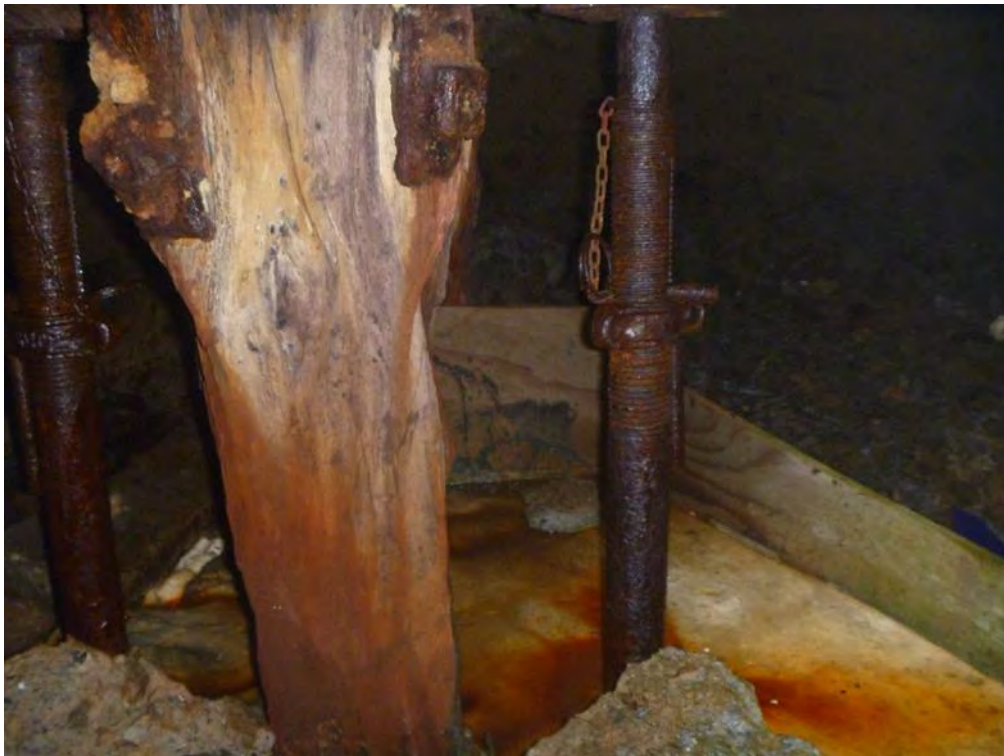
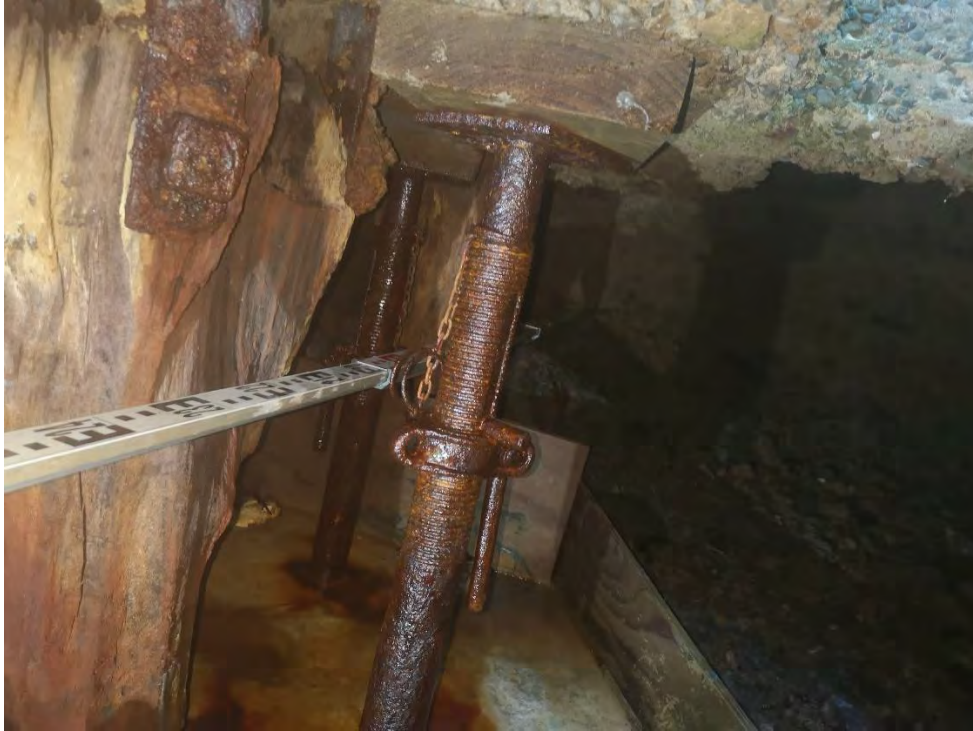
Item	Changes observed since previous visit	Observations and measurements	Photo ID
Void Depth	Nil	3.1 m measured from back of void to front of void (back of plywood facing) using survey ruler.	3
Void Width	Nil	Extends south to Void B and north to Void D (South).	-
Timber Piles	Nil	Front pile is in very poor condition, likely to be offering little or no support to the pile cap. Rear pile is also in very poor condition, likely to be offering little or no support to the pile cap.	1, 3
Steel Props	Nil	Both props show no sign of significant weakening (corrosion) and no sign of buckling, although they are considered to be under significant load from the pile cap. No new undermining of grout pad observed during inspection.	1, 3
Timber (Plywood) Protective Facing	Nil	Facing is secure.	5
Void space B, refer attached Figure 1 for void location

Photograph 3 & 4: Void A. Photos above taken 22/06/2020, below taken 10/10/2019

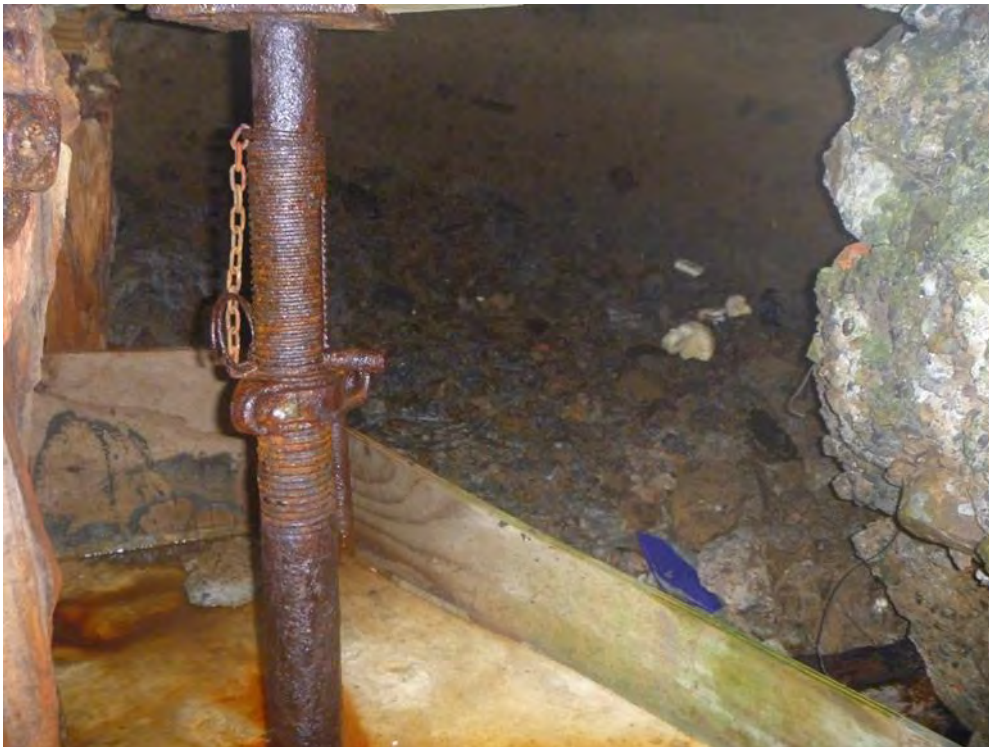
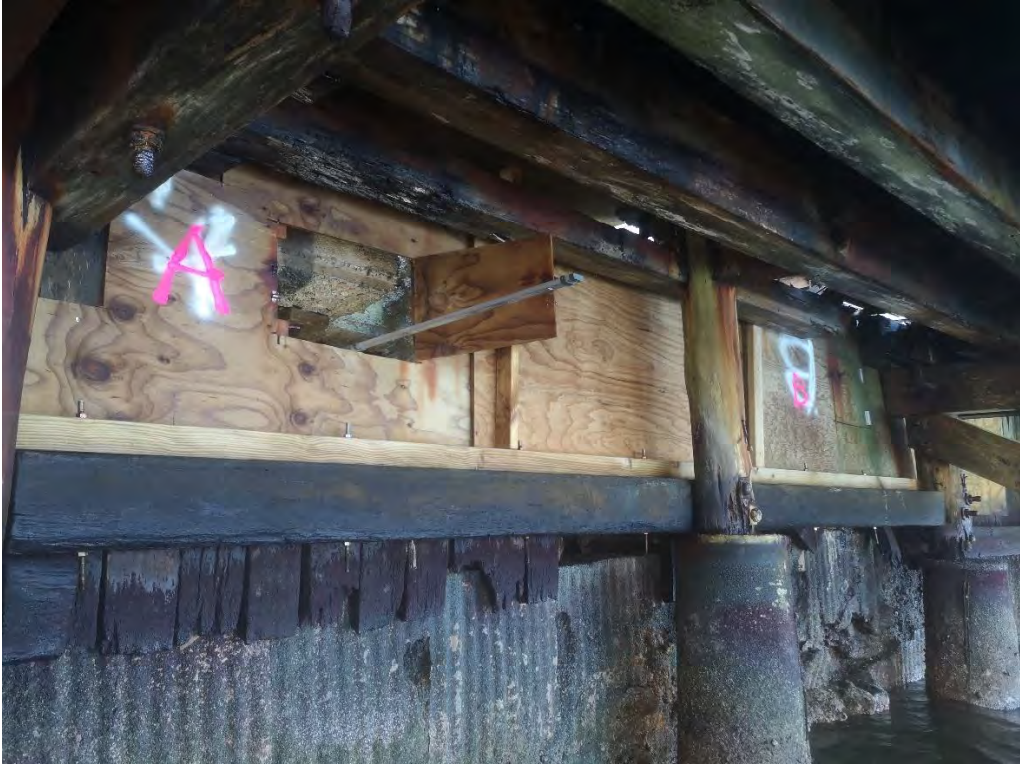
Photographs 5 & 6: Ply facing at Void A. Photographs above taken 22/06/2020. Photo below taken 10/10/2019.

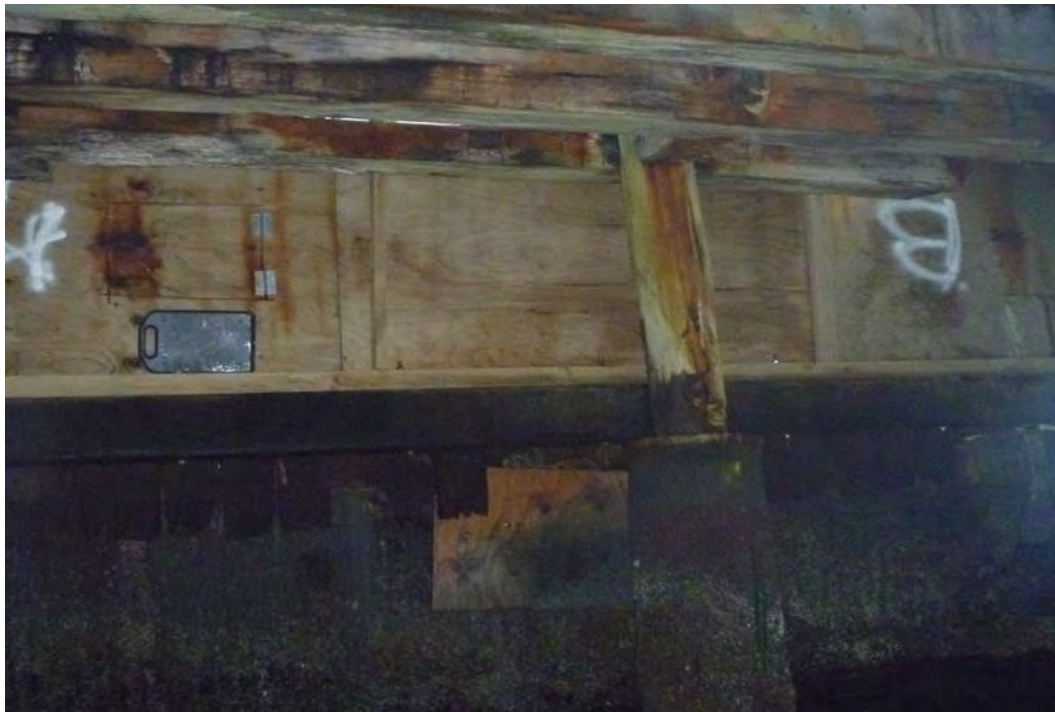
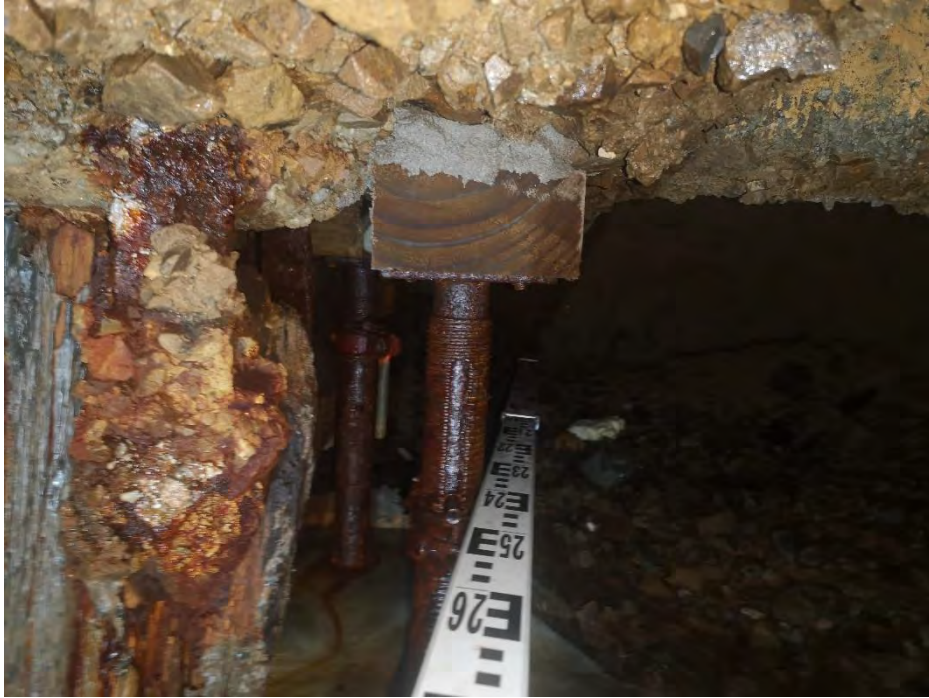
Item	Changes observed since previous visit	Observations and measurements	Photo ID
Void Depth	Nil	3.0m measured from back of void to front of void (back of plywood facing) using survey ruler.	-
Void Width	Nil	Approximately 3.7m measured from southern extent of the void (to the next pile cap) to the centre of the viewing hole. Void extends to the north to Void A.	11
Timber Piles	Nil	Front pile is in very poor condition and likely to be offering no support to the pile cap. Rear pile completely disconnected from the pile cap.	7, 9
Steel Props	Nil	Props show no sign of significant corrosion or weakening and no sign of buckling. No new undermining of grout pad observed during inspection.	7, 9
Timber (Plywood) Protection Facing	Nil	Facing is secure.	-

Photograph 7 & 8: Void B. 22/06/2020 above, 10/10/2019 below.

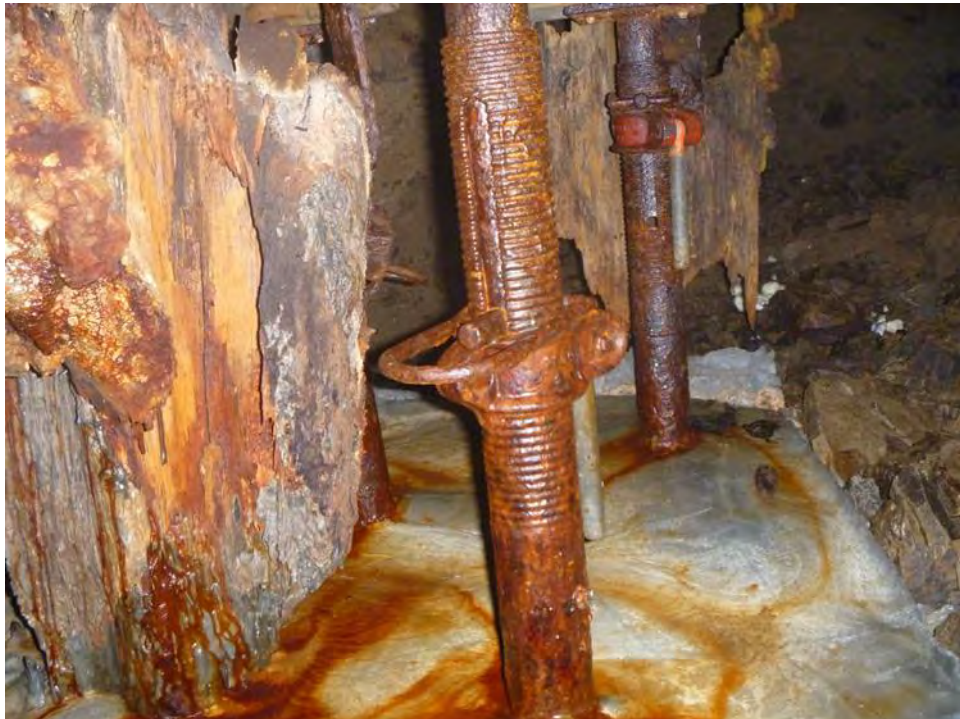
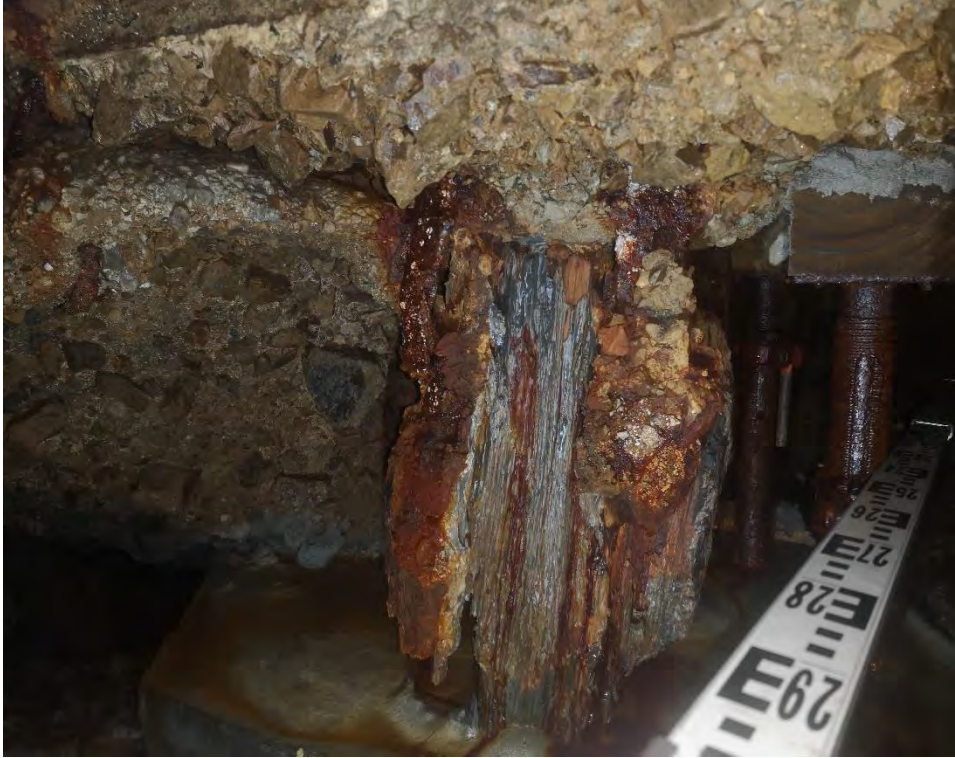
Photograph 9 & 10: Condition of temporary propping and grout pad in Void B. Photo 22/06/2020 above, 10/10/2019 below.

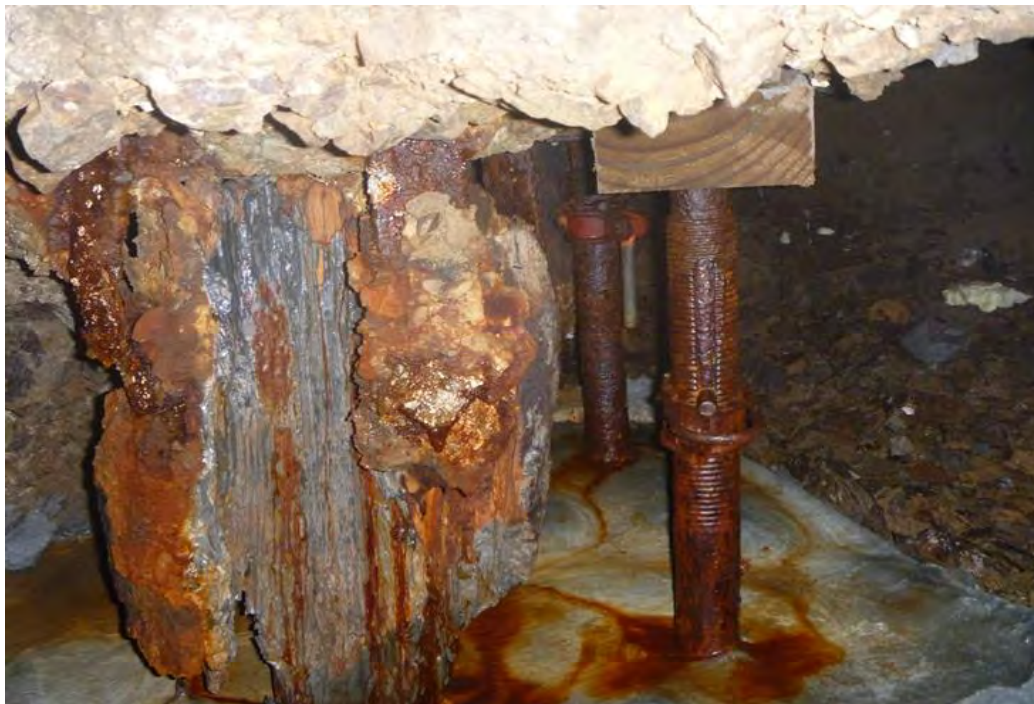
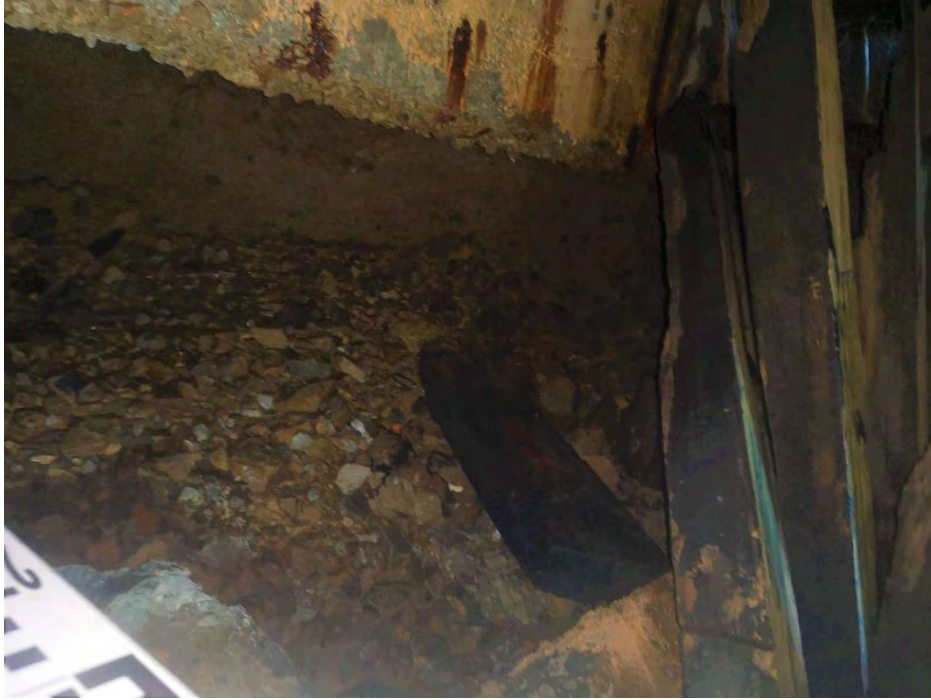
Photograph 11 & 12: View to the right of Void B. Photo above taken 22/06/2020. Photo below taken 10/10/2019.

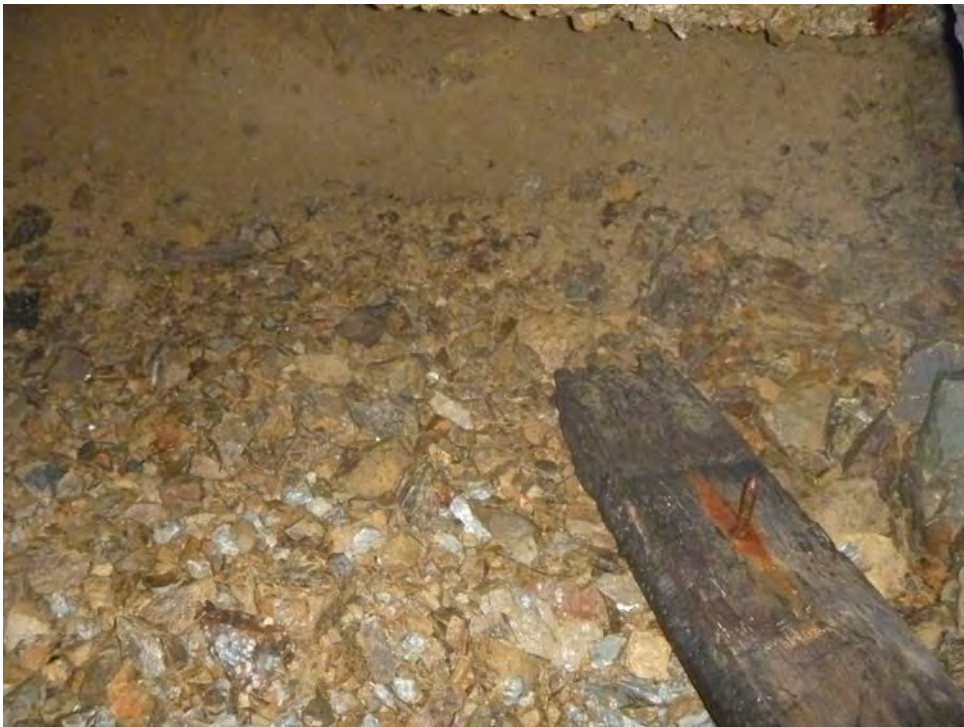
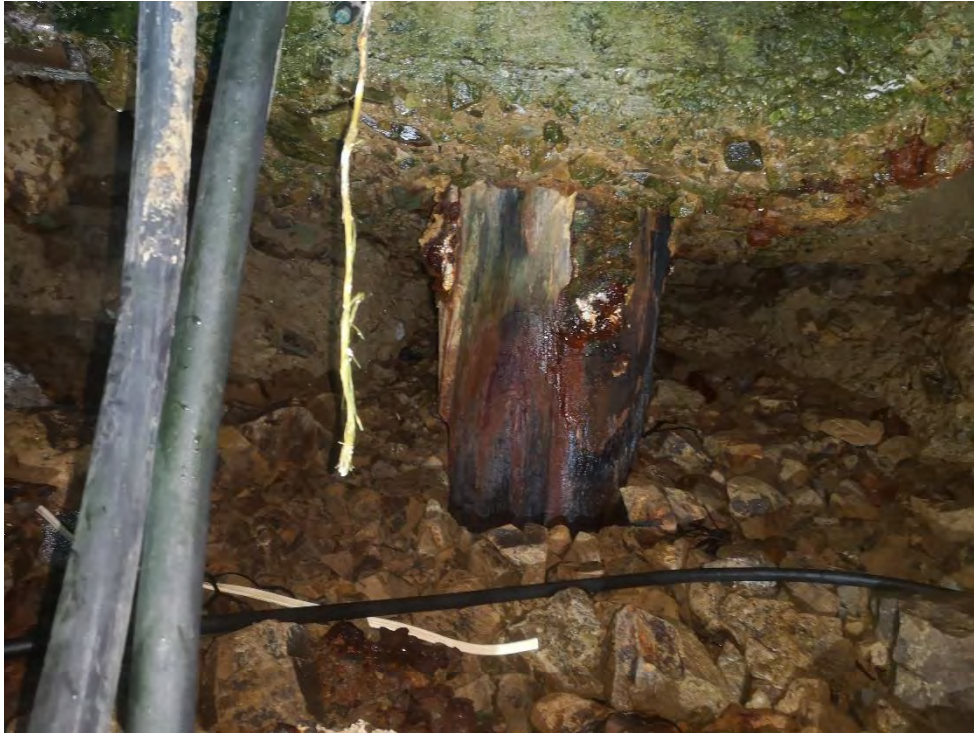
Void space C, refer attached Figure 1 for void location			
Item	Changes observed since previous visit	Observations and measurements	Photo ID
Void Depth	Nil	1.9m measured from the back of the void to the front face of the pile cap with a survey ruler.	13
Void Width	Nil	Measured to be approximately 1.3 m wide on average (with tape measure) beneath the pile cap.	13
Timber Piles	Nil	The front pile is in reasonable condition. The rear pile is in very poor condition and is likely to be providing minimal or no support to the pile cap.	13
Void space D (North), refer attached Figure 1 for void location

Photograph 13 & 14: Void C photo taken 22/06/2020 above. Below 10/10/2019. No noticeable further deterioration of pile nor erosion of void.

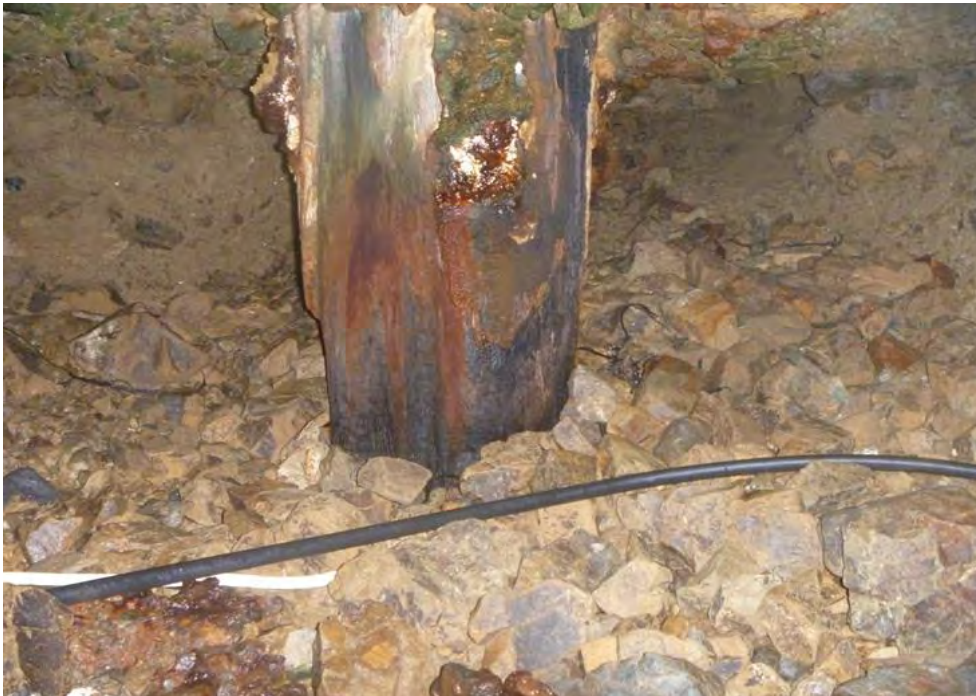
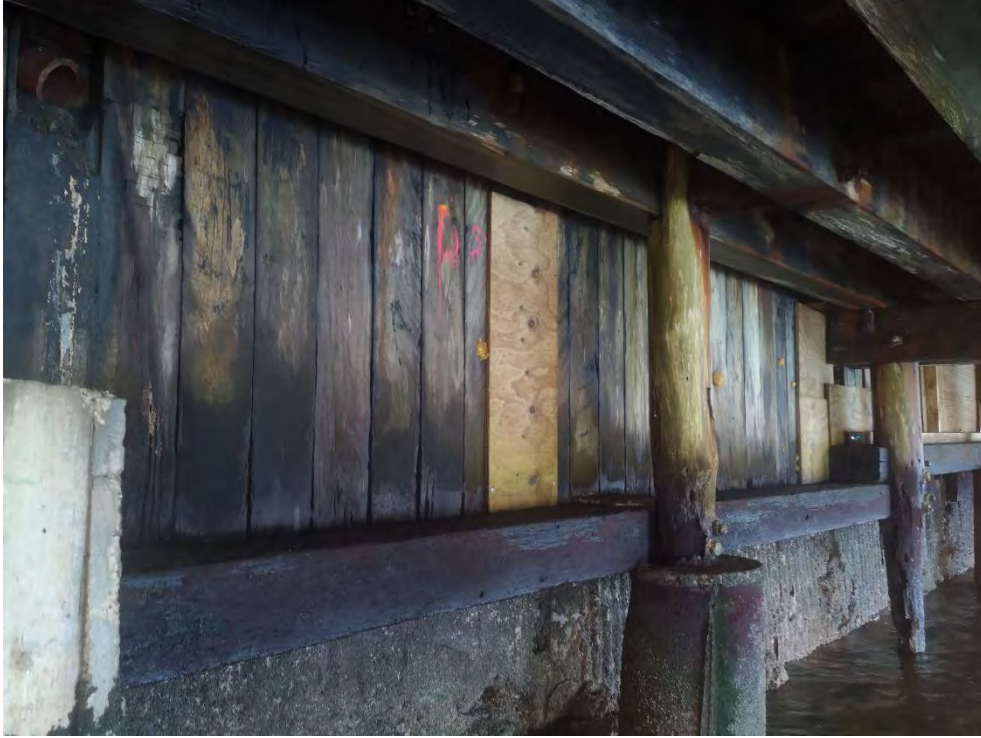
Item	Changes observed since previous visit	Observations and measurements	Photo ID
Void Depth	Unobserved	No longer observable as timber facing has been secured over damaged rails (06/10/2017). It is unlikely that the condition of the void has changed since last visual sighting during inspection on 05 September 2017 (the void is now protected by the timber facing).	-
Void Width	Unobserved		-
Timber Piles	Unobserved		-
Timber Rails	Nil	Facing is secure.	15
Void space D (South), refer attached Figure 1 for void location

Photograph 15 & 16: Condition of timber railings between access point and Void A. Photos taken above 22/06/2020 and 10/10/2019 below. Damaged pile (void space D – foundation to the North) at location indicated by red circle is pictured in Photograph 16 is no longer observable after securing new plywood facing.

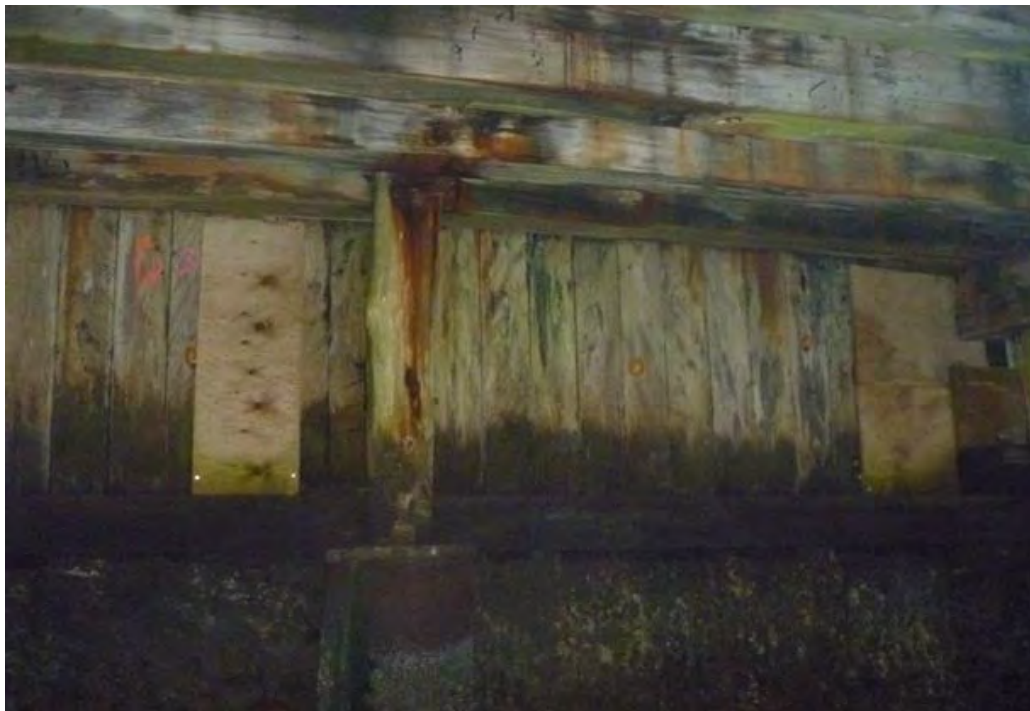
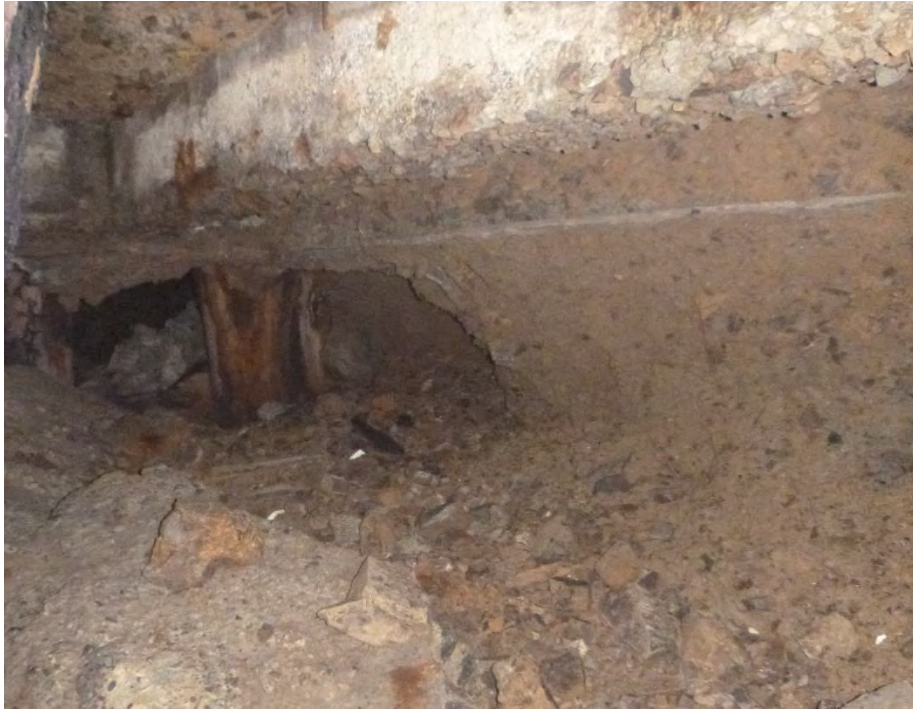
Item	Changes observed since previous visit	Observations and measurements	Photo ID
Void Depth	Unobserved	No longer observable as timber facing has been secured over damaged rails (06/10/2017). It is unlikely that the condition of the void has changed since last visual sighting during inspection on 05 September 2017.	-
Void Width	Unobserved	No longer observable as timber facing has been secured over damaged rails (06/10/2017). It is unlikely that the condition of the void has changed since last visual sighting during inspection on 05 September 2017.	-
Timber Piles	Unobserved	No longer observable as timber facing has been secured over damaged rails (06/10/2017). It is unlikely that the condition of the void has changed since last visual sighting during inspection on 05 September 2017. Rear pile can be observed looking north from Void A. Pile appears to be in a similar poor condition as previously observed. The pile is likely to be providing minimal support to the pile cap. The condition of the front pile is not observable but is likely to be similar to the rear pile.	17

Photograph 17 & 18: Photo 17 above taken 09/03/2020 looking north from Void A. Condition of timber acceptable relative to other piles. Ply facing installed over damaged timber railings so no longer observable from Void D-South. Photo 18 below taken 10/10/2019
