16 December 2022
Job No: 1000057.2000

Update on risk assessment to Shed 8, Shelly Bay, Wellington

Shelly Bay, Shed 8
Figure 1. Cross section
12 December 2022

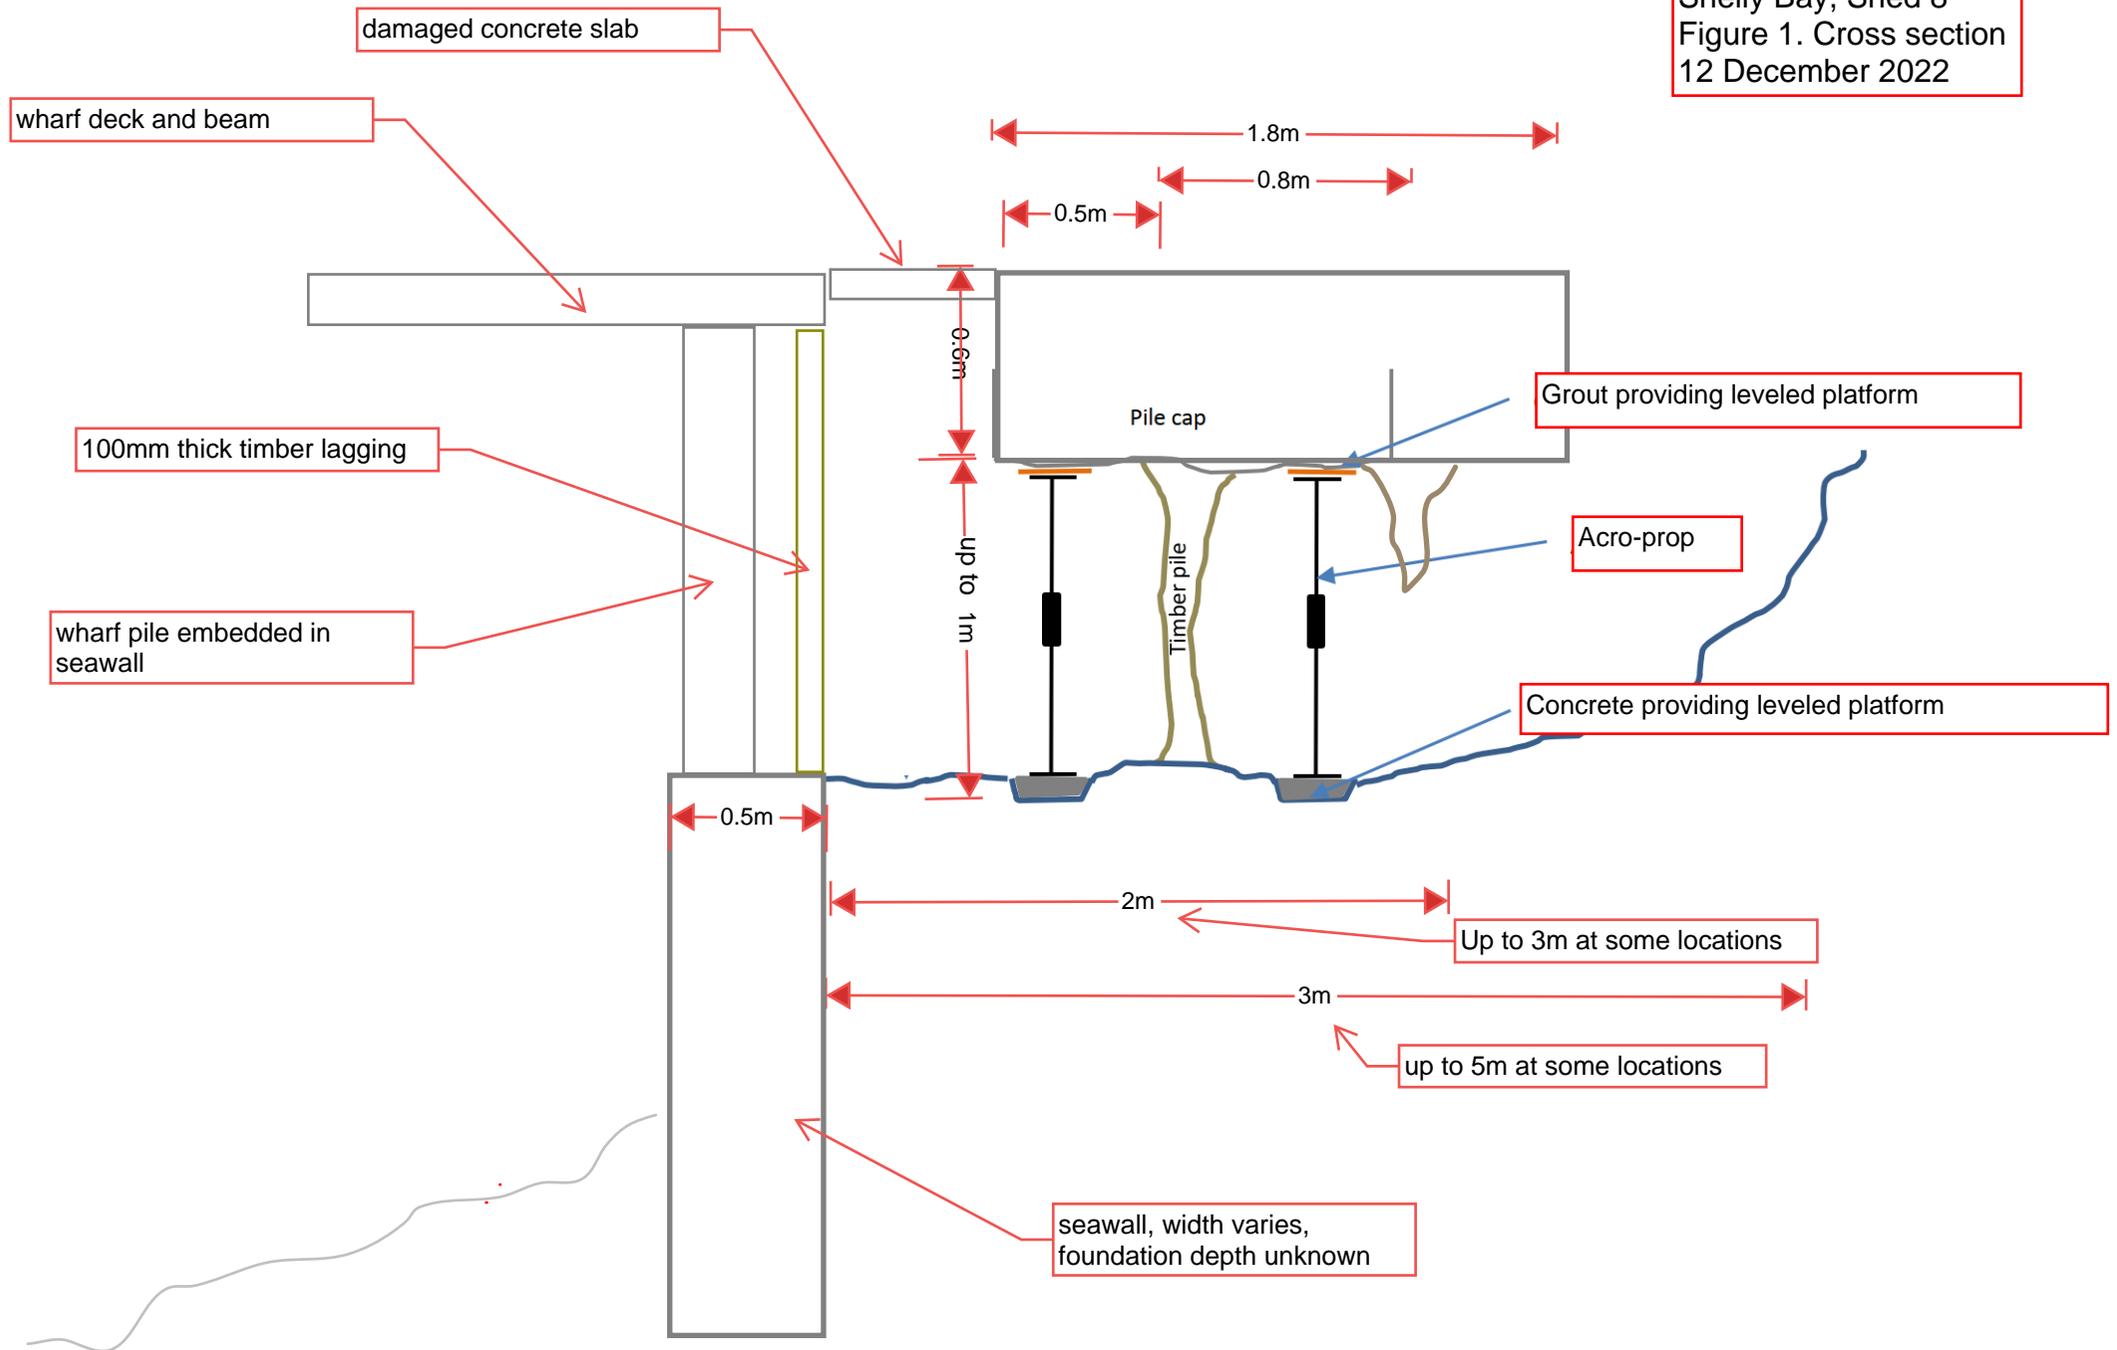
- Ongoing coastal erosion and decay of timber piles has compromised the support provided to the seaward side of the building. Refer to Figures 1 and Figure 2 in Appendix A. There are 26 piles supporting the seaward side of the building. Twelve of these piles were exposed by coastal erosion allowing them to be inspected in 2015. Of these 12 inspected piles, eight were found to be eroded/decayed and did not provide support to their pile caps. Some support was reinstated by the installation of acro-props in 2015. The remaining 14 piles along the building's seaward edge were not exposed by coastal erosion and thus could not be inspected. The condition of these 14 piles is unknown. Some of these piles may not be providing support to their pile caps.

Support of the pile caps from the soil directly beneath the pile caps is likely to be ineffective because that loose fill has limited lateral restraint (Refer Figure 1 Appendix A).

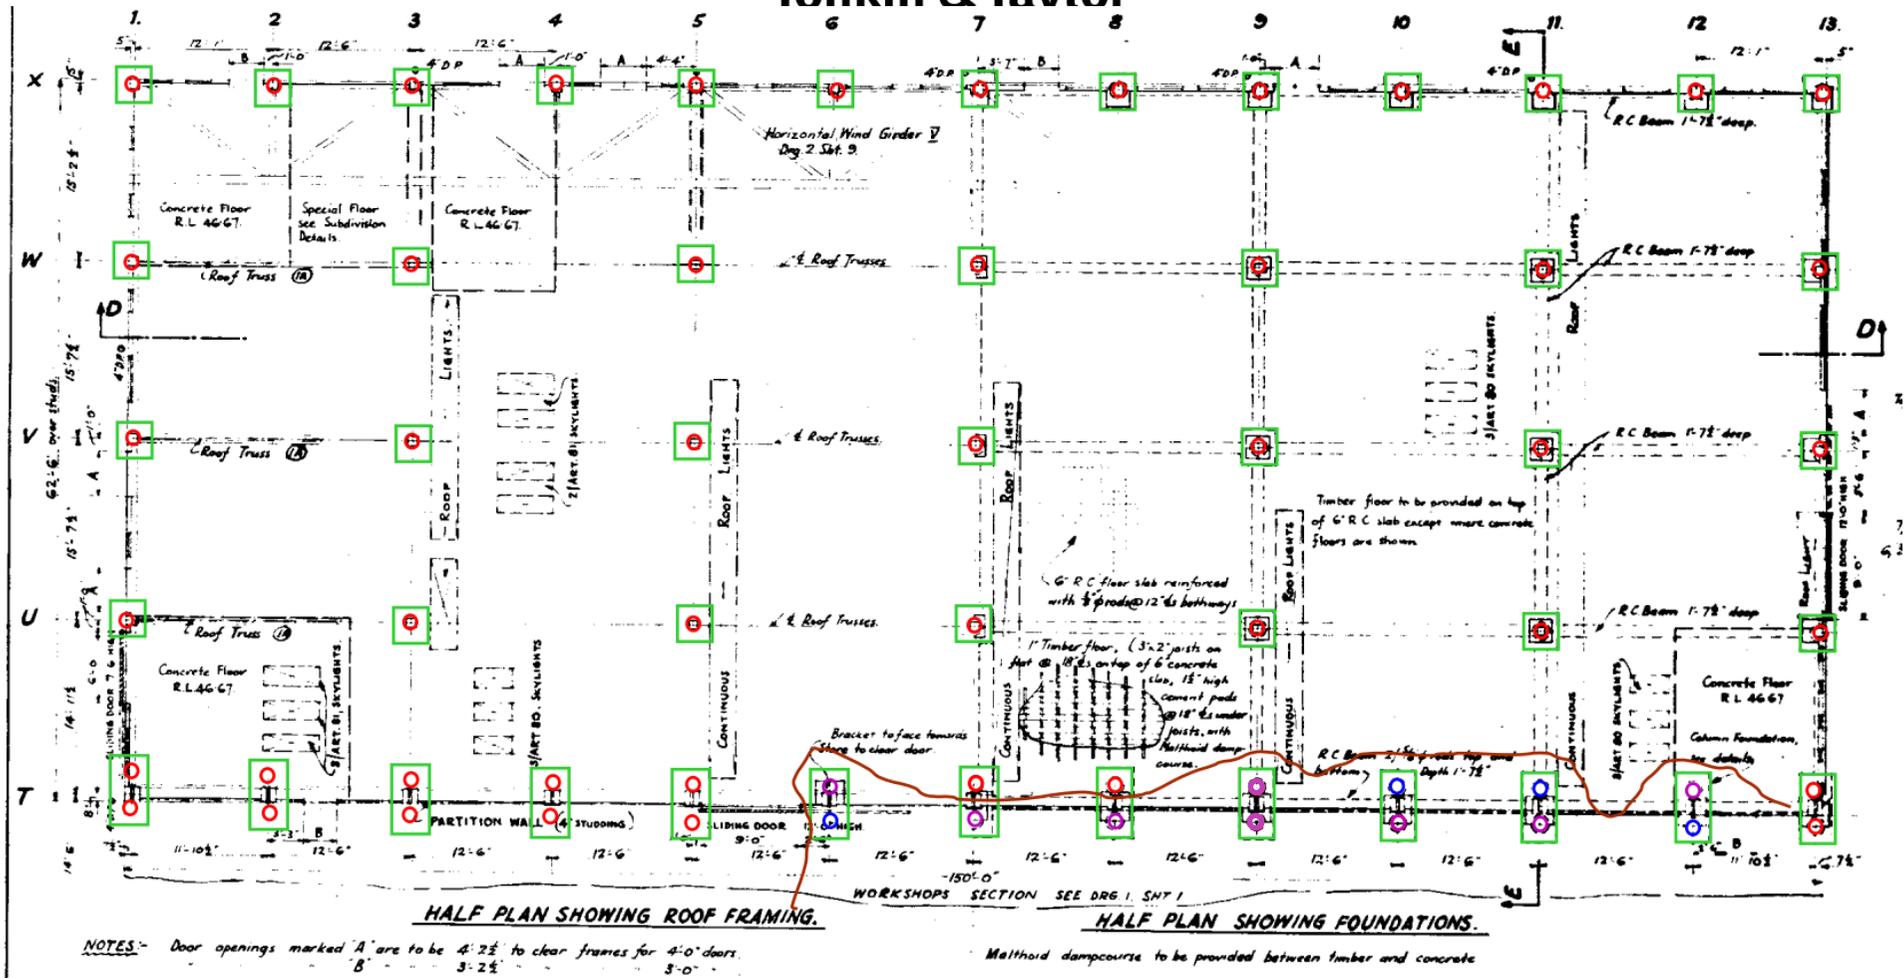
Figure 2 – Foundation Plan

Piles not inspected
-

Inspected piles in acceptable condition
-

Damage piles, no support to pile cap
-

Approximate extent of undermining

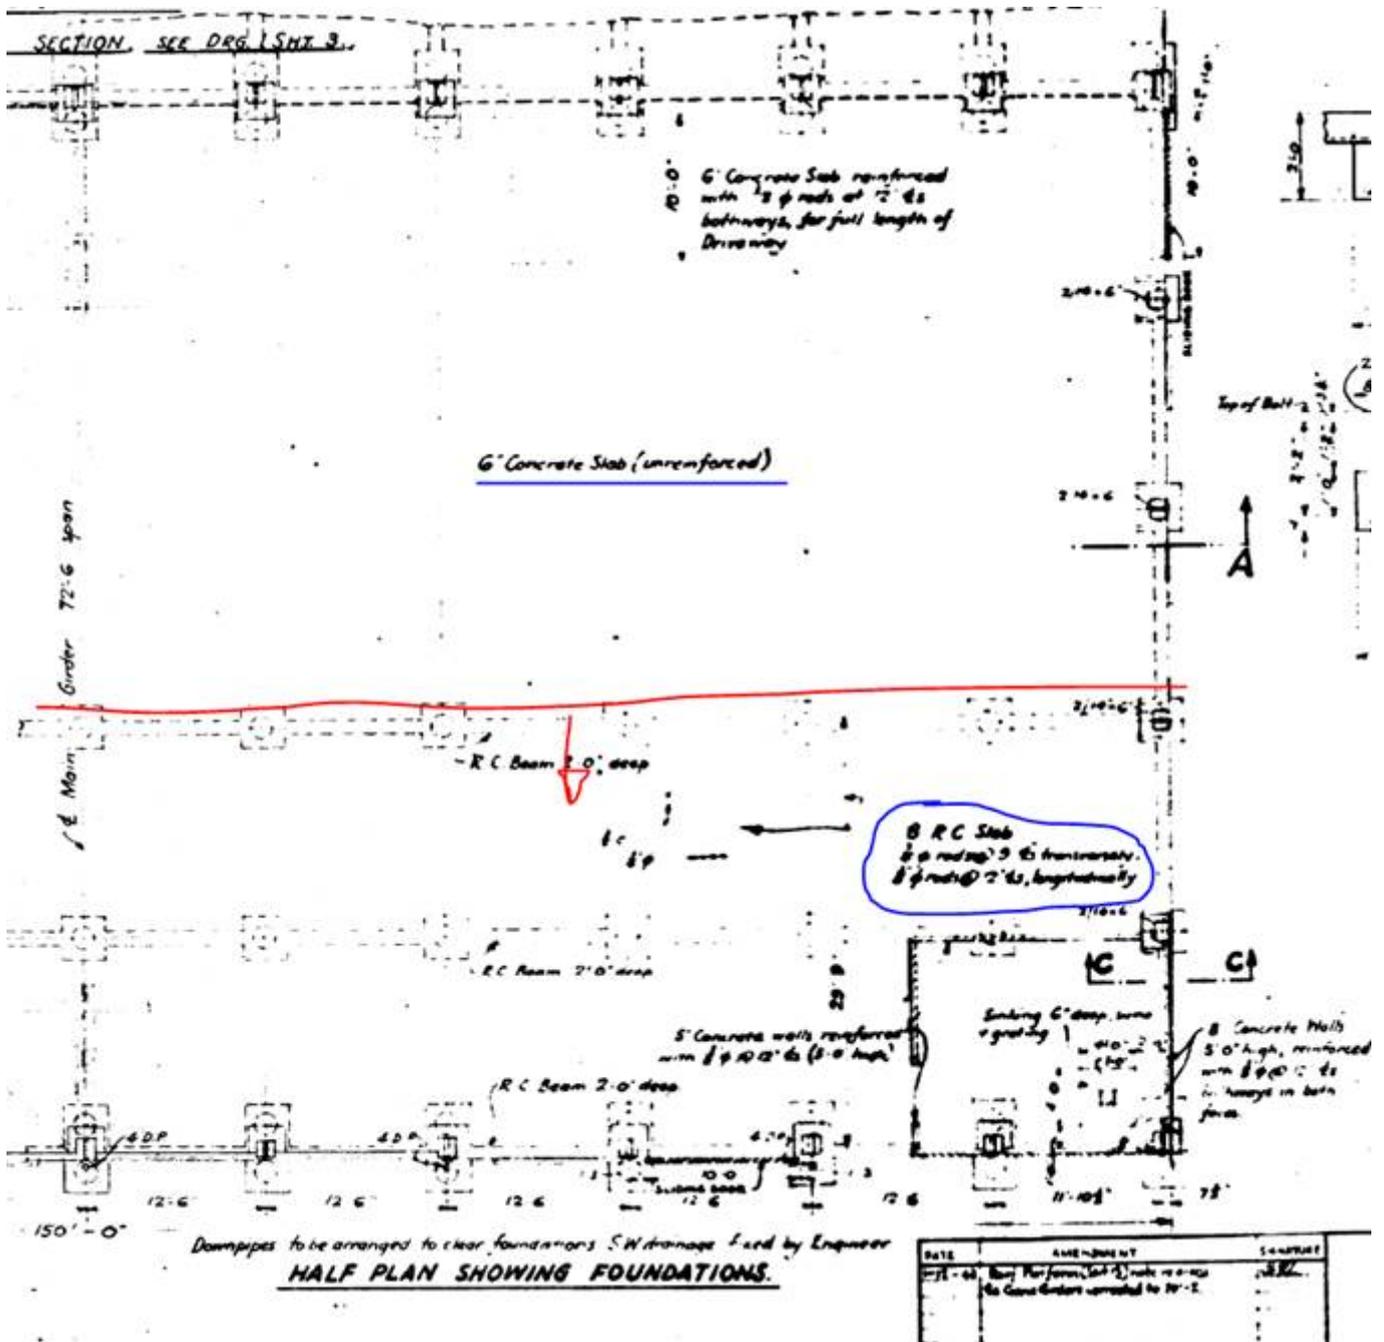
- In review of the original drawings, it is noted that only part of the workshop space has reinforced slab. Also, no tie beams are present in the perpendicular direction to help tie foundations back to the rest of the building. Therefore, it would be expected that all the lateral movement would be reflected to this interface between reinforced and unreinforced.

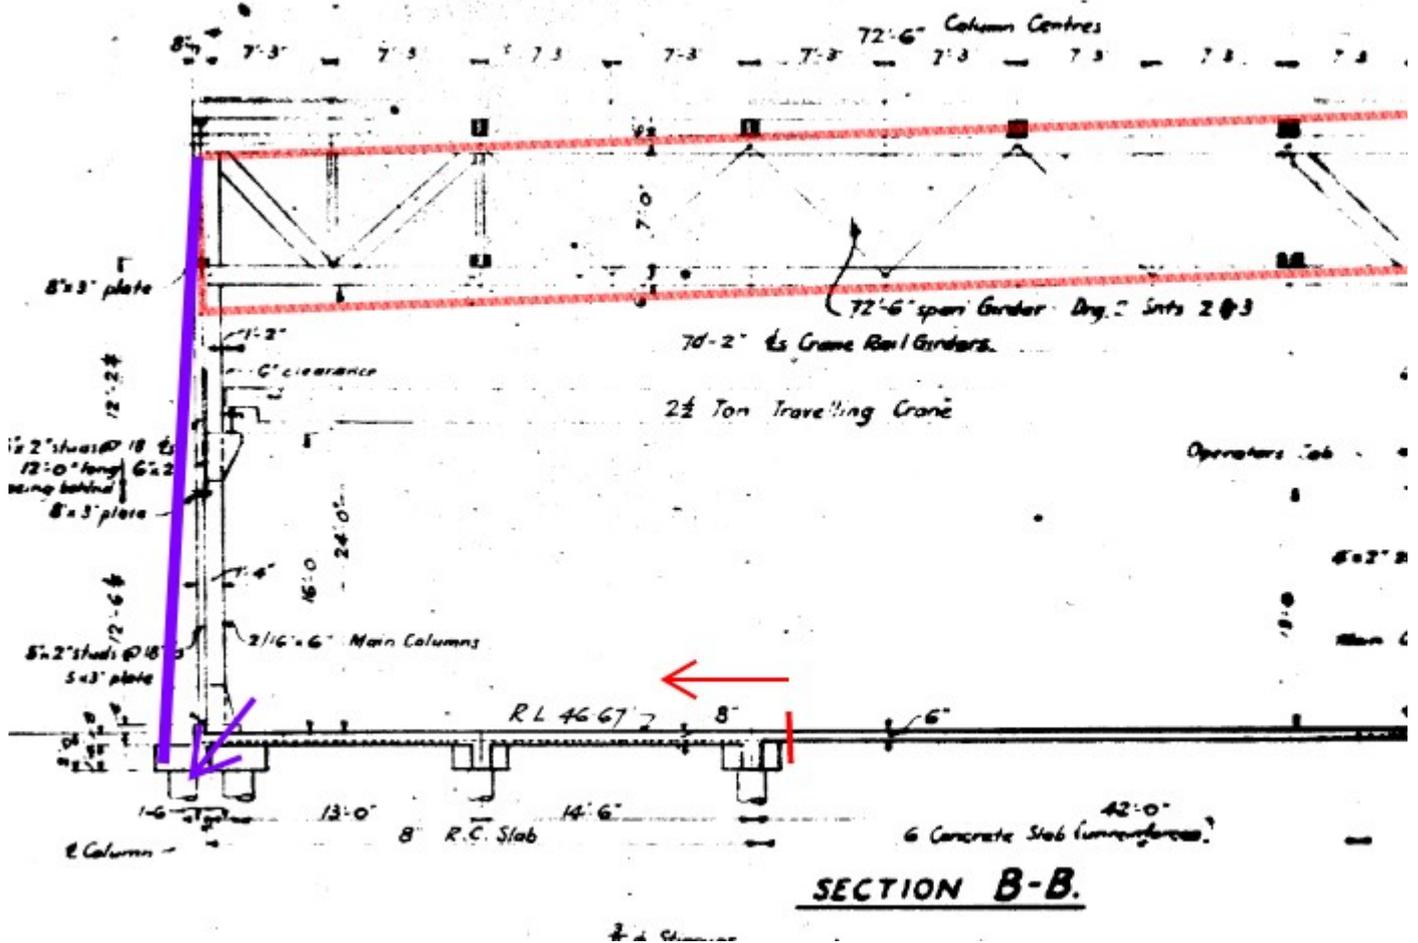
- Due to the large span of the roof truss onto this external wall, there is very little redundancy in this system. No internal columns to help provide a secondary support to hang the trusses from. All the movement would be reflective into the roof system.
