9 December 2022

Shelly Bay Taikuru Ltd
C/- Earl Hope-Pearson
Development Manager
Ground Floor 93 Customhouse Quay, Te Aro, Wellington 6011

Structural Commentary on the condition & risks of Shed 8 & Shipwrights

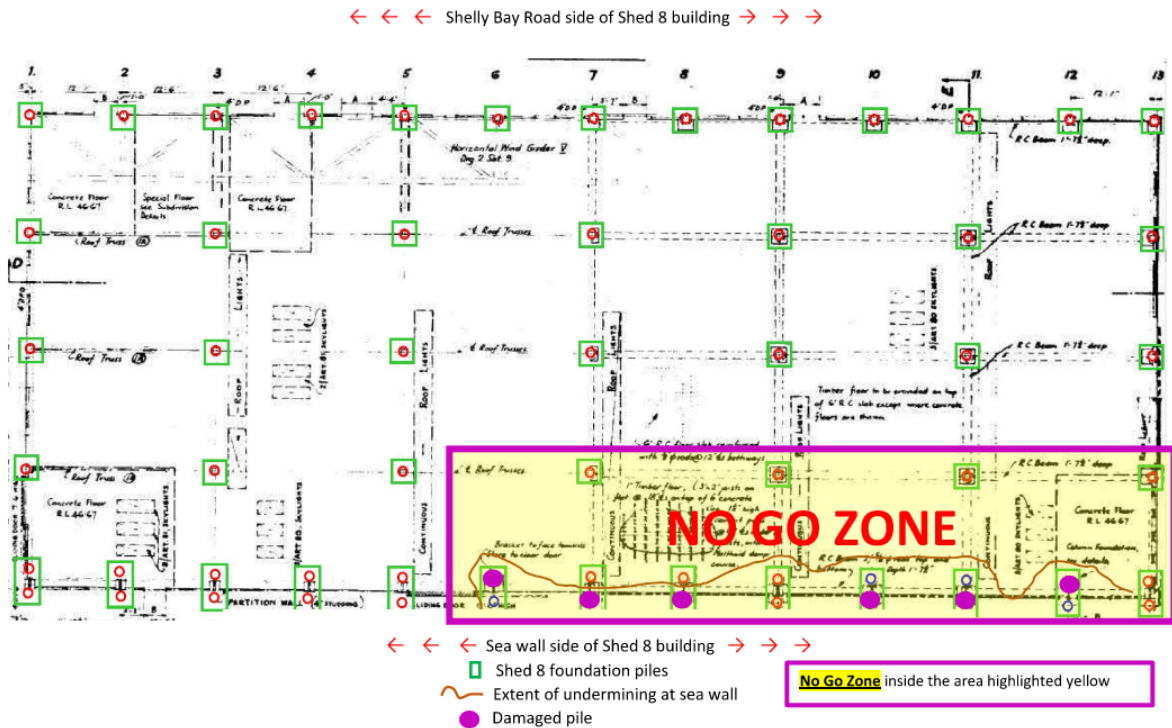
Shed 8 – Foundation Plan

Given the updated information we believe the damaged foundations, which includes some piles having completely corroded away, constitute a critical structural weakness, and pose a severe life safety risk. The piles support main columns which support the large trusses holding up the roof. 60% of the columns along the South-Western side of the building are supported by damaged or completely corrode piles (see Figure 1). This means that even under moderate earthquake shaking or vibrations to the structure there is a risk of the supports of the columns to fail and for a partial collapse of the structure.

Figure 1: Plan of damaged piles from "health and Safety Critical Risks" document

The foundations are the first item that needs to be addressed in the structure before any further work on site can take place.
