Asbestos Management Survey Report

Shelly Bay Complex
Shelly Bay Road
Wellington, 6022

Wellington City Council

Reference: W-01625

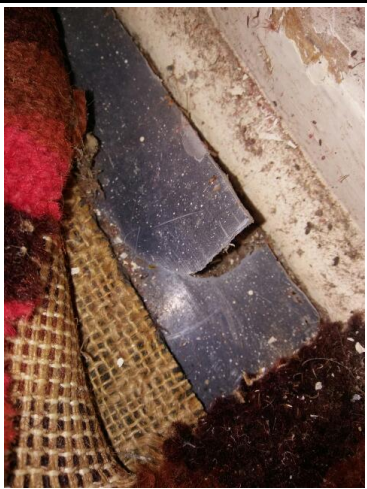
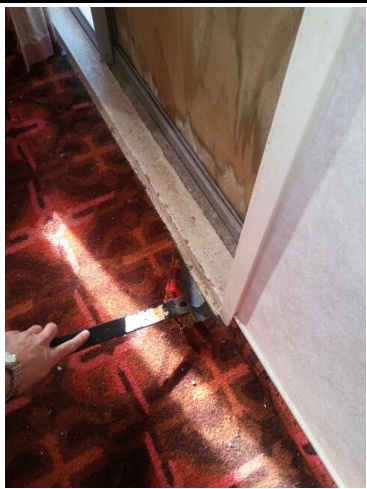
Location	Guard Hut, Ground Floor, 001, Interior		Sample Number	2 (S)

Item / Position	Vinyl Flooring			
	Material:	Vinyl Products			
	Extent	Unknown			
	Product Type	N/A	N/A		
	Condition	N/A	N/A		
	Surface Treatment	N/A	N/A		
	Asbestos Type	NAD	N/A		
	Material Assessment	N/A	0		
	Recommendation	No further action required			
	Comments:	Concealed beneath carpet

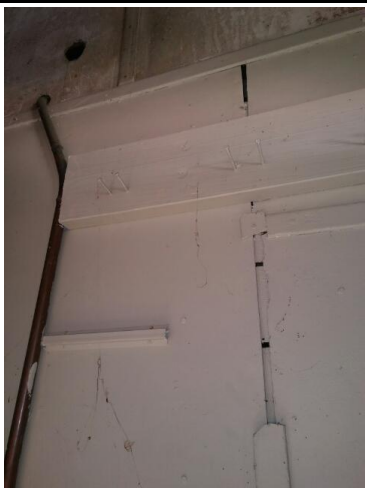
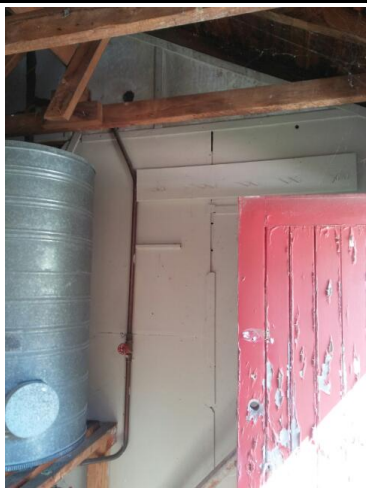
Location	Laundry Building, Ground Floor, 004, Boiler Room		Sample Number	4 (S)

Item / Position	Wall Lining			
	Material:	Cement Product			
	Extent	50m ²			
	Product Type	Asbestos reinforced composites etc.	1		
	Condition	Medium damage	2		
	Surface Treatment	Surface sealed	1		
	Asbestos Type	Amosite / Chrysotile	2		
	Material Assessment	Low	6		
	Recommendation	Manage and Label			
	Comments:

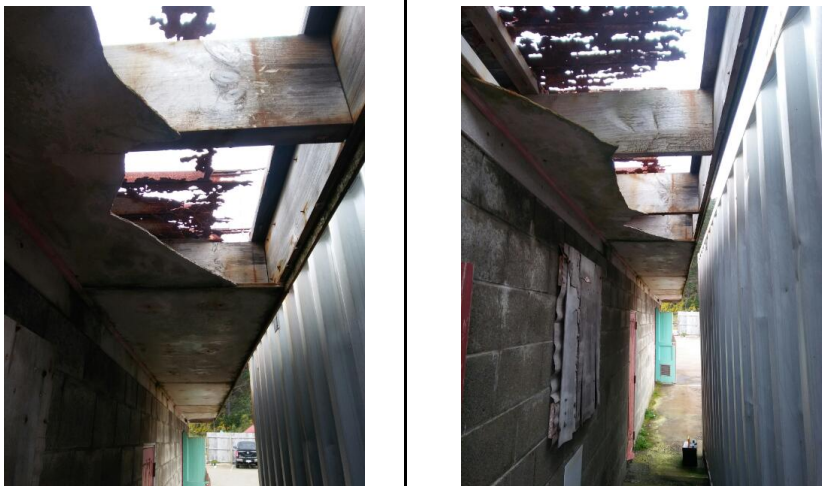
Location	North Yard Bunker, External, 027, South External Wall		Sample Number	18 (S)

Item / Position	Soffit & Fascia - Composite		
	Material:	Cement Product		
	Extent	40linm		
	Product Type	Asbestos reinforced composites etc.	1	
	Condition	High damage	3	
	Surface Treatment	Partially unsealed	2	
	Asbestos Type	Amosite / Chrysotile	2	
	Material Assessment	Medium	8	
	Recommendation	Remove		
	Comments:	Some sections appear to have been replaced with more modern products. Materials are badly damaged and weathered. Access should be restricted until all cement can be removed and disposed of as asbestos waste.

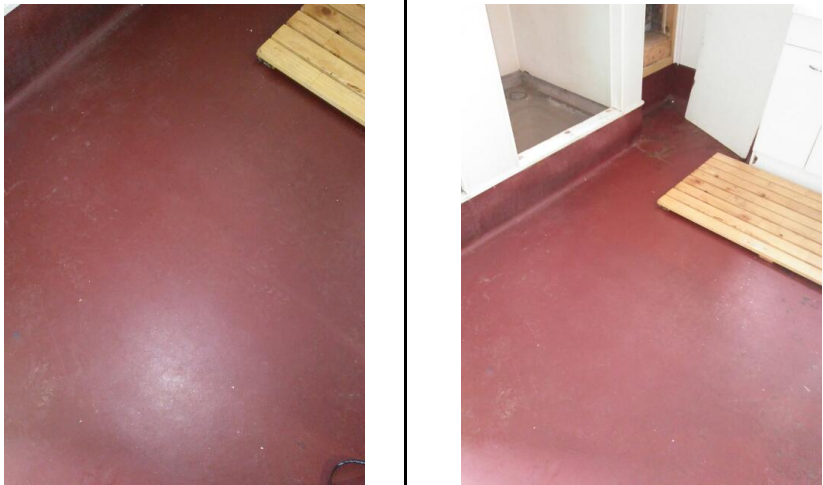
Location	Squash Courts, Ground Floor, 033, Showers		Sample Number	23 (S)

Item / Position	Vinyl Flooring		
	Material:	Vinyl Products		
	Extent	12m ²		
	Product Type	N/A	N/A	
	Condition	N/A	N/A	
	Surface Treatment	N/A	N/A	
	Asbestos Type	NAD	N/A	
	Material Assessment	N/A	0	
	Recommendation	No further action required		
	Comments:

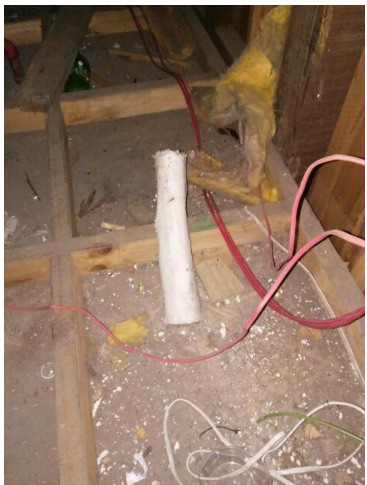
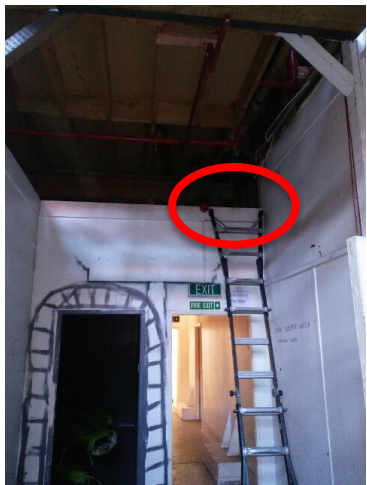
Location	Shed 8, Ground Floor, 061, Corridor Ceiling Void		Sample Number	5 (X)

Item / Position	Pipe Lagging		
	Material:	Insulation		
	Extent	Unknown		
	Product Type	Thermal insulation (eg pipe and boiler lagging), sprayed asbestos, loose asbestos, asbestos mattresses and packing.	3	
	Condition	High damage	3	
	Surface Treatment	Unsealed	3	
	Asbestos Type	Chrysotile	1	
	Material Assessment	High	10	
	Recommendation	Remove		
	Comments:

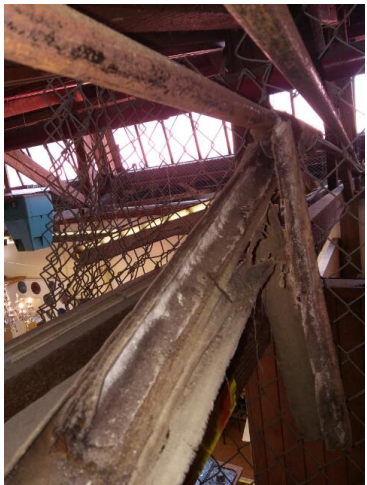
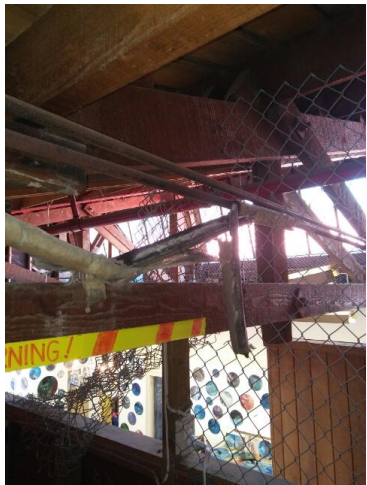
Location	Shed 8, Ground Floor, 068, Artist Tenancy Mezzanine		Sample Number	5 (X)

Item / Position	Pipe Lagging		
	Material:	Insulation		
	Extent	1lin m		
	Product Type	Thermal insulation (eg pipe and boiler lagging), sprayed asbestos, loose asbestos, asbestos mattresses and packing.	3	
	Condition	High damage	3	
	Surface Treatment	Unsealed	3	
	Asbestos Type	Chrysotile	1	
	Material Assessment	High	10	
	Recommendation	Remove		
	Comments:

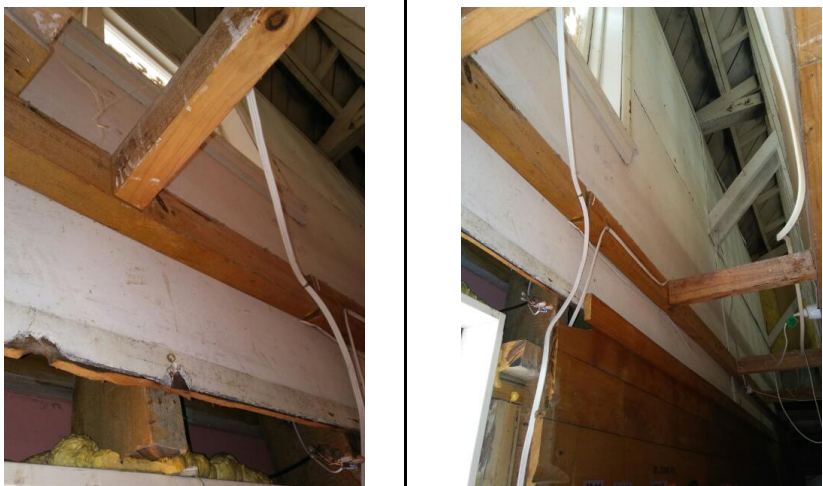
Location	Squash Courts, Ground Floor, 032, Interior		Sample Number	14 (X)

Item / Position	Wall Lining		
	Material:	Cement Product		
	Extent	100m ²		
	Product Type	Asbestos reinforced composites etc.	1	
	Condition	Low damage	1	
	Surface Treatment	Surface sealed	1	
	Asbestos Type	Presumed Asbestos	3	
	Material Assessment	Low	6	
	Recommendation	Manage and Label		
	Comments:	Extends around internal walls above head height. Edge encapsulated by surveyor where damaged at entrance.

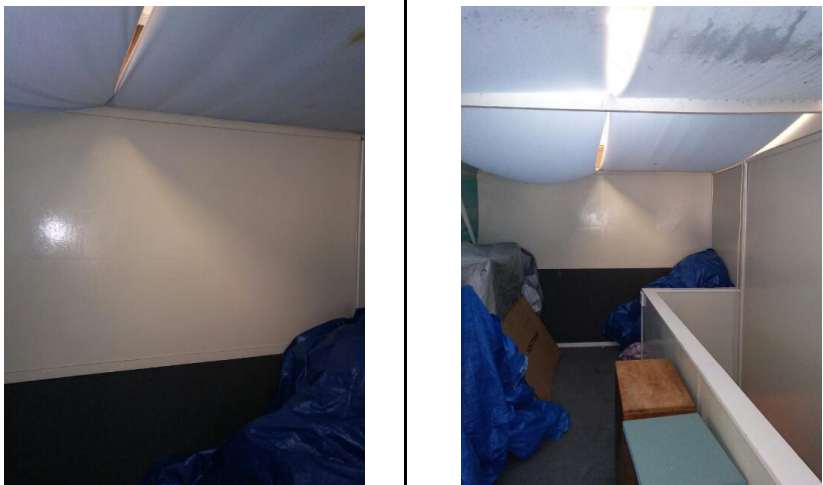
Location	Squash Courts, 1st Floor, 034, Mezzanine Office		Sample Number	14 (X)

Item / Position	Wall Lining		
	Material:	Cement Product		
	Extent	20m ²		
	Product Type	Asbestos reinforced composites etc.	1	
	Condition	Good condition	0	
	Surface Treatment	Completely sealed	0	
	Asbestos Type	Presumed Asbestos	3	
	Material Assessment	Very Low	4	
	Recommendation	Manage and Label		
	Comments:	Wall lining is covered by GIB on south wall however is present behind. Do not penetrate any wall linings.

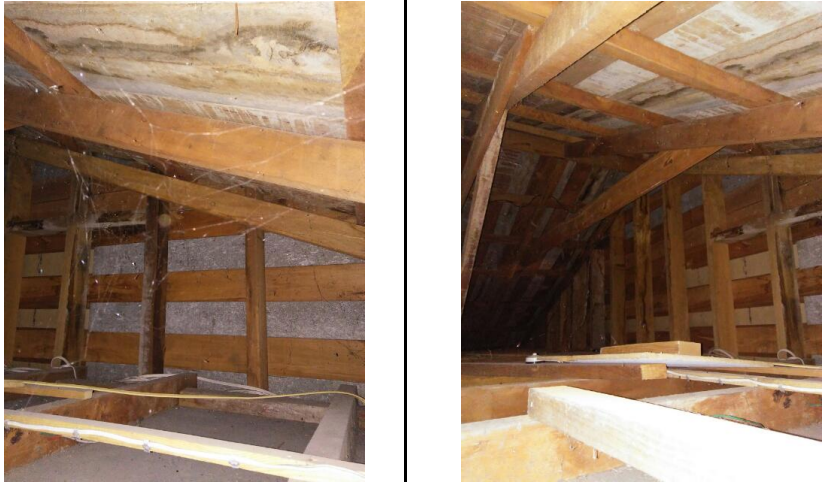
Location	Squash Courts, External, 023, Lower Ceiling Void	Sample Number	14 (X)

Item / Position	Cement Board
		Material:	Cement Product
		Extent	10m ²
		Product Type	Asbestos reinforced composites etc. 1
		Condition	Low damage 1
		Surface Treatment	Surface sealed 1
		Asbestos Type	Presumed Asbestos 3
		Material Assessment	Low 6
		Recommendation	Manage and Label
		Comments:	Do not penetrate wall lining from other side

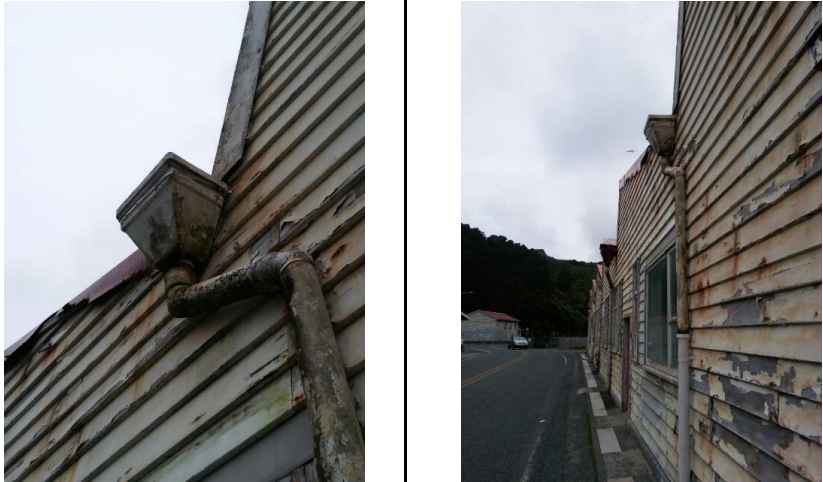
Location	Shed 8, External, 030, East External Wall	Sample Number	19 (X)

Item / Position	Cement Rain Hoppers
		Material:	Cement Product
		Extent	4no
		Product Type	Asbestos reinforced composites etc. 1
		Condition	Low damage 1
		Surface Treatment	Surface sealed 1
		Asbestos Type	Presumed Asbestos 3
		Material Assessment	Low 6
		Recommendation	Manage and Label
		Comments:

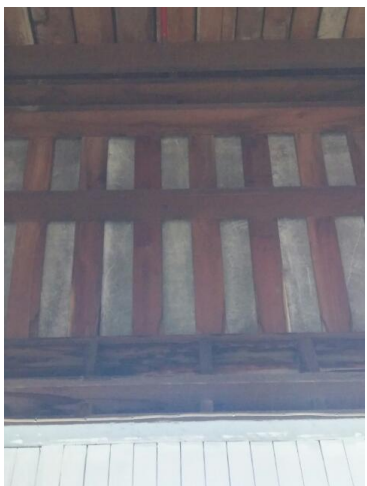
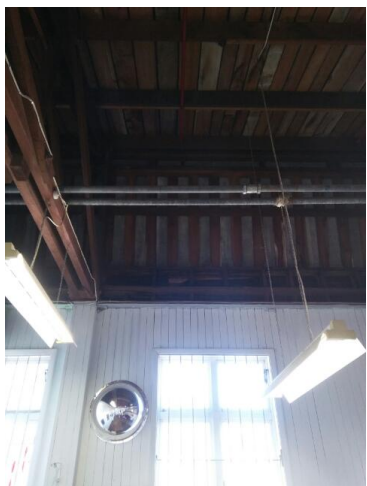
Location	Shed 8, Ground Floor, 067, Artist Tenancy		Sample Number	22 (X)

Item / Position	Cement Panels		
	Material:	Cement Product		
	Extent	30m ²		
	Product Type	Asbestos reinforced composites etc.	1	
	Condition	Low damage	1	
	Surface Treatment	Surface sealed	1	
	Asbestos Type	Presumed Asbestos	3	
	Material Assessment	Low	6	
	Recommendation	Encapsulate, Label and Manage		
	Comments:	If building is to remain and space continues to be occupied, encapsulating the interior surface of the cement boards will reduce risk and prolong life of product.

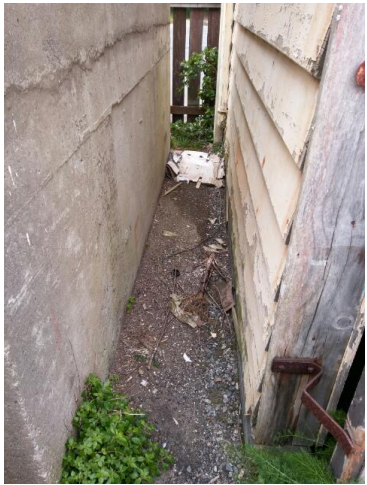
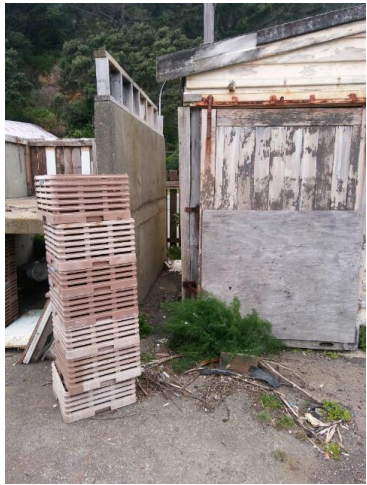
Location	Winding House, External, 037, Perimeter		Sample Number	31 (X)

Item / Position	Cement Debris		
	Material:	Cement Product		
	Extent	All		
	Product Type	Asbestos reinforced composites etc.	1	
	Condition	High damage	3	
	Surface Treatment	Unsealed	3	
	Asbestos Type	Presumed Asbestos	3	
	Material Assessment	High	10	
	Recommendation	Remove		
	Comments:	Debris and soils contaminated by run-off surrounding building. Restrict access until remediation can be conducted.

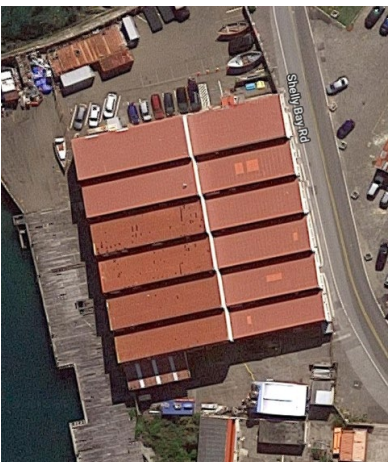
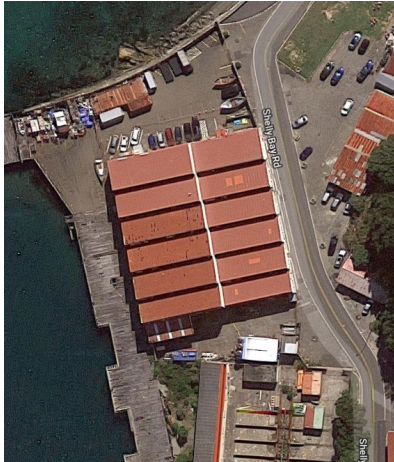
Item / Position	Corrugated Cement Roof		
	Material:	Cement Product		
	Extent	1000m ²		
	Product Type	Asbestos reinforced composites etc.	1	
	Condition	Low damage	1	
	Surface Treatment	Surface sealed	1	
	Asbestos Type	Presumed Asbestos	3	
	Material Assessment	Low	6	
	Recommendation	Manage and Label		
	Comments:	8 of 12 corrugated cement roof sections replaced, however dust and debris may be concealed beneath metal roof

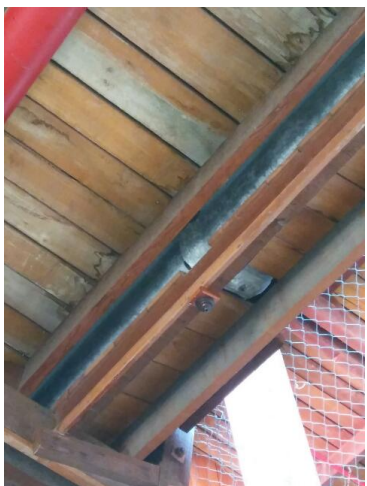
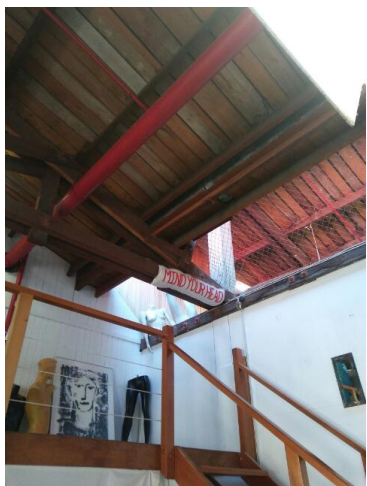
Item / Position	Cement Guttering
		Material:	Cement Product
		Extent	30lin m
		Product Type	Asbestos reinforced composites etc. 1
		Condition	Low damage 1
		Surface Treatment	Surface sealed 1
		Asbestos Type	Presumed Asbestos 3
		Material Assessment	Low 6
		Recommendation	Encapsulate, Label and Manage
		Comments:	Recommend exposed guttering is encapsulated to reduce risk and prolong life of product if area will continue to be occupied in the medium to long-term

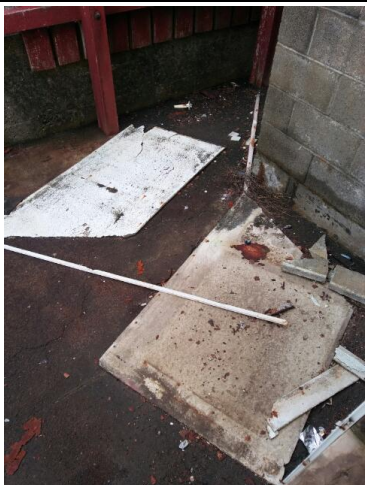
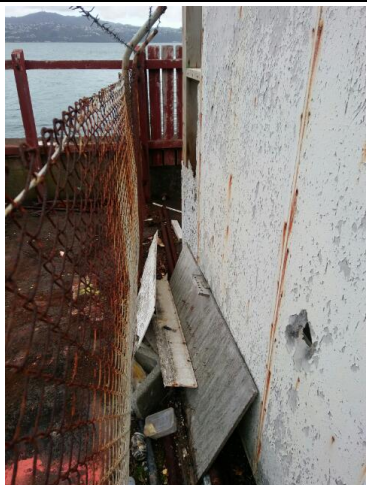
Item / Position	Debris
		Material:	Cement Product
		Extent	All
		Product Type	Asbestos reinforced composites etc. 1
		Condition	High damage 3
		Surface Treatment	Partially unsealed 2
		Asbestos Type	Chrysotile 1
		Material Assessment	Medium 7
		Recommendation	Remove
		Comments:	Debris scattered around building extension perimeter

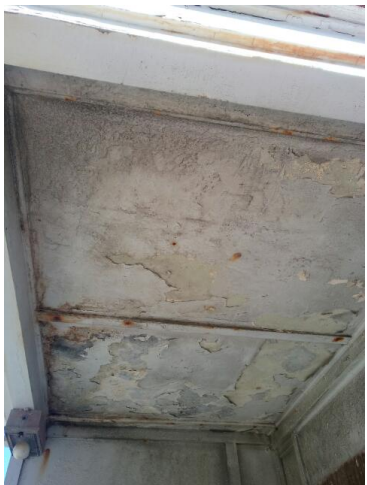
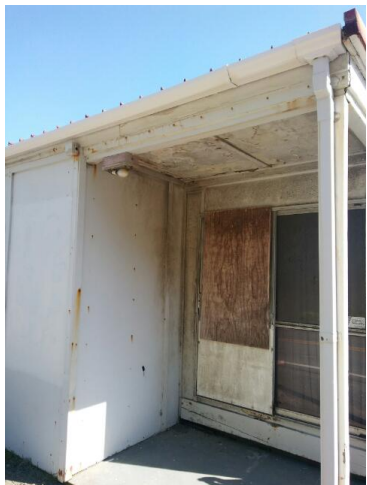
Item / Position	Cement Board Lining	
	Material:	Cement Product	
	Extent	2m ²	
	Product Type	Asbestos reinforced composites etc.	1
	Condition	Low damage	1
	Surface Treatment	Completely sealed	0
	Asbestos Type	Amosite / Crocidolite / Chrysotile	3
	Material Assessment	Low	5
	Recommendation	Manage and Label	
	Comments:

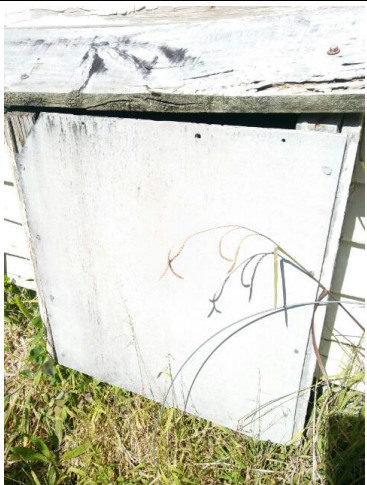
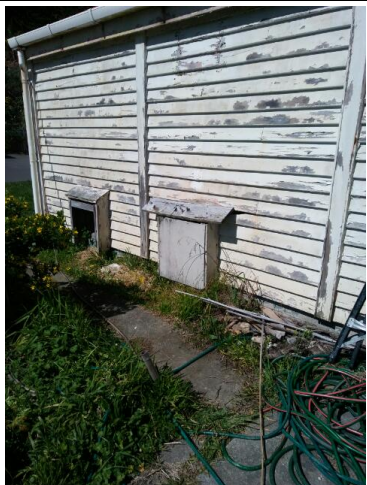
Item / Position	Vent Cover	
	Material:	Cement Product	
	Extent	1no	
	Product Type	Asbestos reinforced composites etc.	1
	Condition	Medium damage	2
	Surface Treatment	Completely sealed	0
	Asbestos Type	Presumed Asbestos	3
	Material Assessment	Low	6
	Recommendation	Manage and Label	
	Comments:	Encapsulated by surveyor

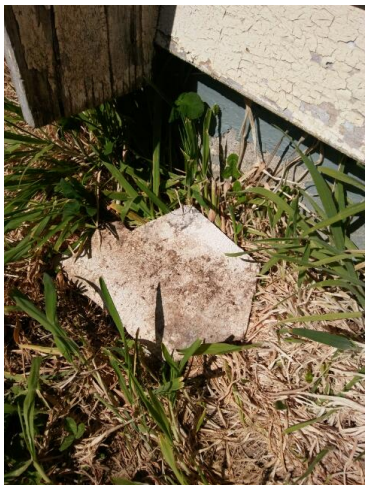
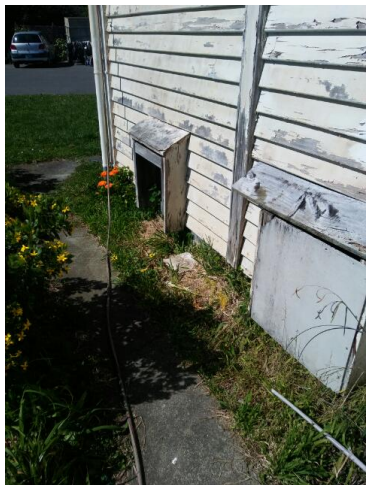
Item / Position	Cement Debris	
	Material:	Cement Product	
	Extent	Unknown	
	Product Type	Asbestos reinforced composites etc.	1
	Condition	High damage	3
	Surface Treatment	Partially unsealed	2
	Asbestos Type	Presumed Asbestos	3
	Material Assessment	Medium	9
	Recommendation	Remove	
	Comments:	Removed by surveyor, additional debris may be concealed in undergrowth

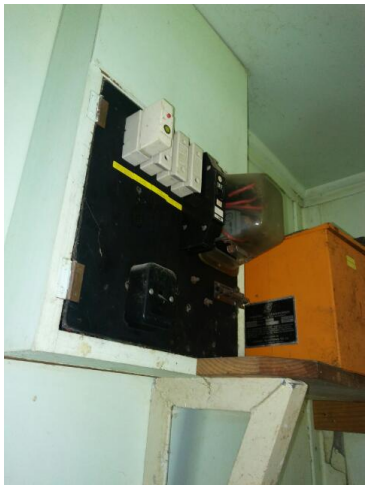
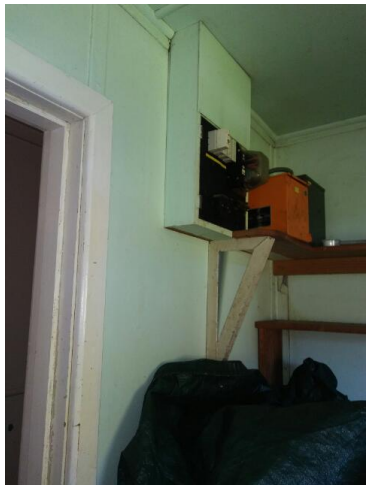
Item / Position	Switchboard	
	Material:	Bituminous Product	
	Extent	1no	
	Product Type	Asbestos reinforced composites etc.	1
	Condition	Low damage	1
	Surface Treatment	Completely sealed	0
	Asbestos Type	Chrysotile	1
	Material Assessment	Very Low	3
	Recommendation	Manage and Label	
	Comments:

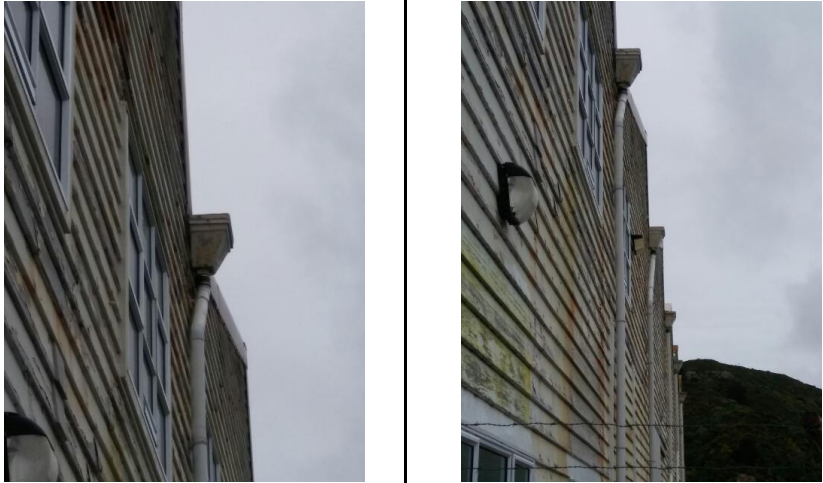
Item / Position	Cement Rain Hoppers		
	Material:	Cement Product		
	Extent	5no		
	Product Type	Asbestos reinforced composites etc.	1	
	Condition	Low damage	1	
	Surface Treatment	Surface sealed	1	
	Asbestos Type	Presumed Asbestos	3	
	Material Assessment	Low	6	
	Recommendation	Manage and Label		
	Comments:

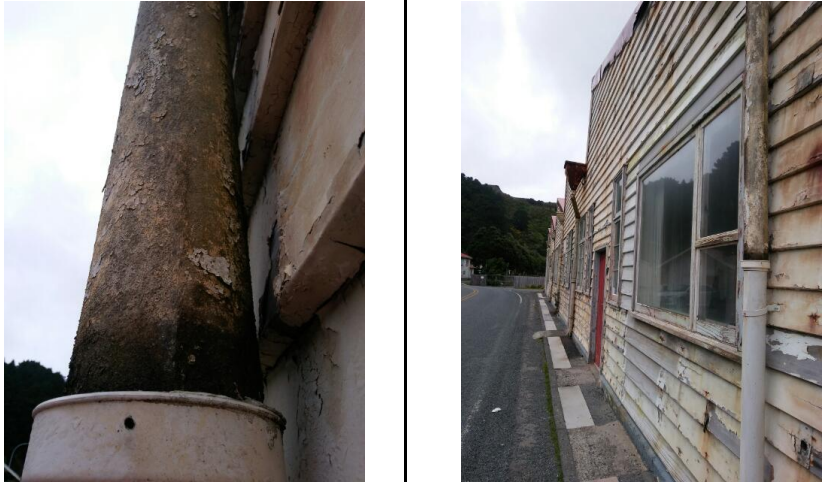
Item / Position	Cement Downpipes		
	Material:	Cement Product		
	Extent	4no		
	Product Type	Asbestos reinforced composites etc.	1	
	Condition	Medium damage	2	
	Surface Treatment	Partially unsealed	2	
	Asbestos Type	Presumed Asbestos	3	
	Material Assessment	Medium	8	
	Recommendation	Manage and Label, Address Drainage Issues		
	Comments:	Run-off from roof is discharging onto the ground. Run-off should be directed into drains to prevent accumulation of debris and asbestos fibre on the ground.

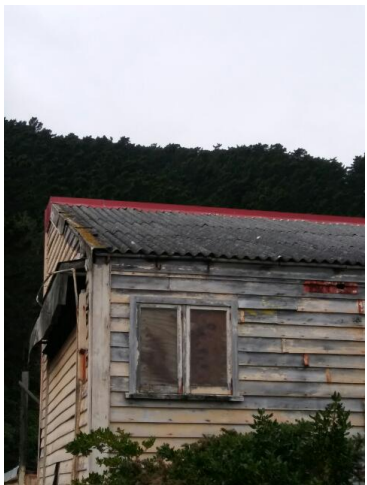
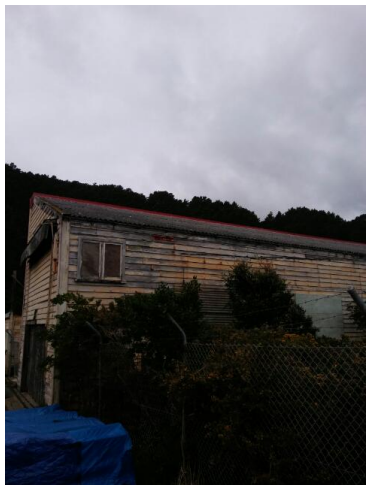
Item / Position	Corrugated Cement Roof and Flashing		
	Material:	Cement Product		
	Extent	500m ²		
	Product Type	Asbestos reinforced composites etc.	1	
	Condition	Medium damage	2	
	Surface Treatment	Partially unsealed	2	
	Asbestos Type	Presumed Asbestos	3	
	Material Assessment	Medium	8	
	Recommendation	Manage and Label		
	Comments:

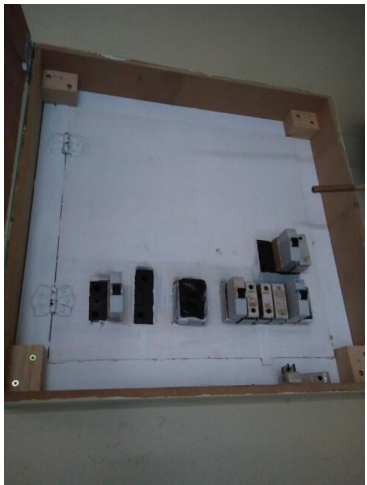
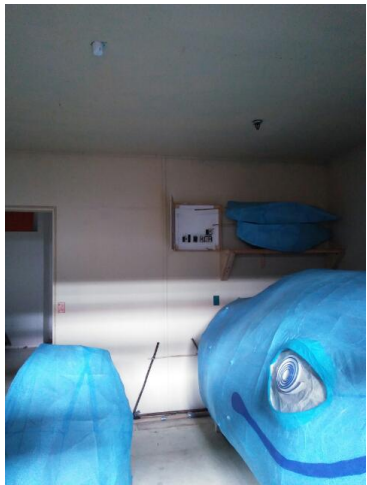
Item / Position	Switchboard		
	Material:	Bituminous Product		
	Extent	1no		
	Product Type	Asbestos reinforced composites etc.	1	
	Condition	Good condition	0	
	Surface Treatment	Completely sealed	0	
	Asbestos Type	Chrysotile	1	
	Material Assessment	Very Low	2	
	Recommendation	Manage and Label		
	Comments:	Black bituminous switchboard painted white

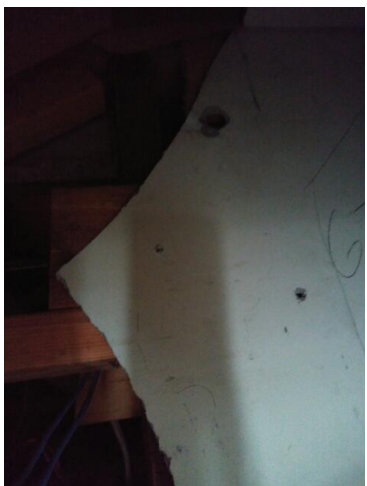
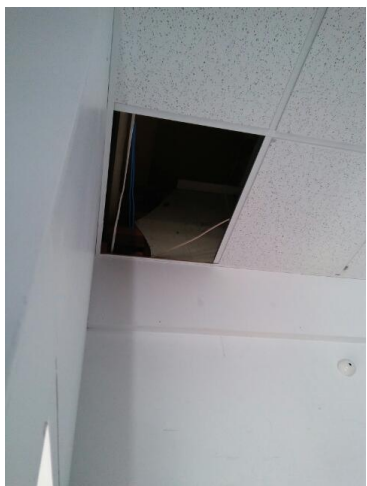
Item / Position	Wall and Ceiling Lining		
	Material:	Cement Product		
	Extent	Unknown		
	Product Type	Asbestos reinforced composites etc.	1	
	Condition	Medium damage	2	
	Surface Treatment	Partially unsealed	2	
	Asbestos Type	Presumed Asbestos	3	
	Material Assessment	Medium	8	
	Recommendation	Manage and Label		
	Comments:	Material is concealed by false ceiling and wall linings. Full extent is unknown but all walls and ceiling in the marked locations (refer to drawings) are asbestos cement.

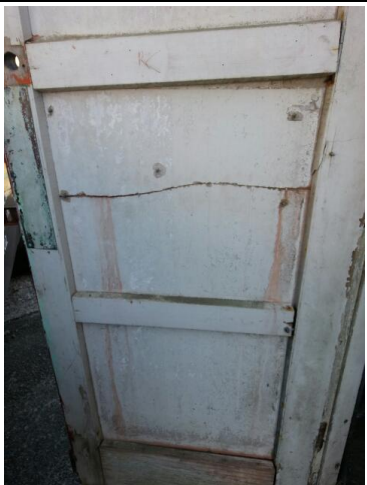
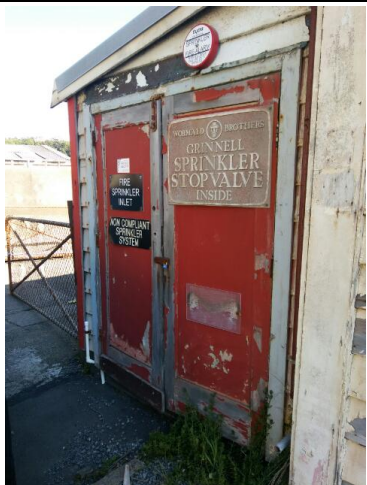
Item / Position	Cement Door Panels		
	Material:	Cement Product		
	Extent	2no		
	Product Type	Asbestos reinforced composites etc.	1	
	Condition	Medium damage	2	
	Surface Treatment	Partially unsealed	2	
	Asbestos Type	Presumed Asbestos	3	
	Material Assessment	Medium	8	
	Recommendation	Manage and Label		
	Comments:	Encapsulate or remove if items will remain long-term

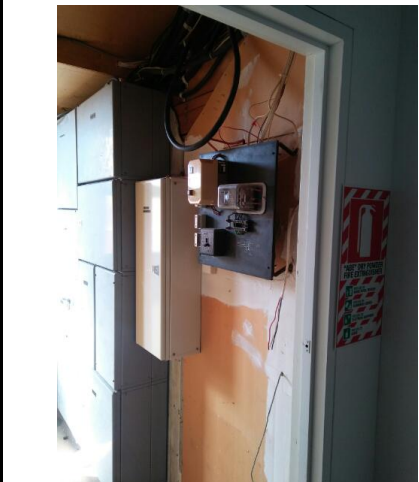
Item / Position	Switchboard		
	Material:	Bituminous Product		
	Extent	2no		
	Product Type	Asbestos reinforced composites etc.	1	
	Condition	Good condition	0	
	Surface Treatment	Surface sealed	1	
	Asbestos Type	Chrysotile	1	
	Material Assessment	Very Low	3	
	Recommendation	Manage and Label		
	Comments:	A second switchboard is present in the adjacent room

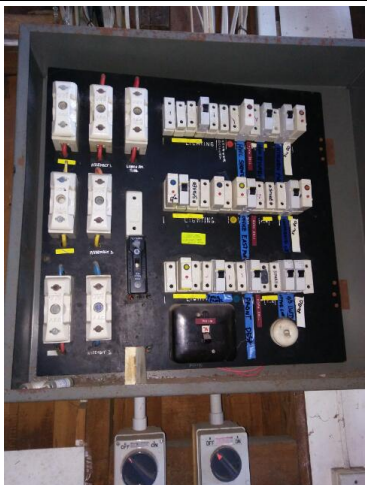
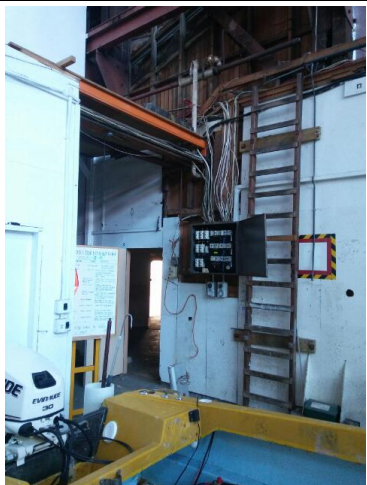
Item / Position	Switchboard		
	Material:	Bituminous Product		
	Extent	1no		
	Product Type	Asbestos reinforced composites etc.	1	
	Condition	Good condition	0	
	Surface Treatment	Completely sealed	0	
	Asbestos Type	Chrysotile	1	
	Material Assessment	Very Low	2	
	Recommendation	Manage and Label		
Comments:

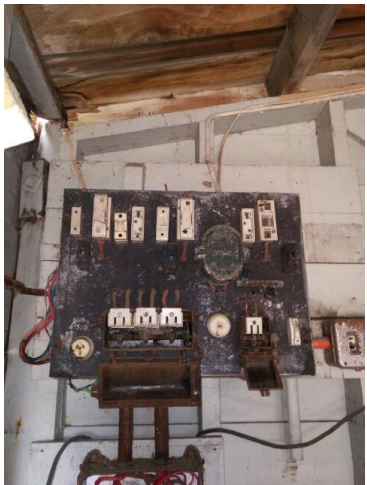
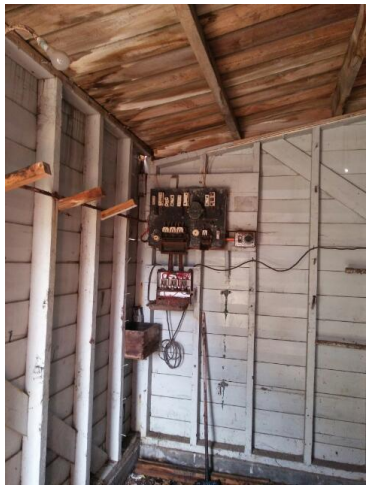
Item / Position	Switchboard		
	Material:	Bituminous Product		
	Extent	1no		
	Product Type	Asbestos reinforced composites etc.	1	
	Condition	Low damage	1	
	Surface Treatment	Surface sealed	1	
	Asbestos Type	Chrysotile	1	
	Material Assessment	Very Low	4	
	Recommendation	Manage and Label		
Comments:

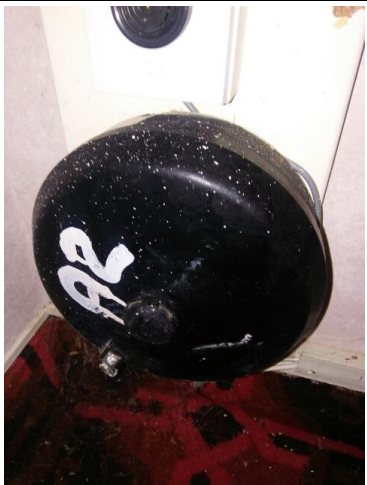
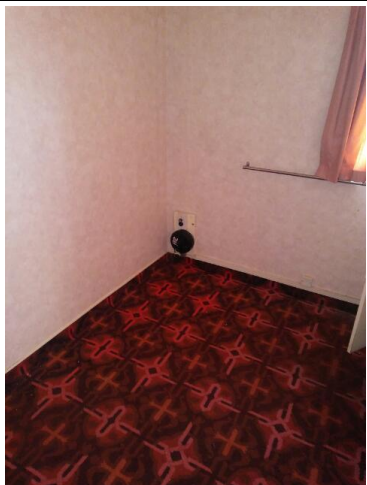
Item / Position	Electrical Fitting		
	Material:	PVC / Reinforced Plastics		
	Extent	1no		
	Product Type	Asbestos reinforced composites etc.	1	
	Condition	Low damage	1	
	Surface Treatment	Completely sealed	0	
	Asbestos Type	Chrysotile	1	
	Material Assessment	Very Low	3	
	Recommendation	Manage and Label		
	Comments:

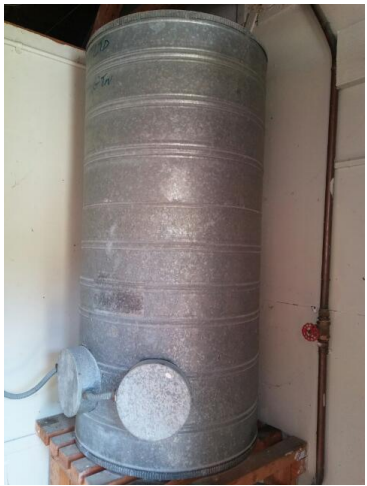
Item / Position	Hot Water Cylinder		
	Material:	Suspected Asbestos		
	Extent	1no		
	Product Type	Thermal insulation (eg pipe and boiler lagging), sprayed asbestos, loose asbestos, asbestos mattresses and packing.	3	
	Condition	Good condition	0	
	Surface Treatment	Completely sealed	0	
	Asbestos Type	Presumed Asbestos	3	
	Material Assessment	Low	6	
	Recommendation	Manage and Label		
	Comments:	Hot Water Cylinders can contain a variety of ACMs including insulation, gaskets, wiring and reinforced plastics. As it is not usually possible to fully inspect the internals, HWCs should be presumed to contain asbestos as a precaution, unless proven otherwise.

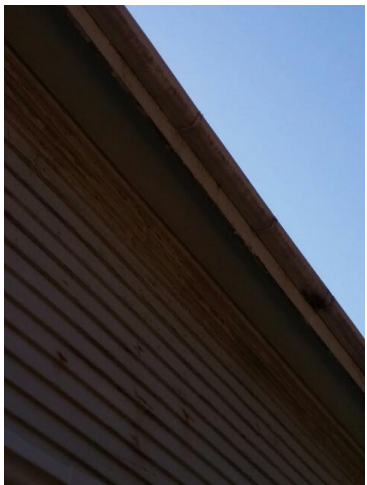
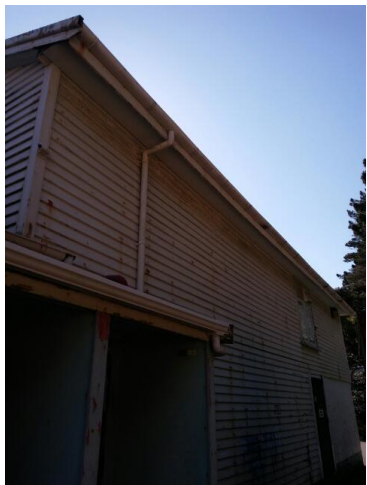
Item / Position	Soffits		
	Material:	Cement Product		
	Extent	40lin m		
	Product Type	Asbestos reinforced composites etc.	1	
	Condition	Good condition	0	
	Surface Treatment	Completely sealed	0	
	Asbestos Type	Presumed Asbestos	3	
	Material Assessment	Very Low	4	
	Recommendation	Manage and Label		
	Comments:	Upper soffits appear to have been replaced, however due to height, detailed inspection was not possible. Even if this is a modern product, asbestos cement should be presumed to be concealed.

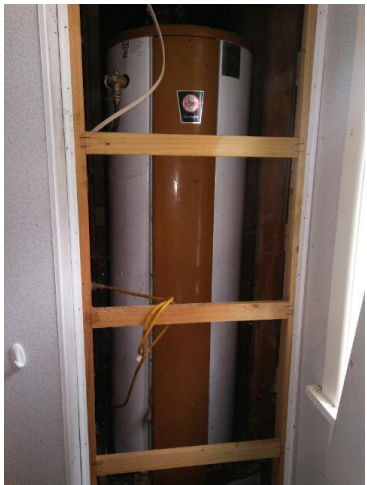
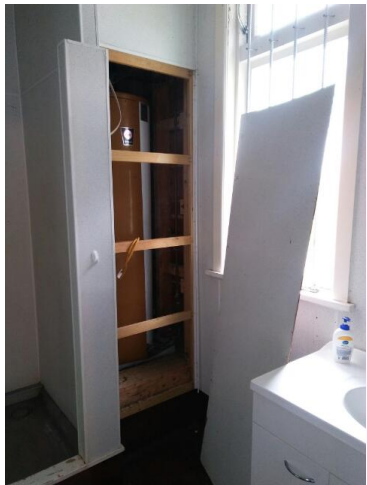
Item / Position	Hot Water Cylinder		
	Material:	Suspected Asbestos		
	Extent	1no		
	Product Type	Thermal insulation (eg pipe and boiler lagging), sprayed asbestos, loose asbestos, asbestos mattresses and packing.	3	
	Condition	Good condition	0	
	Surface Treatment	Completely sealed	0	
	Asbestos Type	Presumed Asbestos	3	
	Material Assessment	Low	6	
	Recommendation	Manage and Label		
	Comments:	Hot Water Cylinders can contain a variety of ACMs including insulation, gaskets, wiring and reinforced plastics. As it is not usually possible to fully inspect the internals, HWCs should be presumed to contain asbestos as a precaution, unless proven otherwise.

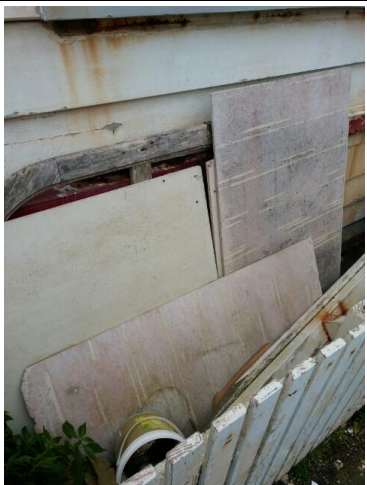
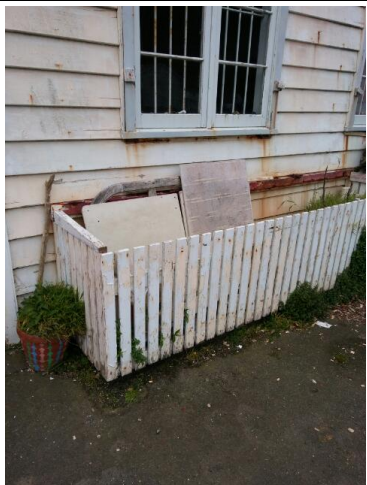
Item / Position	Loose Cement Boards		
	Material:	Cement Product		
	Extent	All		
	Product Type	Asbestos reinforced composites etc.	1	
	Condition	Low damage	1	
	Surface Treatment	Surface sealed	1	
	Asbestos Type	Presumed Asbestos	3	
	Material Assessment	Low	6	
	Recommendation	Manage and Label		
	Comments:	Boards appear modern, however, should be disposed of as asbestos waste as a precaution

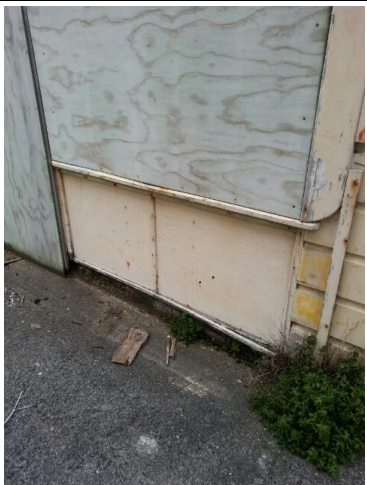
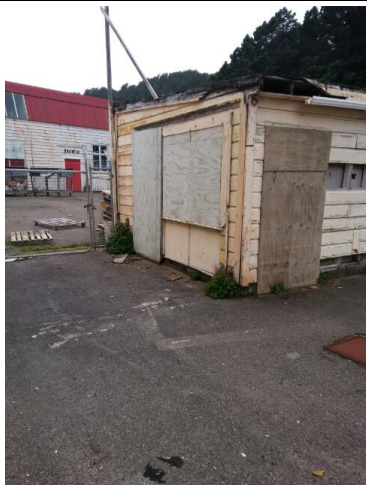
Item / Position	Cement Board		
	Material:	Cement Product		
	Extent	2no		
	Product Type	Asbestos reinforced composites etc.	1	
	Condition	Low damage	1	
	Surface Treatment	Surface sealed	1	
	Asbestos Type	Presumed Asbestos	3	
	Material Assessment	Low	6	
	Recommendation	Manage and Label		
	Comments:	Sample prior to disturbance or dispose of as asbestos waste as a precaution.

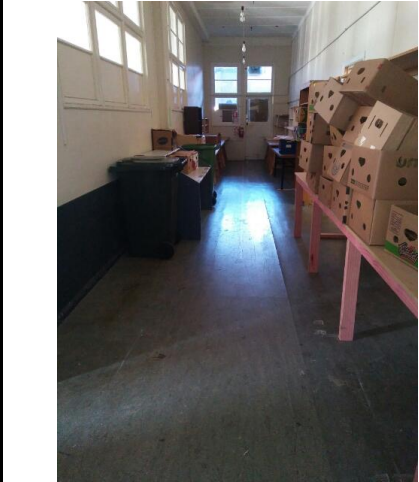
Item / Position	Vinyl Flooring		
		Material:	Vinyl Products		
		Extent	100m ²		
		Product Type	N/A	N/A	
		Condition	N/A	N/A	
		Surface Treatment	N/A	N/A	
		Asbestos Type	NAD	N/A	
		Material Assessment	N/A	0	
		Recommendation	No further action required		
		Comments:

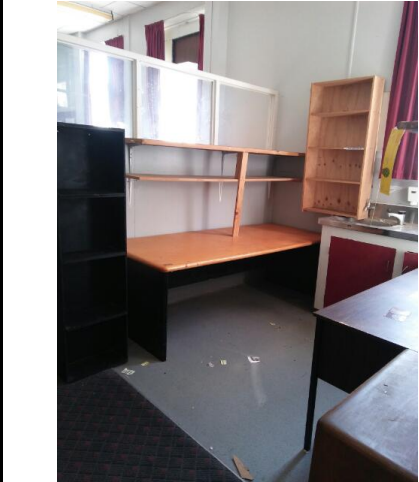
Item / Position	Vinyl Flooring		
		Material:	Vinyl Products		
		Extent	8m ²		
		Product Type	N/A	N/A	
		Condition	N/A	N/A	
		Surface Treatment	N/A	N/A	
		Asbestos Type	NAD	N/A	
		Material Assessment	N/A	0	
		Recommendation	No further action required		
		Comments:

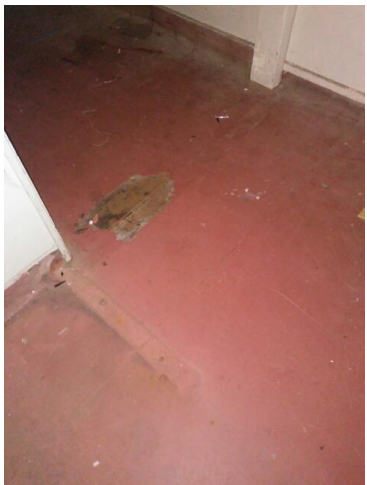
Item / Position	Red Vinyl Flooring			
	Material:	Vinyl Products			
	Extent	Unknown			
	Product Type	Asbestos reinforced composites etc.	1		
	Condition	Medium damage	2		
	Surface Treatment	Surface sealed	1		
	Asbestos Type	Chrysotile	1		
	Material Assessment	Low	5		
	Recommendation	Manage and Label			
	Comments:	Full extent is unclear and material may extend under more recent floor coverings

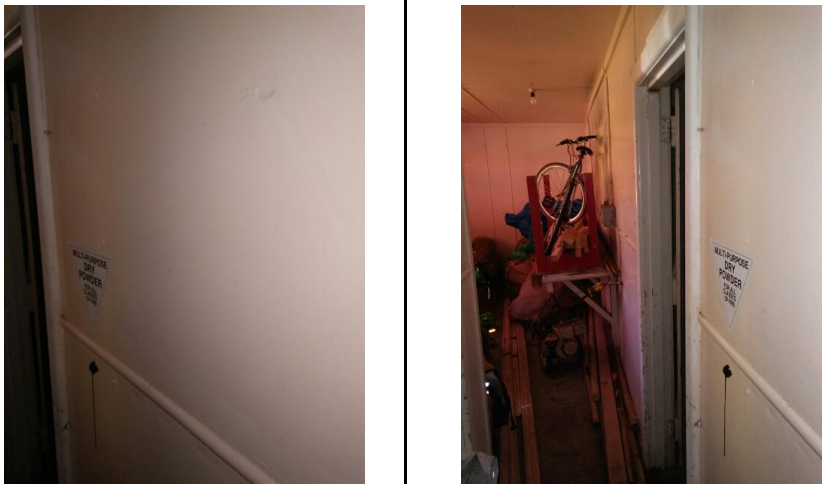
Item / Position	Wall Lining			
	Material:	Cement Product			
	Extent	50m ²			
	Product Type	Asbestos reinforced composites etc.	1		
	Condition	Good condition	0		
	Surface Treatment	Completely sealed	0		
	Asbestos Type	Chrysotile	1		
	Material Assessment	Very Low	2		
	Recommendation	Manage and Label			
	Comments:

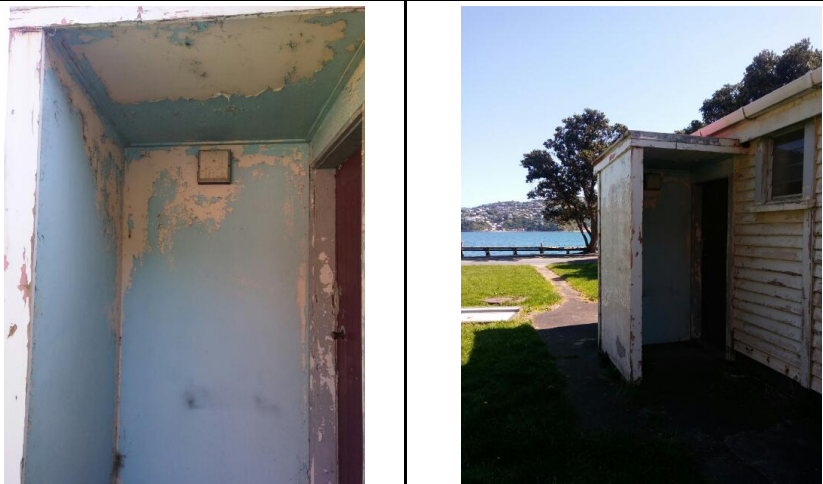
Item / Position	Porch Cladding and Soffit			
	Material:	Cement Product			
	Extent	12m ²			
	Product Type	Asbestos reinforced composites etc.	1		
	Condition	Low damage	1		
	Surface Treatment	Surface sealed	1		
	Asbestos Type	Chrysotile	1		
	Material Assessment	Very Low	4		
	Recommendation	Manage and Label			
	Comments:	Cladding is external and internal to porch

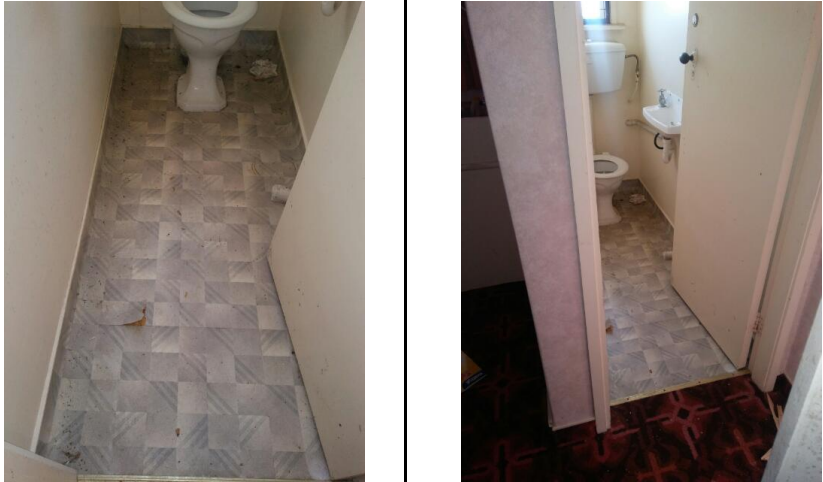
<table><tr> <td data-bbox="990 233 1227 280">Item / Position</td> <td colspan="2" data-bbox="1227 233 2152 280">Vinyl Flooring</td> </tr><tr> <td data-bbox="990 424 1227 472">Condition</td> <td data-bbox="1227 424 2033 472">N/A</td> <td data-bbox="2033 424 2152 472">N/A</td> </tr><tr> <td data-bbox="990 616 1227 663">Recommendation</td> <td colspan="2" data-bbox="1227 616 2152 663">No further action required</td> </tr></table>

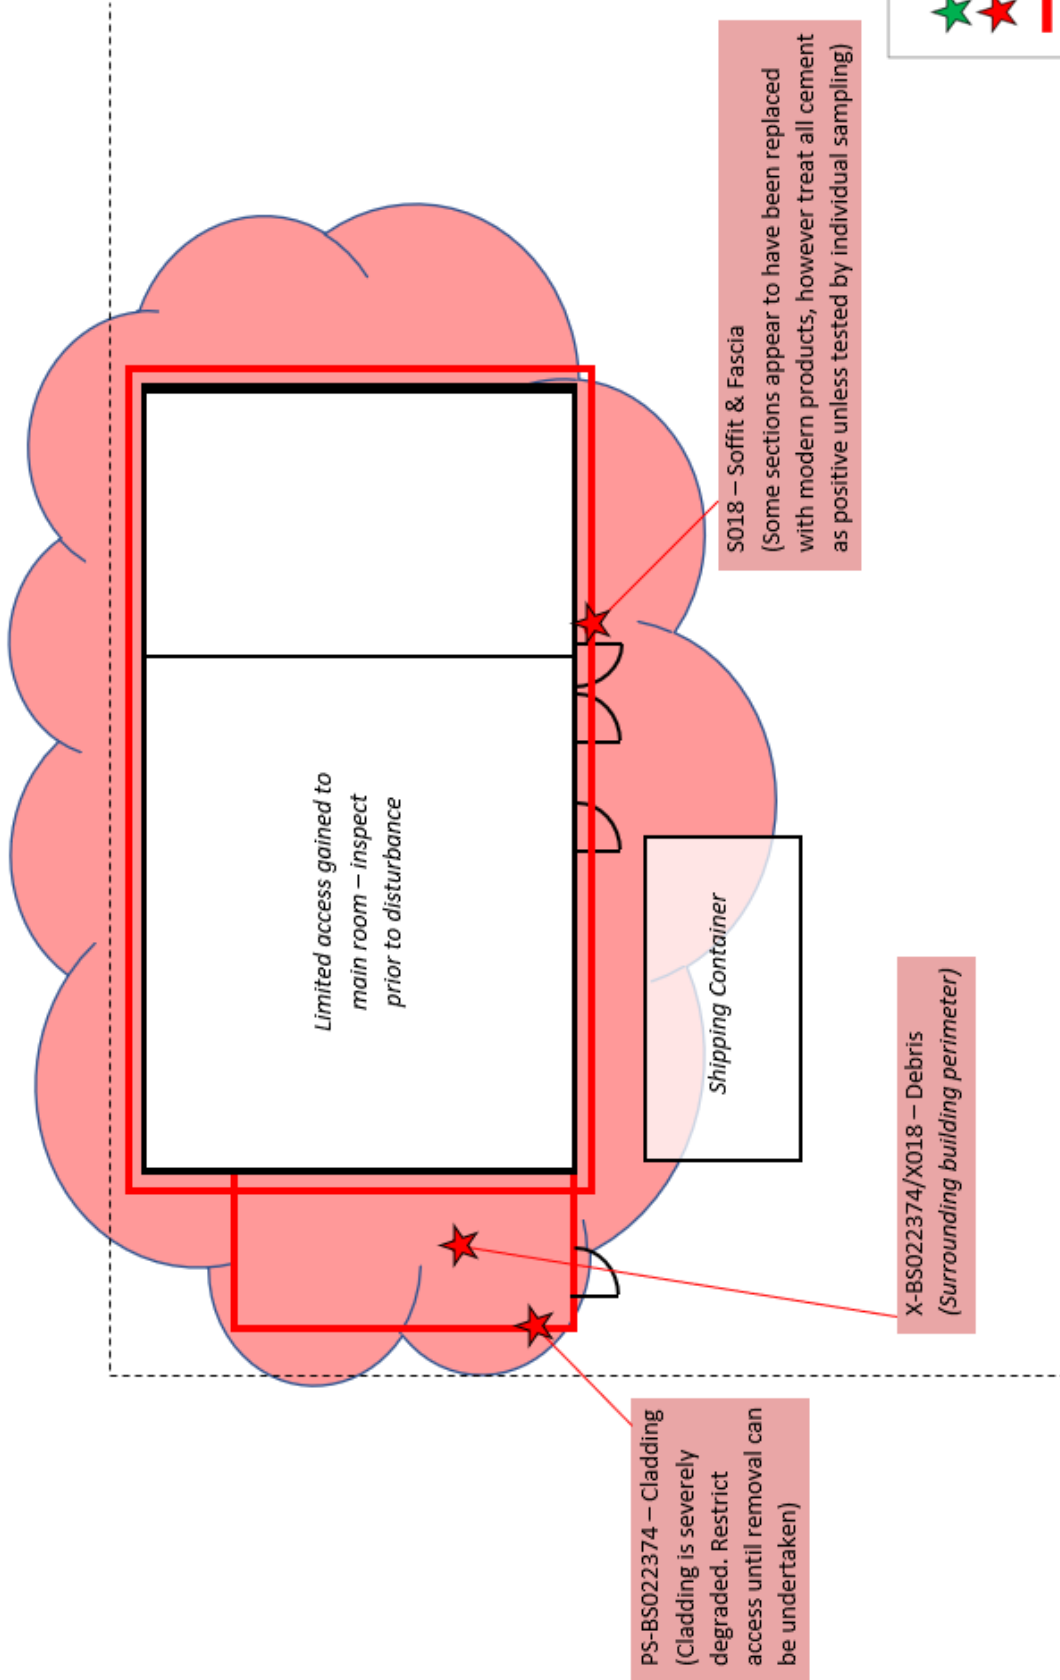
PS-BS022374 – Cladding
 (Cladding is severely degraded. Restrict access until removal can be undertaken)

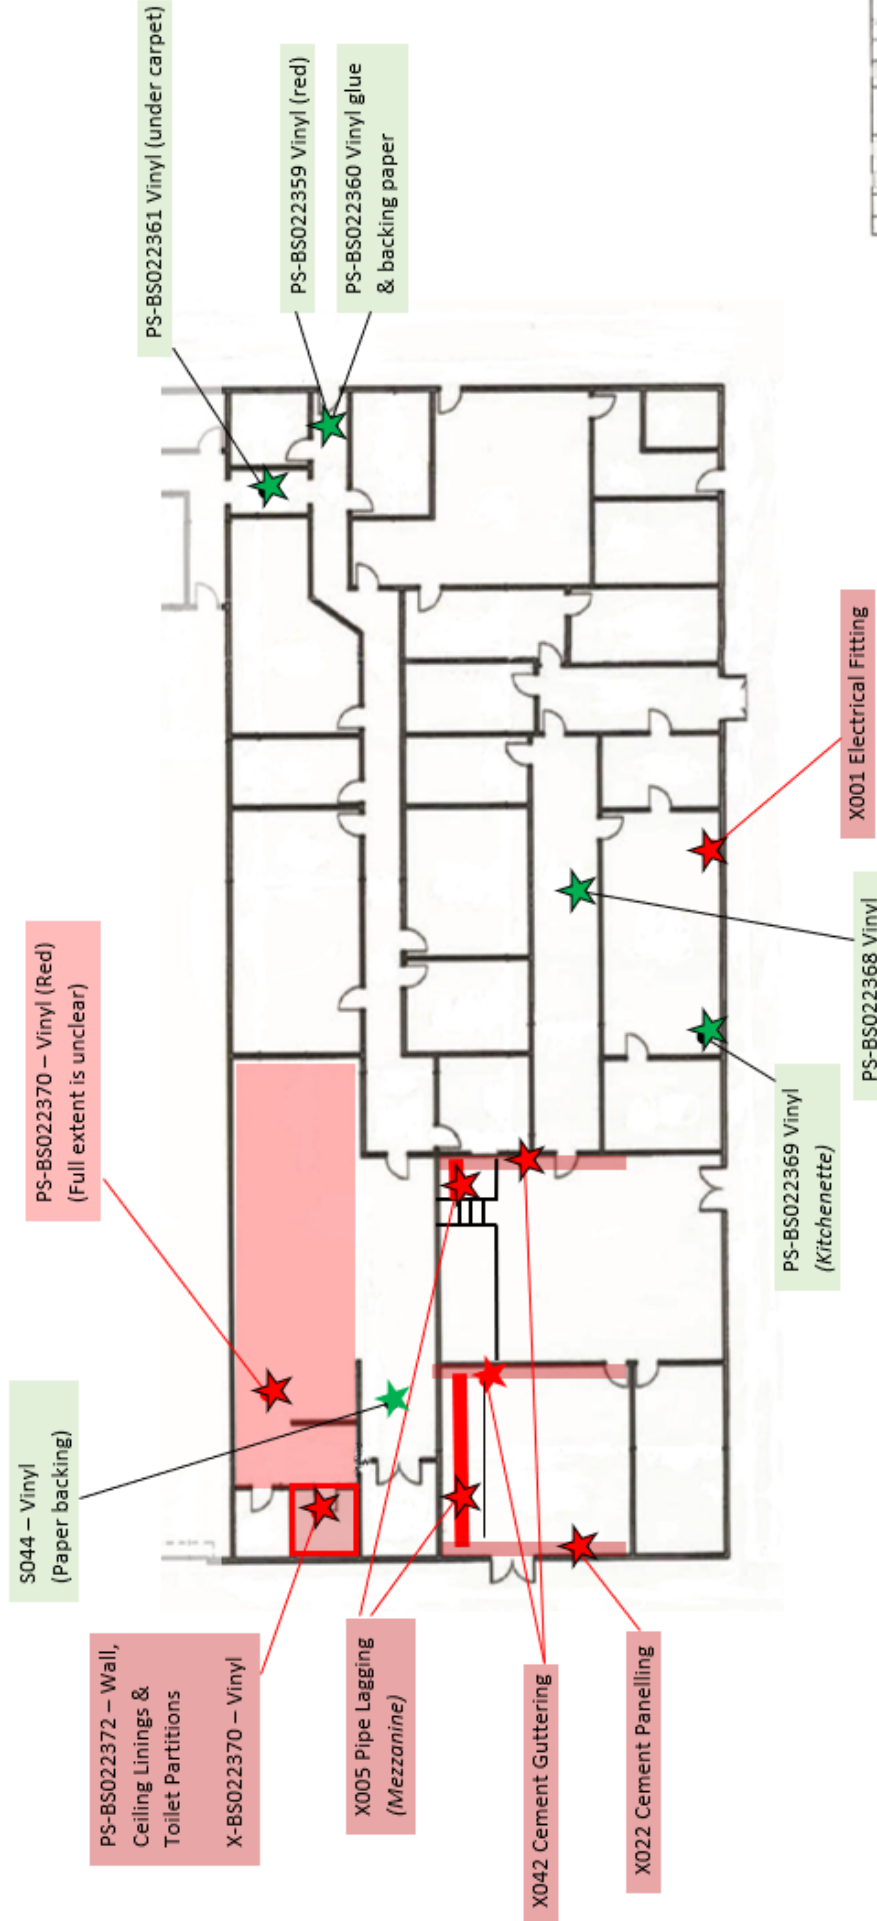
Note on Pipe Lagging: The majority of pipe lagging inspected and visible in the building is non-suspect fibreglass lagging, ranging from good to very poor condition. However, highly damaged asbestos pipe lagging and associated debris has been identified in multiple locations (indicated on maps) and therefore disturbance of any lagging material, ceiling and wall voids should proceed with extreme caution, should additional concealed ACMs be present.
