Asbestos Management Survey Report

Shelly Bay Complex
Shelly Bay Road
Wellington, 6022

Wellington City Council

Reference: W-01625

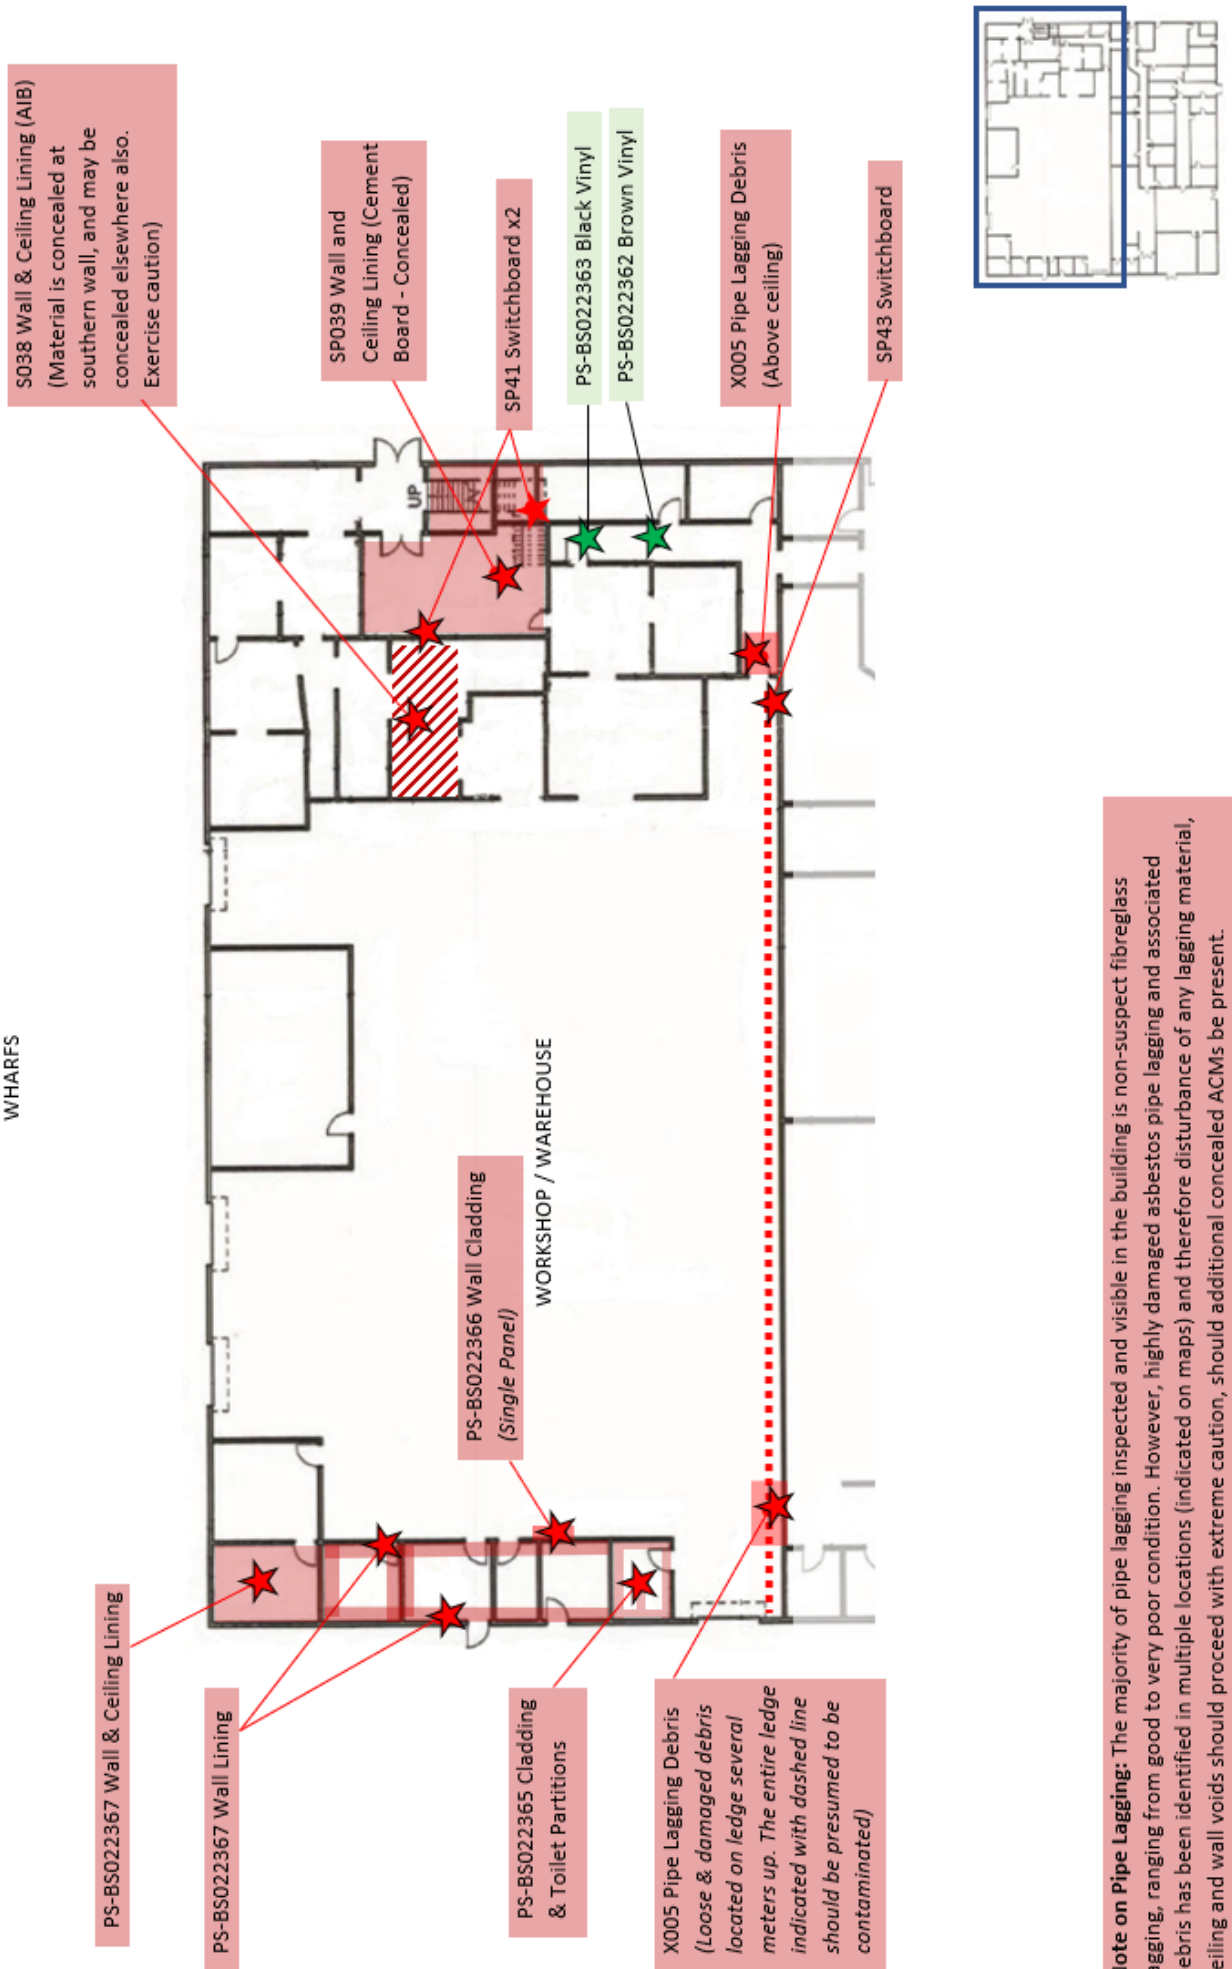
Note on Pipe Lagging: The majority of pipe lagging inspected and visible in the building is non-suspect fibreglass lagging, ranging from good to very poor condition. However, highly damaged asbestos pipe lagging and associated debris has been identified in multiple locations (indicated on maps) and therefore disturbance of any lagging material, ceiling and wall voids should proceed with extreme caution, should additional concealed ACMs be present.

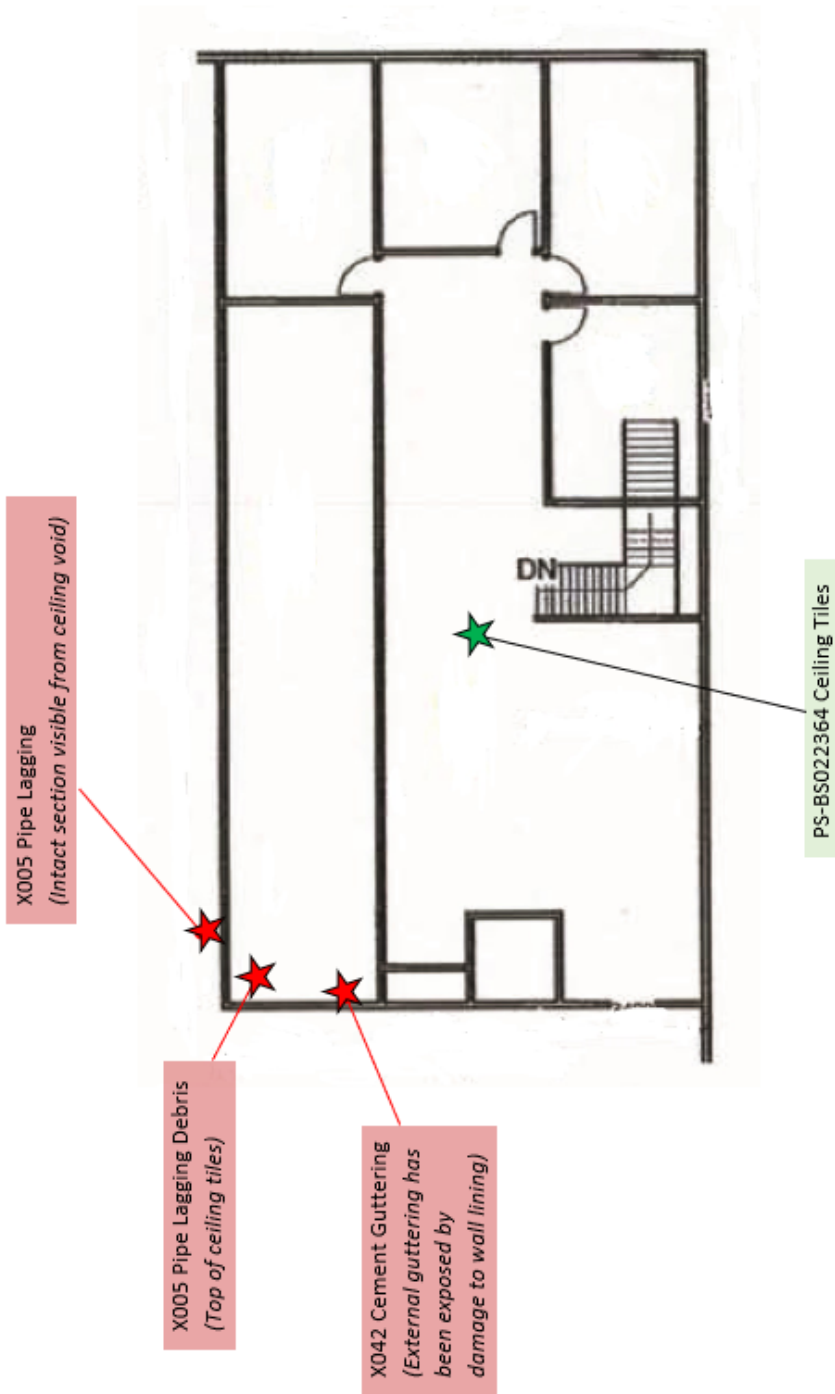
Note on Pipe Lagging: The majority of pipe lagging inspected and visible in the building is non-suspect fibreglass lagging, ranging from good to very poor condition. However, highly damaged asbestos pipe lagging and associated debris has been identified in multiple locations (indicated on maps) and therefore disturbance of any lagging material, ceiling and wall voids should proceed with extreme caution, should additional concealed ACMs be present.
