September 2020

Te Aro Park Assessing Harm

This report outlines safety concerns within Te Aro Park, actions taken to date and potential solutions.

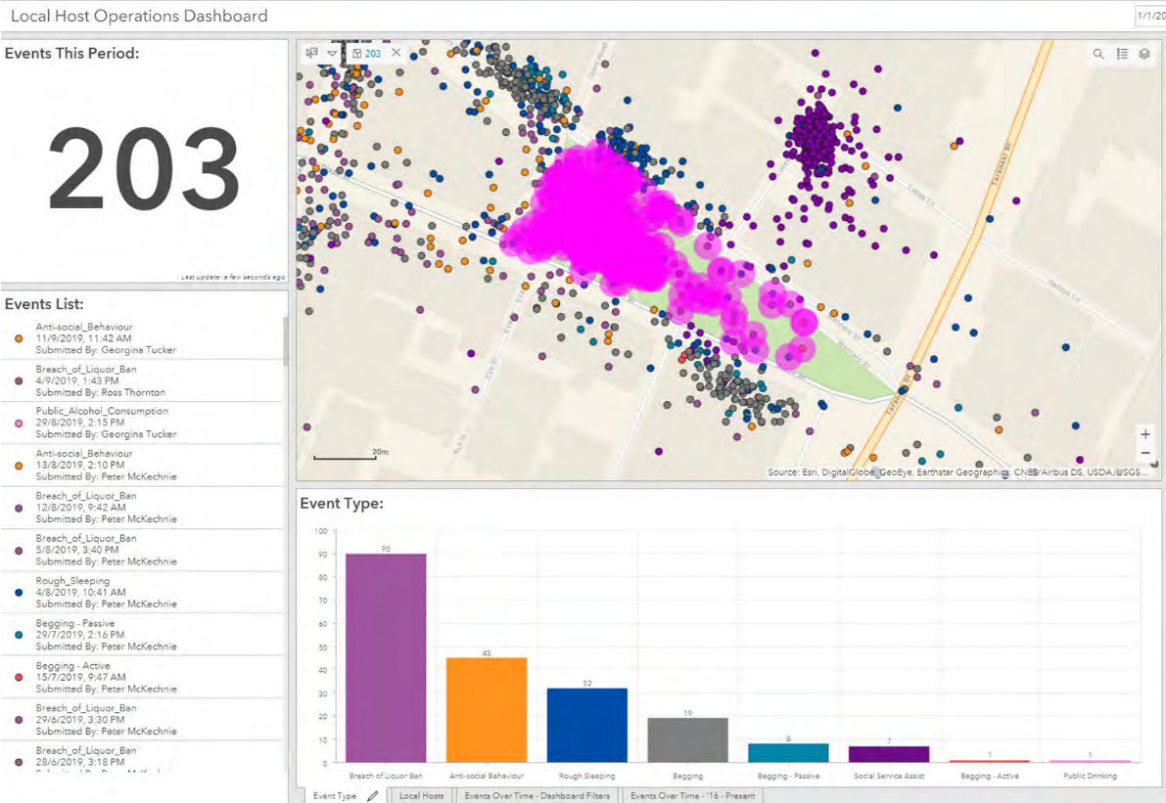
Fig D.

Figure D: Local hosts incidents 1 Jan 2017–30 Sept 2019 (Te Aro Park incidents highlighted in pink)

The dashboard illustrates the various incidences reported by Local Hosts during their walks around the city between Jan 1st, 2017 and September 30, 2019. There is a high density of breach of liquor ban logged within the park follow by number of anti-social behaviour incidences logged.

This shows a concentration of anti-social behaviour in the park, with breach of liquor ban being historically the highest reported incident by Council's Local Hosts in the immediate vicinity of the park, followed by anti-social behaviour. There is also a concentration of rough sleeping in the surrounding area (see Figure D). CCTV observed incidents show a concentration of breach of alcohol ban and anti-social behaviour incidents in the park (see Figure E).

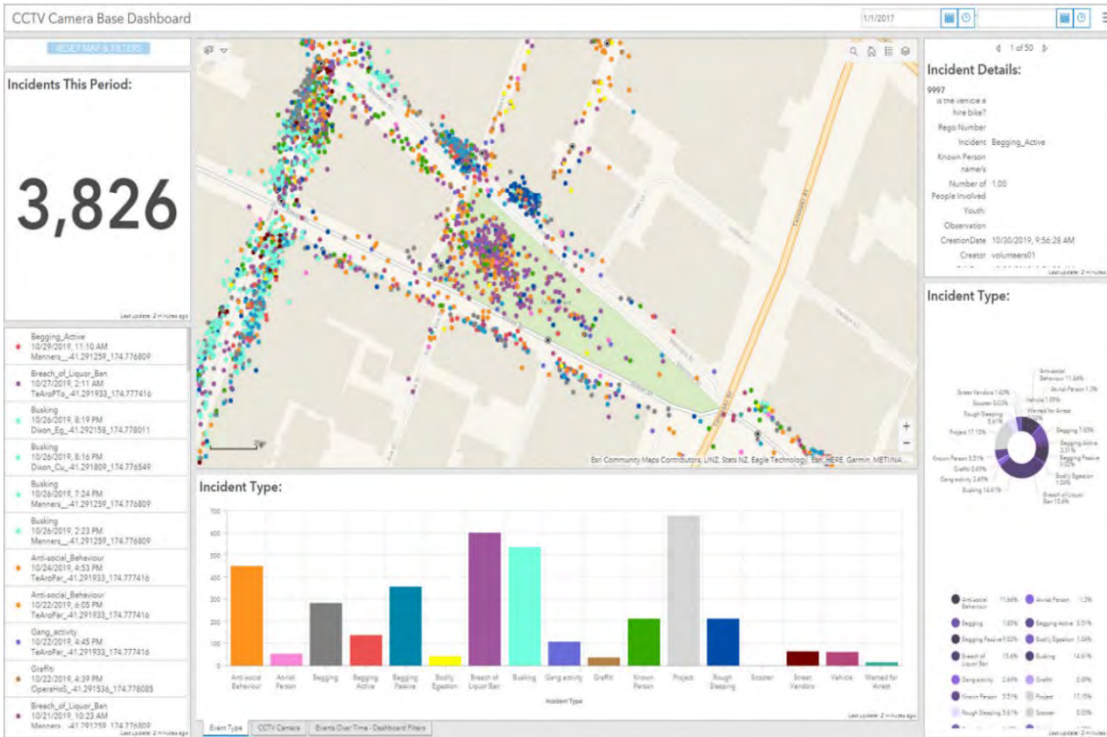
FIGURE E: CCTV observed incidents 1 January 2017–30 September 2019

Fig E.
 The dashboard illustrates the CCTV incidences observed between 1st January 2017 and September 30th, 2019. The incidences logged show that there is overrepresentation of harm associated with Te Aro Park compared to the surrounded areas. The levels of anti-social behaviour and breach of liquor ban are much higher in the park than nearby streets. Most of these reports are in the area around the toilet block.
