Embassy Theatre (10 Kent Terrace) Detailed Seismic Assessment Report

Job number: 8651

This report has been carried out for Wellington City Council with the intention of establishing the likely seismic strength of the Embassy Theatre (10 Kent Terrace), using the MBIE publication *Seismic Assessment of Existing Buildings – Technical Guidelines for Engineering Assessments*, July 2017 and expressed in terms of %NBS (New Building Standard).

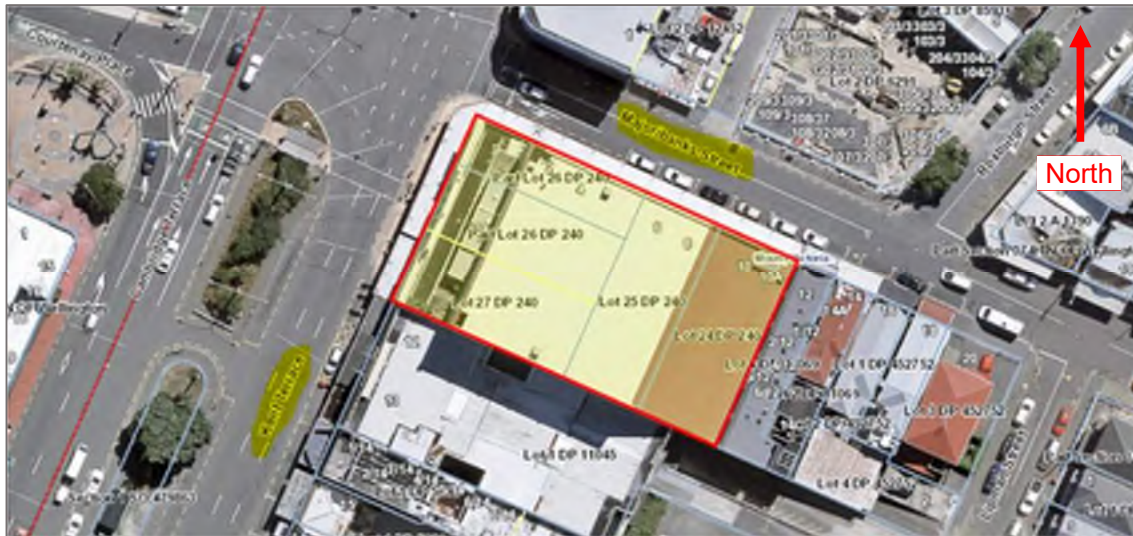
Figure 2.1: Site location plan with Majoribanks St to the north and Kent Terrace to the West.

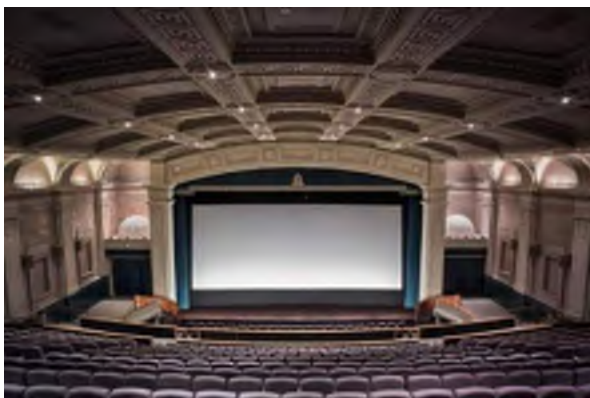
Figure 3.5: Photos of ceiling from inside main theatre with sketch of ceiling tributary to roof truss.

- The main theatre plaster ceiling bracing capacity was assessed using parts loading with a ductility of 2.
- The ceiling comprises a mix of flat plaster board elements supported on timber joists, intersected with a grid of set down, decorative, moulded plaster panels on light weight steel frame fixed back to timber joists. The joists span between trusses and are supported by timber hangers framed around the trusses. Framing is fixed with nails. The ceiling was assessed using Part C of the guidelines for diaphragm and timber/nail connection capacities. The figures below show a cross-section and photos of the ceiling/roof structure.

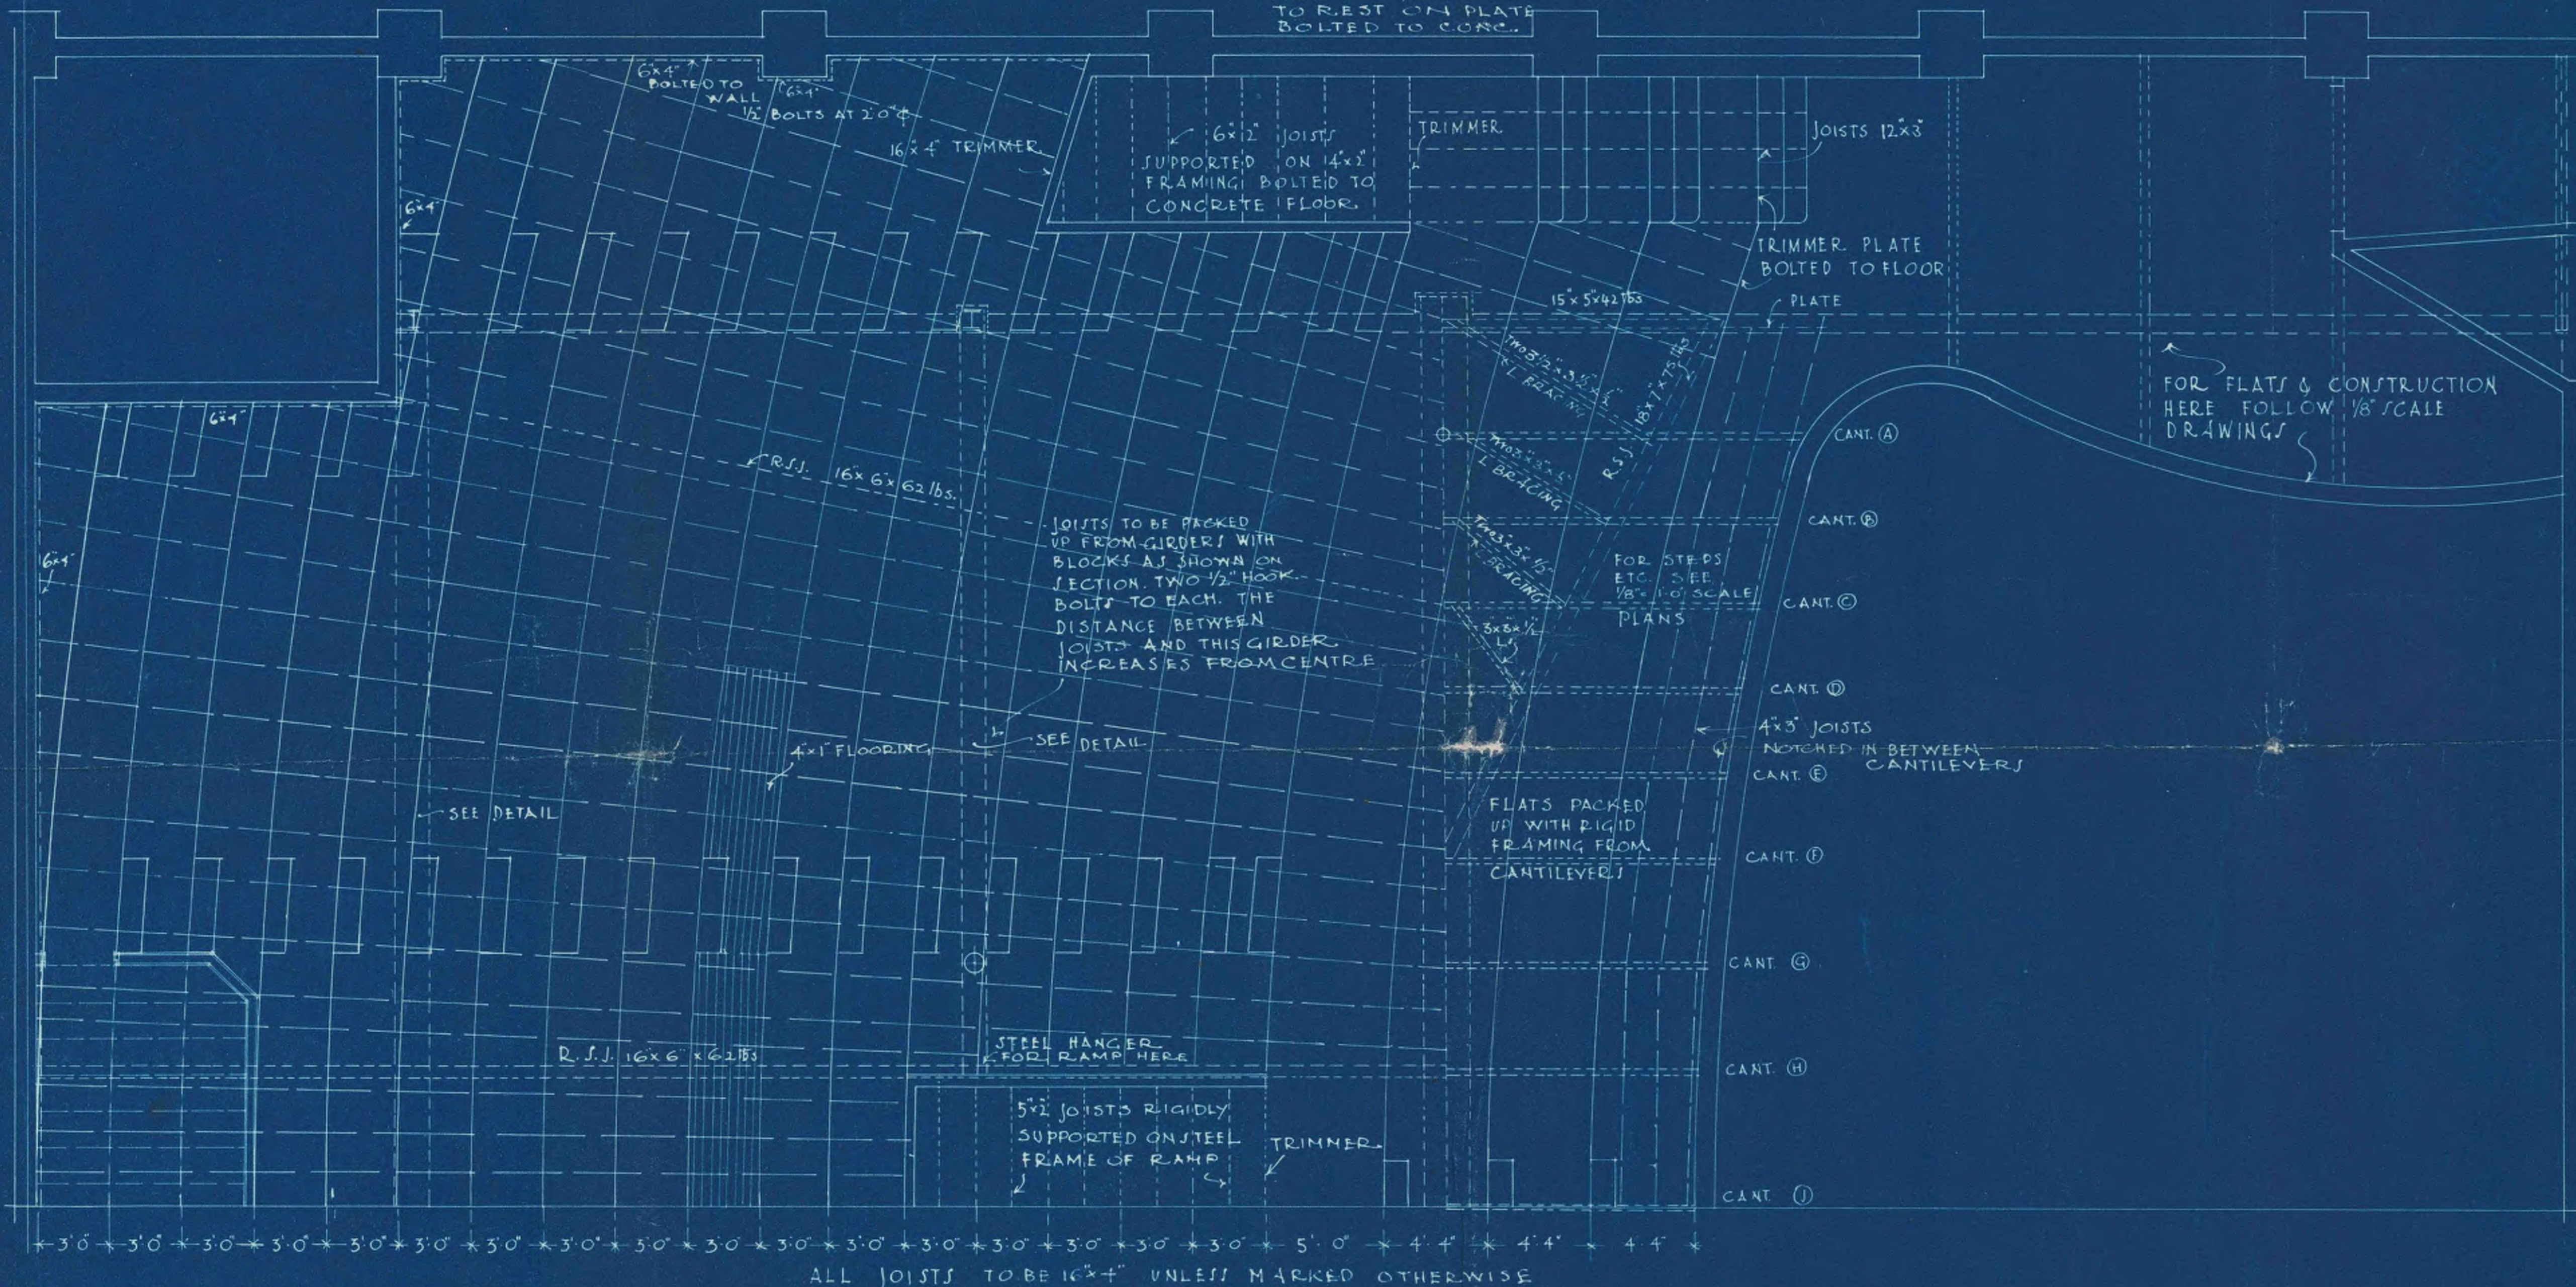
SHEET No 87
CIRCLE CONSN
SCALE 1/4" = 1'-0"
DATE 1 MARCH 1923

ALL TIMBER WHERE TOUCHING CONCRETE
TO REST ON PLATE
BOLTED TO CONC.

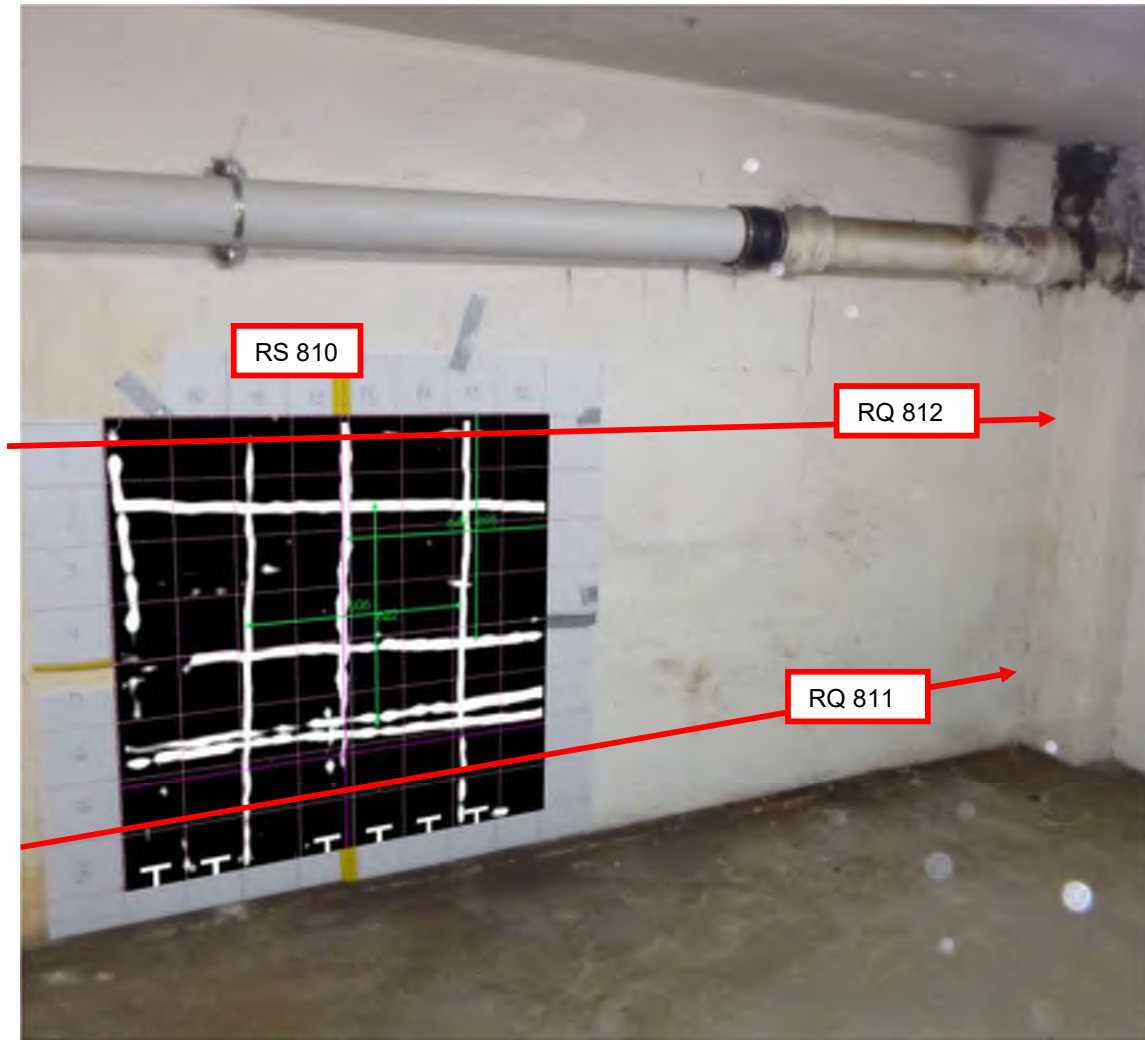
Figure 7: Wall Scan Grid 11- E/F

Project name:	234158	Customer:	-
Location:	-	Object:	-
User:	-	Permittivity:	5.6
Filename	RS_054210001_000810.hscan	Timestamp	-
<p>Wall</p> <p>Scan taken on Grid 11/E-F, as depicted in Figure 7. The Left scan margin is approx. 720mm from the column 11/E and the top scan margin is 1300mm above the floor.</p> <p>Increased moisture content is present in the bottom of the scan, within the concrete</p> <p>Reinforcing bars:</p> <ul style="list-style-type: none"> • two layers of reinforcement bars • vertical and horizontal bars connect <ul style="list-style-type: none"> ○ First layer: <ul style="list-style-type: none"> ▪ min. concrete cover approx. 48mm ▪ horizontal bars, c/c approx. 620mm ▪ vertical bars, c/c approx. 600mm ○ Second layer: <ul style="list-style-type: none"> ▪ horizontal bars, c/c from approx. 570mm and 645mm, respectively ▪ vertical bars, c/c approx. 540mm and 640mm, respectively <p>Starter bars:</p> <ul style="list-style-type: none"> • suspected starter bars at annotations 1, 2, 3 and 4 • bars terminate approx. 550mm above the slab • for c/c refer to RQ811

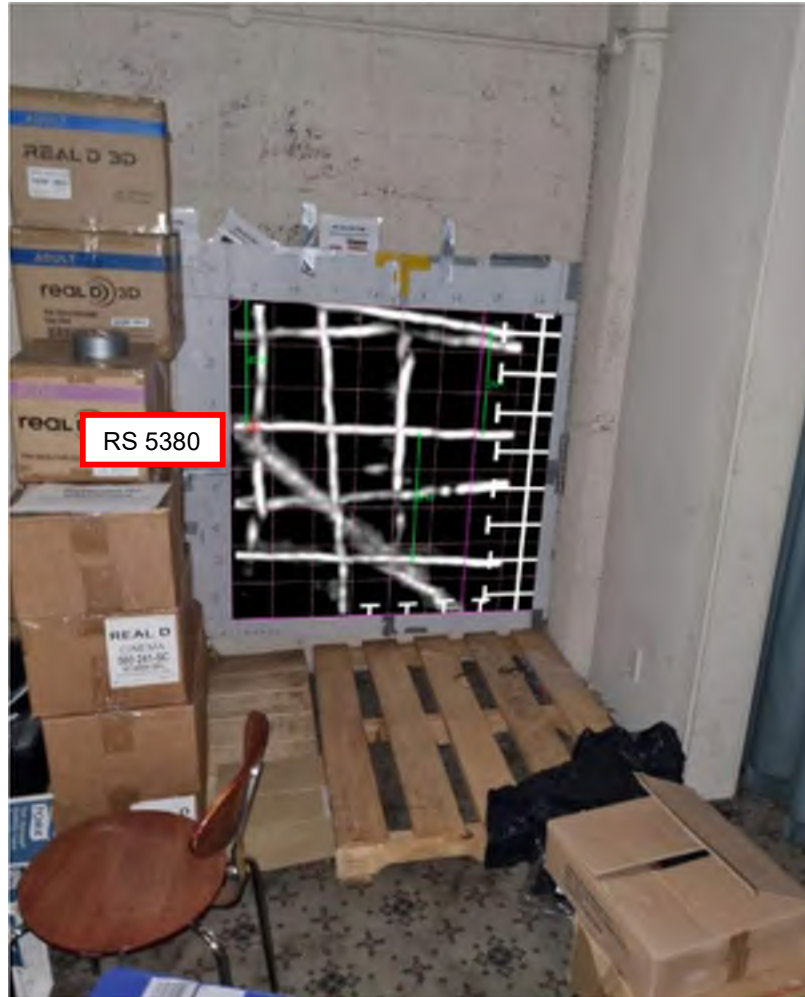
Figure 14: Wall Scan Grid G- 8/9

Project name:	234158	Customer:	-
Location:	-	Object:	-
User:	-	Permittivity:	6.0
Filename	RS_070140002_005380.hscan	Timestamp	-
Comment:	<p>Wall</p> <p>Scan taken on Grid G/8-9, as depicted in Figure 14. The right scan margin is 75mm from the column and the top scan margin is 1500mm above the floor.</p> <p>Scan data indicate the possibility for increased moisture content within the concrete</p> <p>Reinforcing bars:</p> <ul style="list-style-type: none"> • reinforcement is irregularly placed • annotations 1 and 2; diagonal bar • vertical and horizontal bars connect <ul style="list-style-type: none"> ○ horizontal bars, c/c from approx. 200mm to 360mm ○ vertical bars, c/c from approx. 210mm to 360mm • min. concrete cover approx. 31mm

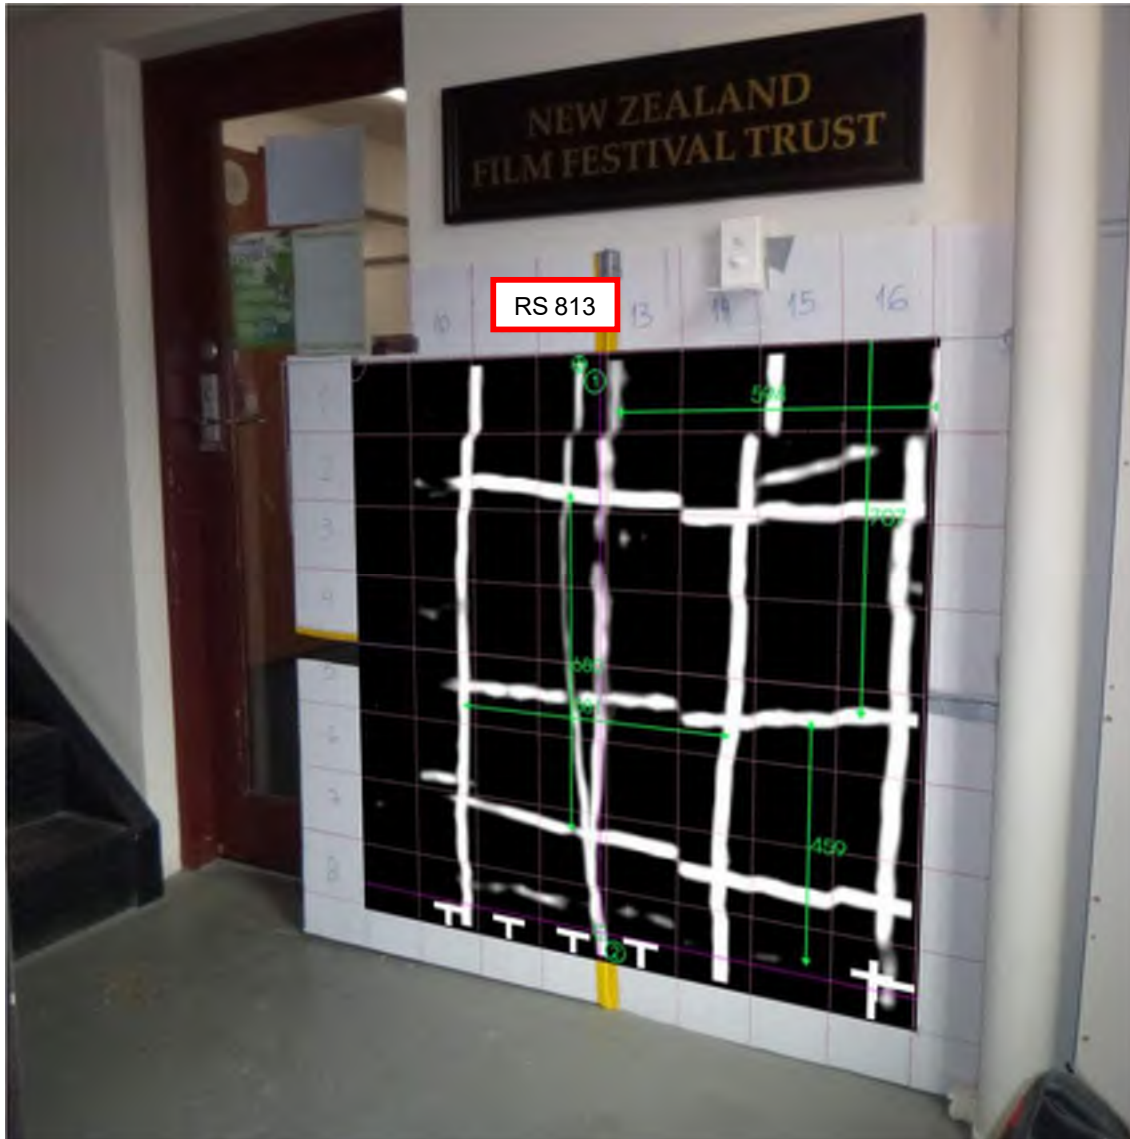
Figure 22: Wall Scan Grid 2- A/B

Project name:	234158	Customer:	-
Location:	-	Object:	-
User:	-	Permittivity:	6.0
Filename	RS_054210001_000813.hscan	Timestamp	-
Comment:	<p>Wall</p> <p>Scan taken on Grid 2/A-B, as depicted in Figure 22. Left edge aligns with y=150, top scan margin is 1300mm above the floor.</p> <p>Reinforcing bars:</p> <ul style="list-style-type: none"> • two layers of reinforcement bars • vertical and horizontal bars connect <ul style="list-style-type: none"> ○ first layer: <ul style="list-style-type: none"> ▪ min. concrete cover approx. 65mm ▪ horizontal bars, c/c approx. 680mm ▪ vertical bars, c/c approx. 580mm ○ second layer: <ul style="list-style-type: none"> ▪ horizontal bars, c/c approx. 460mm and 710mm ▪ vertical bars, c/c approx. 590mm <p>Low cover detection between annotations 1 & 2</p> <ul style="list-style-type: none"> • min. cover of 9mm • unclear whether it is a service or bar • does not connect to any reinforcement

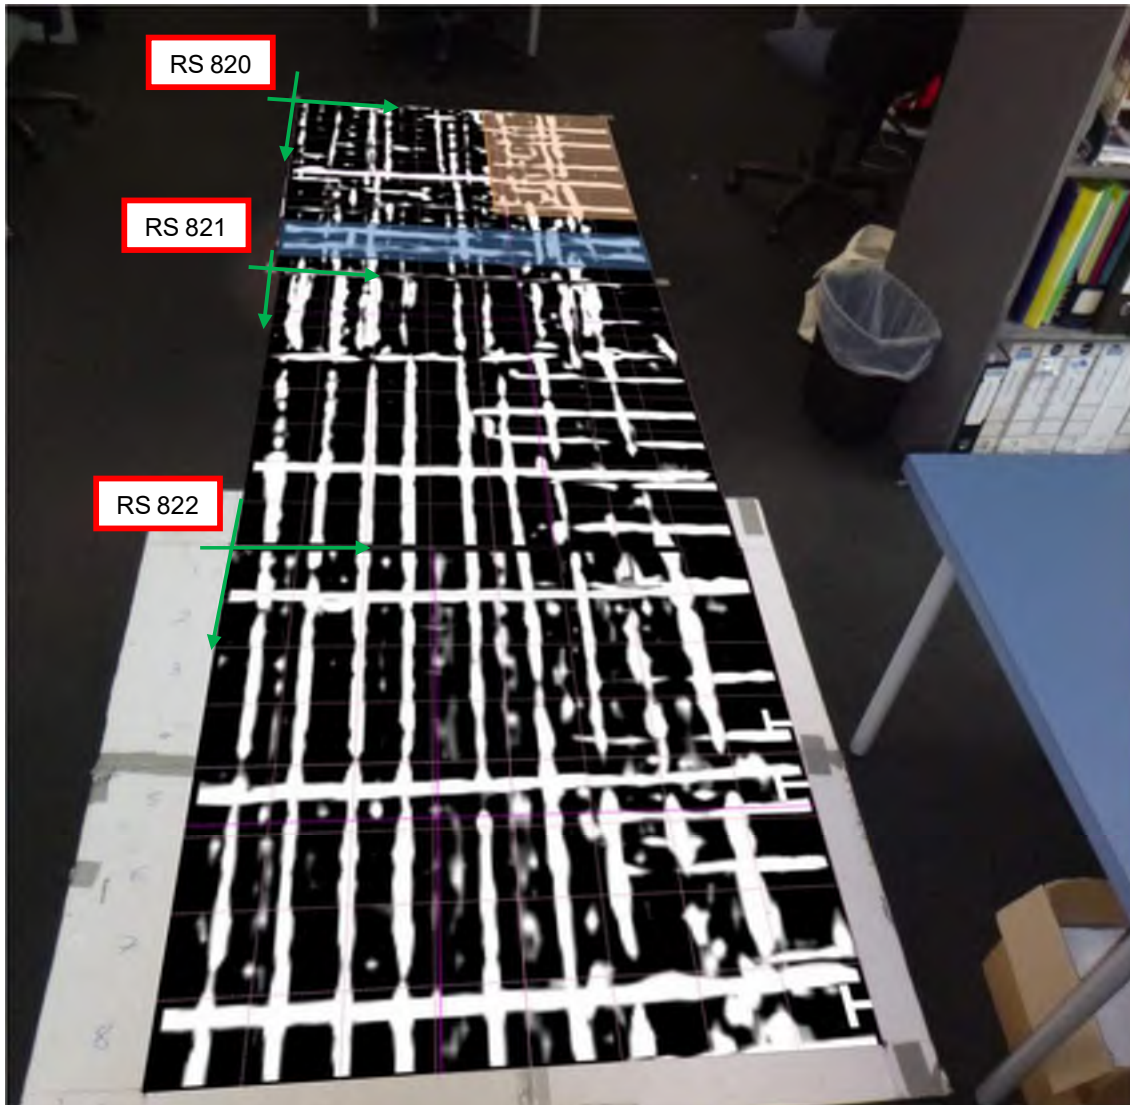
Figure 30: Slab Scan Grid 1/2 - D/C

Project name:	234158	Customer:	-
Location:	-	Object:	-
User:	-	Permittivity:	7.0
Filename	RS_054210001_000820.hscan	Timestamp	-
Comment:	<p>Slab</p> <p>Scan taken on Grid D/1-2, as depicted in Figure 30. The top scan margin is approx. 8000mm from the wall at grid G, the right scan margin is approx. 1780mm from the wall at grid 1</p> <p>Steel beam:</p> <ul style="list-style-type: none"> highlighted in blue flange width is approx. 150mm <p>Slab reinforcement:</p> <ul style="list-style-type: none"> one layer: <ul style="list-style-type: none"> c/c average of 600mm, parallel to numbered grid lines (x-direction) c/c average of 118mm, parallel to lettered grid lines (y-direction) additional bars: <ul style="list-style-type: none"> bars in x-direction <ul style="list-style-type: none"> orange highlighted areas bars emerge from the right and terminate at around x=750 average c/c approx. 159mm the bars sit on top of the above-mentioned layer the bars connect to the above-mentioned layer possible structural change at the right scan margin, visual inspection from below is recommended bars in y-direction <ul style="list-style-type: none"> bars emerge from the bottom of the scan where possible the termination is determined to be between y=510-665

Project name:	234158	Customer:	-
Location:	-	Object:	-
User:	-	Permittivity:	7.0
Filename	RS_054210001_000821.hscan	Timestamp	-
Comment:	<p>Slab</p> <p>Scan taken on Grid D/1-2, as depicted in Figure 30. The top scan margin is approx. 9200mm from the wall grid G, right scan margin is approx. 1780mm from the wall grid 1.</p> <p>Slab reinforcement:</p> <ul style="list-style-type: none"> • one layer: <ul style="list-style-type: none"> ○ c/c average is 450mm, parallel to numbered grid lines (x-direction) ○ c/c average is 116mm, parallel to lettered grid lines (y-direction) • additional bars: <ul style="list-style-type: none"> ○ bars in x-direction <ul style="list-style-type: none"> ▪ orange highlighted area ▪ bars emerge from the right and terminate between around x=600-750 ▪ c/c average is 153mm ▪ the bars sit on top of the above-mentioned layer ▪ the bars connect to the above-mentioned layer ▪ possible structural change at the right scan margin, visual inspection from below is recommended ○ bars in y-direction <ul style="list-style-type: none"> ▪ bars emerge from top of scan and terminate between y=310-455 ▪ c/c average is 145mm

Project name:	234158	Customer:	-
Location:	-	Object:	-
User:	-	Permittivity:	7.0
Filename	RS_054210001_000822.hscan	Timestamp	-
Comment:	<p>Slab</p> <p>Scan taken on Grid line D-C/1-2, as depicted in Figure 30. The top scan margin is approx. 10400mm from the wall at grid G, the right scan margin is approx. 1780mm from the wall grid 1.</p> <p>Slab reinforcement:</p> <ul style="list-style-type: none"> one layer: <ul style="list-style-type: none"> c/c average of 450mm, parallel to numbered grid lines (x-direction) c/c average of 159mm, parallel to lettered grid lines (y-direction) additional bars: <ul style="list-style-type: none"> bars in x-direction <ul style="list-style-type: none"> in orange highlighted areas bars emerge from the right and terminate at around x=705 average c/c approx. 159mm the bars sit on top of the above-mentioned layer the bars connect to the above-mentioned layer possible structural change at the right scan margin, visual inspection from below is recommended
