**STOKE ST, TREVOR TER AND KENWYN TER NEWTOWN WELLINGTON RESIDENCE
JOINT SUBMISSION ON WELLINGTON CITY COUNCIL'S DRAFT DISTRICT PLAN
SEPTEMBER 2022 (PRE001 MDRZ CHARACTER PRECINCTS)**

26 Stoke Street
Newton, Wellington

Conservation Plan

Arch 273: Building Heritage Conservation

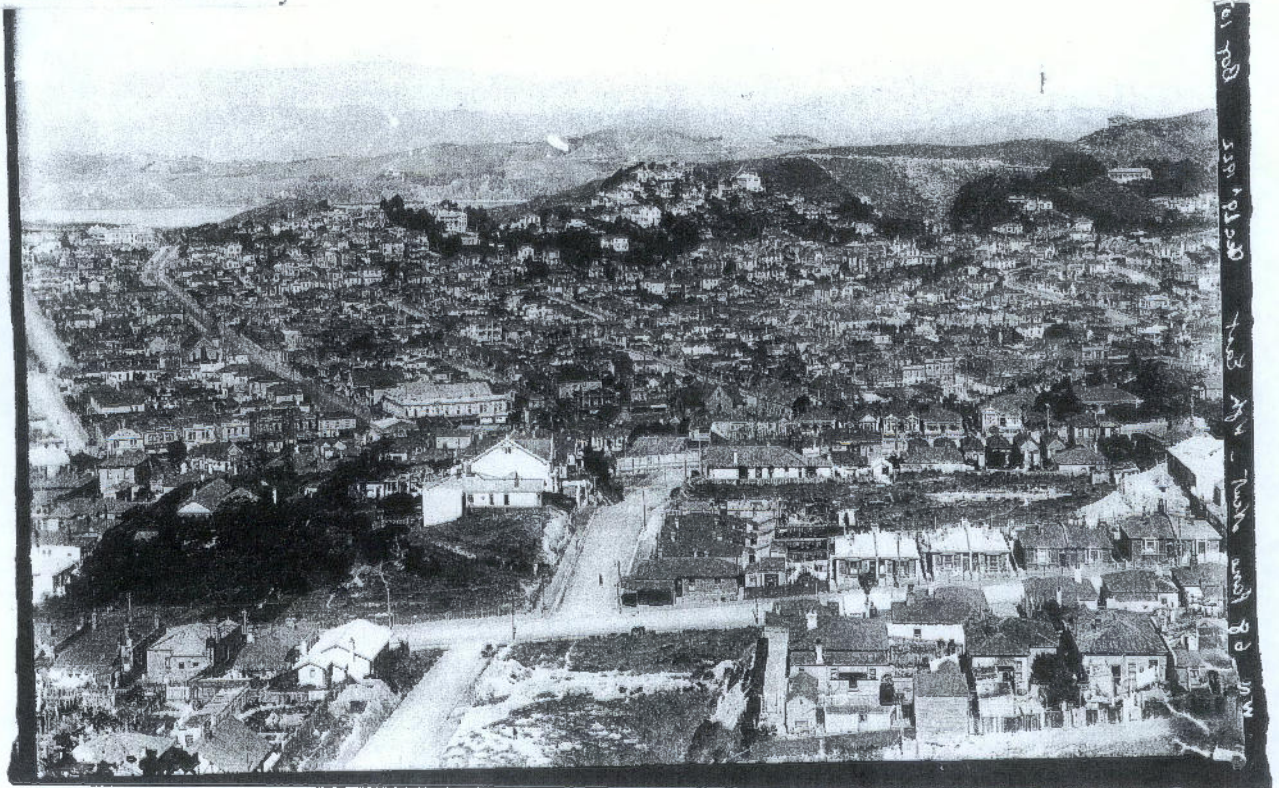
Fig 3.
Stoke House, 1922. Stoke Street Center
46098
Alexander Turnbull Library

It appears that as the town encroached upon the brickworks that would have once stood on the outskirts, it gave way to residential use. By 1922 (fig. 3) Town Acre 955 was no longer on the outskirts. One more block had been added and the site of the brickworks was now mostly occupied by residences. However, the Thos. Stephens land adjoining to the north still appears unsubdivided. In comparison with the earlier photographs (ca 1895-1908), Newtown had become much more densely populated. The house at 26 Stoke Street can clearly be seen in this photo of 1922 (fig 3.), towering over its neighbours.

This house has a somewhat strange presence in the street as it is of a different style and size than its neighbours. Even in an early photo of 1922, it stands out above the streetscape (fig 3.)

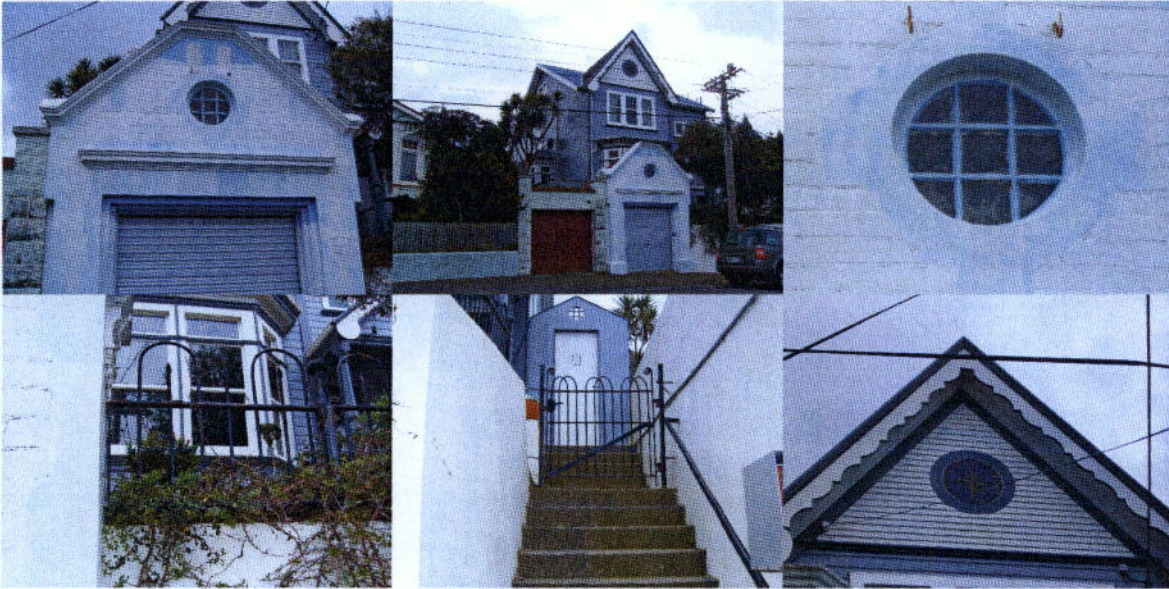
Garage and Front Elevation

Garage				
	Roof	Asbestos tiles, showing some wear. Need to be replaced with a safe but sympathetic material. Parapets are in good condition.	orig.	B/A
	Walls	Brick, fairly good condition.		B
	Mouldings	Plaster moldings, good condition.		A
	Oculus	Fairly good condition, original glass? (needs some attention)		A
House

Roof	Front Gable &Porch roof	Asbestos tiles, showing some wear. Need to be replaced with a safe but sympathetic material.		
	Rest of Roof	Corrugated iron. Probably not originally. Original roof would probably have been completely clad in the 'gingerbread' look red asbestos tiles. As a trademark of Queen Anne Style, the tiles are important to its heritage value.	new	D detracts
Front Elevation	Gable	Shingles to gable, decorative trim and framing probably original although it deviates from original plans, its was probably constructed as is. Texture is important to Queen Anne Style and therefore the differentiated shingles to the gable are important. The decoration on the front facade is very important as this displayed the status of the owner. Glass in oculus has been replaced.		
		Shingles significant but can be replaced with similar		C
		Trim and framing		A
		Oculus		A
		Glass. New and therefore not significant	new	Neutral

Garage	Roof	Replace asbestos tiles with material of similar pattern and scale. The textured roof is an important feature of the Queen Anne style and it is desirable that similar material is used rather than corrugated iron.
	Walls	Check condition of walls for moisture.
	Oculus	Check condition of glass and replace cracked panes with similar if necessary.
Roof	Front Gable & Porch Roof	Replace asbestos tiles with material of similar pattern and scale.
	Rest of Roof	It is desirable that the corrugated iron be replaced with material closer to the original. See reasons given above.
Rear Facade	Balcony	It is not clear from plans weather this balcony is original or not. Balcony railing needs to be inspected for state of timber, currently unpainted and needs to be repainted to protect it. Check condition of floor boards and repair if necessary.
Brick Chimneys		Inspect for earthquake requirements and strengthen if necessary.
