MICHAEL FOWLER CENTRE

DETAILED SEISMIC ASSESSMENT
REPORT

DETAILED SEISMIC ASSESSMENT (DSA) – USING NLTHA

Date: 14 November 2014
Project No: 107303
Revision No: 1

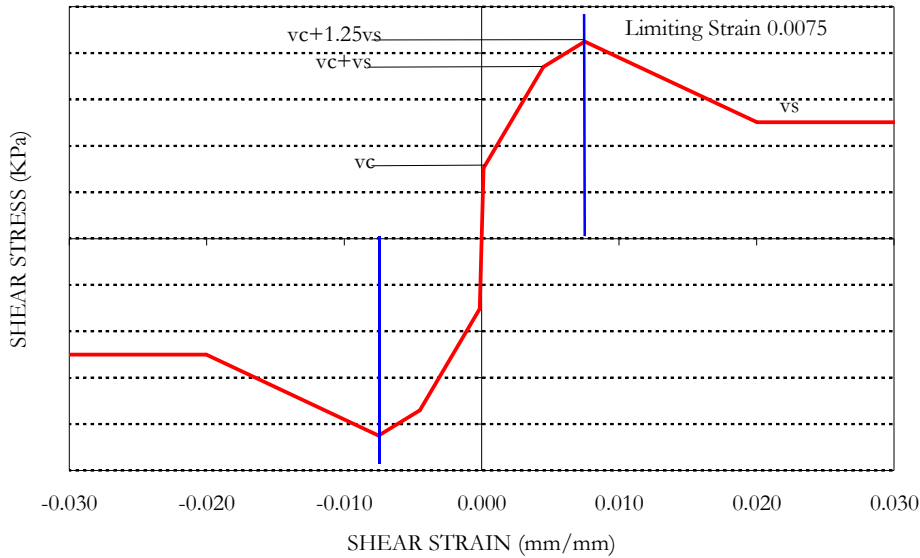
Figure 3-1 Wall Shear Strength Envelope

The shear stiffness of the element may include degradation in strength and stiffness, depending on the level of shear stress. The wall panel yield function is shear controlled. A strength envelope is developed, with three regions defined by the strength provided respectively by the concrete, the nominal strength of the shear reinforcing (strain of 0.0045) and the over-strength of the reinforcing (strain of 0.0075).

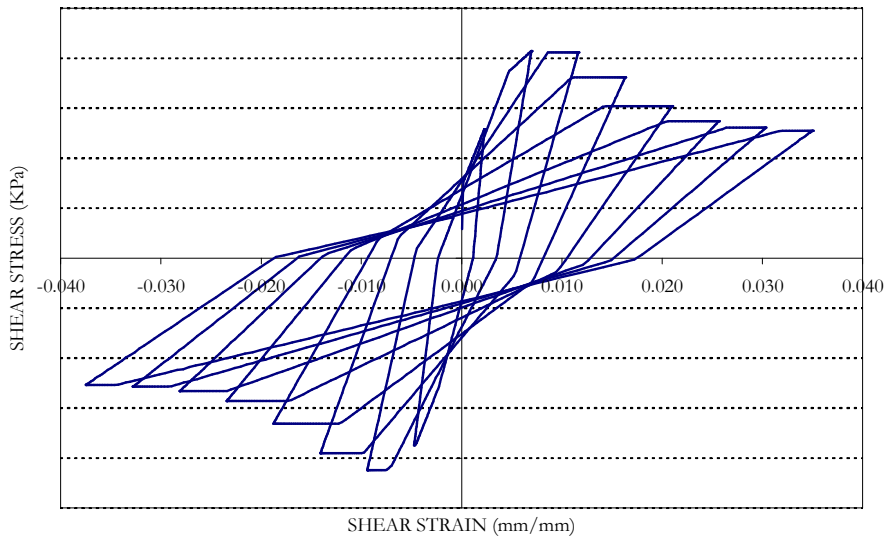
Figure 3-2 Shear Hysteresis

When the shear stress reaches the strength envelope the stiffness reduces to the secant stiffness for unloading and this reduced stiffness is maintained for reversed loading, as shown in Figure 3-2. The stiffness degradation is non-recoverable.

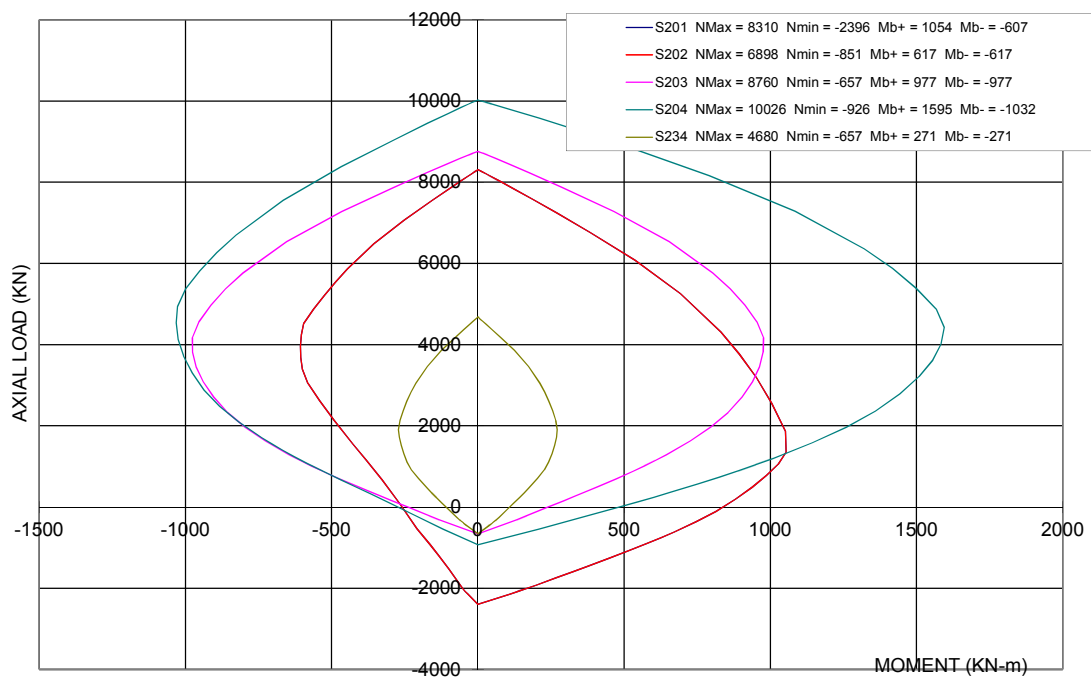
Figure 4-6 Beam Interaction Diagram

Table 4-11 lists all beam strengths. Although strength degradation is usually modelled for beams, this was not implemented for beams where axial load dependency was incorporated. This is because the gravity loads were significant for some beams. A reduction in strength due to applied axial loads together with strength loss due to plastic rotation would result in moment capacity lower than required to support gravity loads. In this situation, equilibrium cannot be satisfied and the analysis terminates.

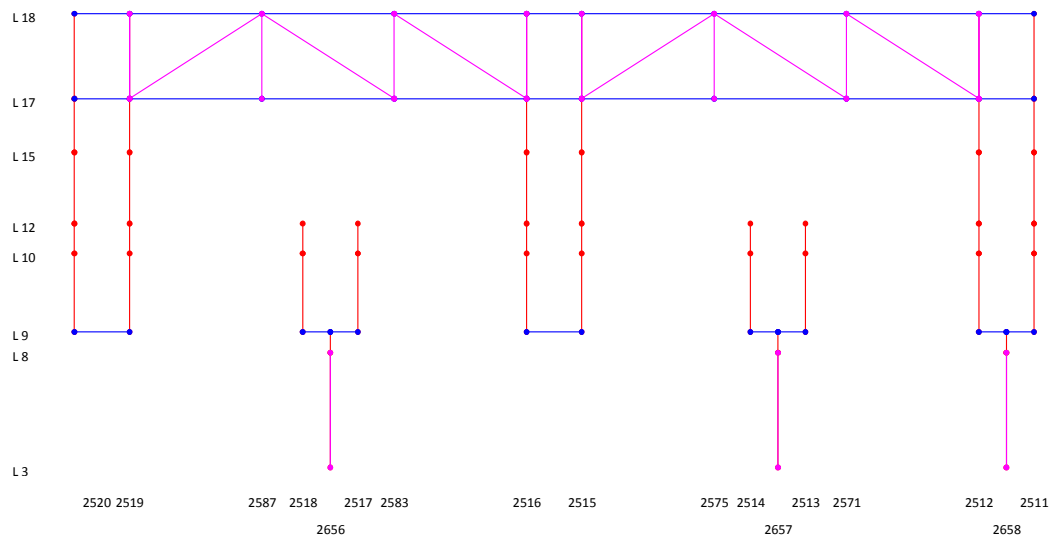
Figure 4-18 East-West Section of Entrance Foyer Model (Outer)

In the E-W direction, the close coupled columns are linked together with a reinforced concrete slab at floor level (and part-way up their height for the end and central frames) to act as narrow frames to provide lateral resistance in this direction. Column groups are linked together with foundation beams, supported on reinforced concrete enlarged base piles. Figure 4-18 shows the outer frames (column lines 2510 to 2501) and Figure 4-19 shows the inner frame (column lines 2520 to 2511). The roof trusses span between columns in the inner frames.

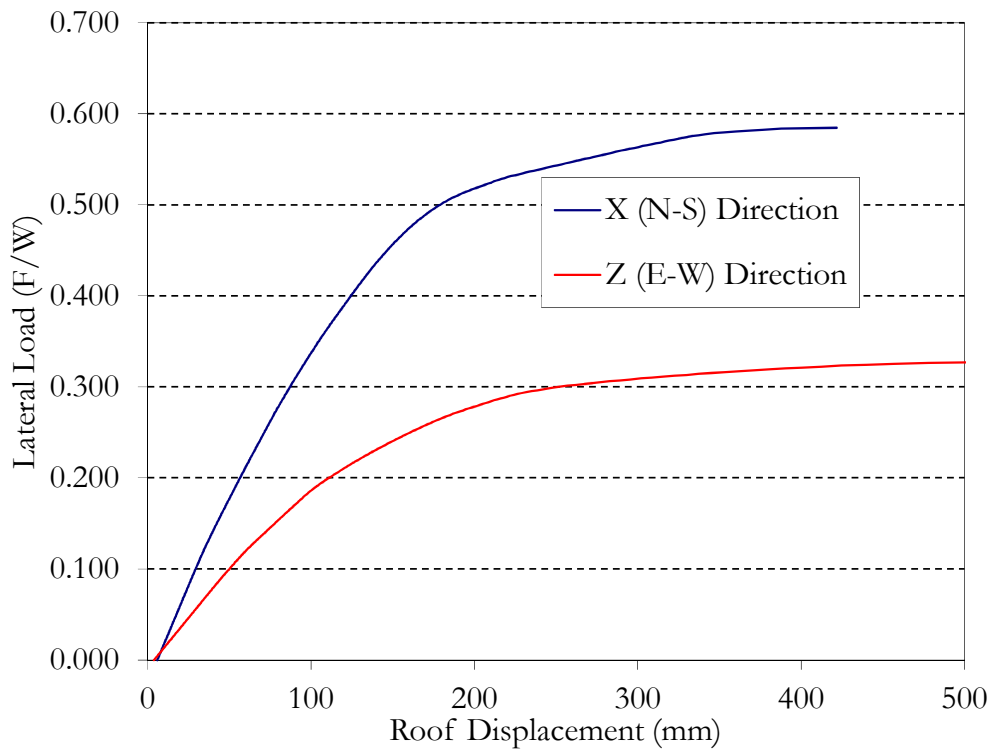
Figure 5-2 Entrance Foyer Capacity Curve

Figure 5-2 shows that the Entrance Foyer has a definite yield point in the X direction at about $0.5W$ and the analysis terminates at $0.6W$. This is in the transverse frame direction (Figure 4-17). In the Z direction where lateral load resistance is provided by the narrow frames formed of floor slabs (Figures 4-18 and 4-19) the frame is more flexible and has a lower strength, with a yield level of about $0.30W$ and ultimate strength of about $0.35W$.

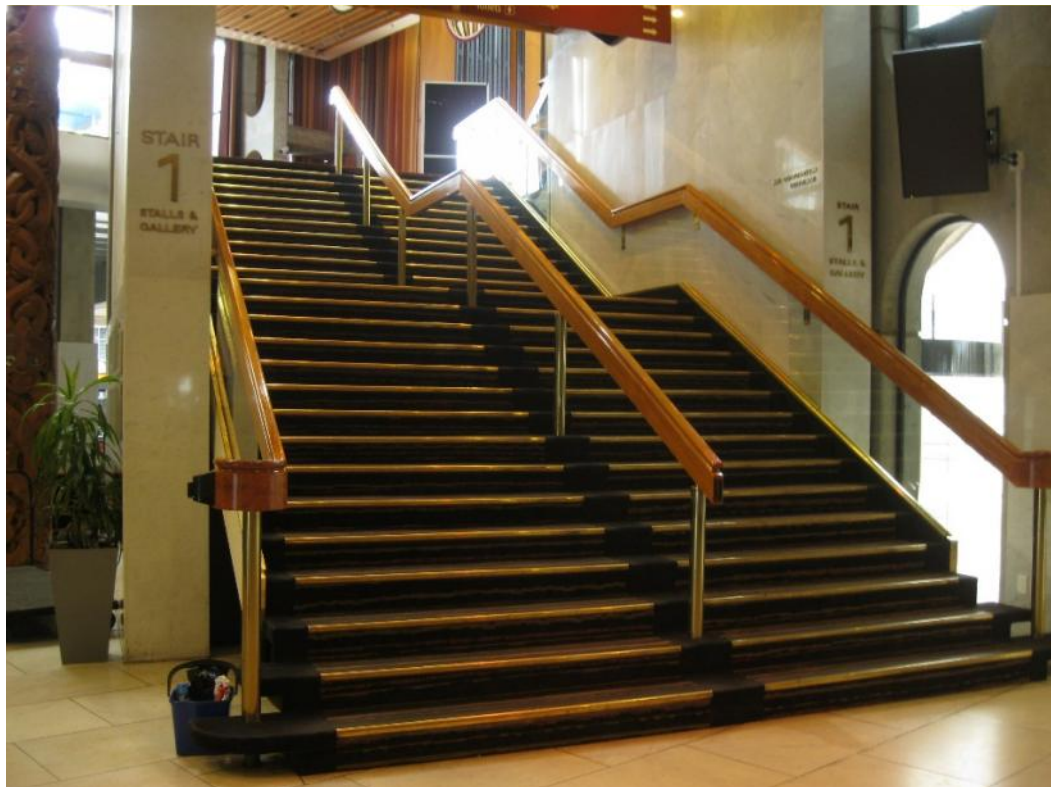
Figure 7-2: Stair 2 (Stair 1 as per building signage)

Reviewed Flights of Stairs - L2 to L4

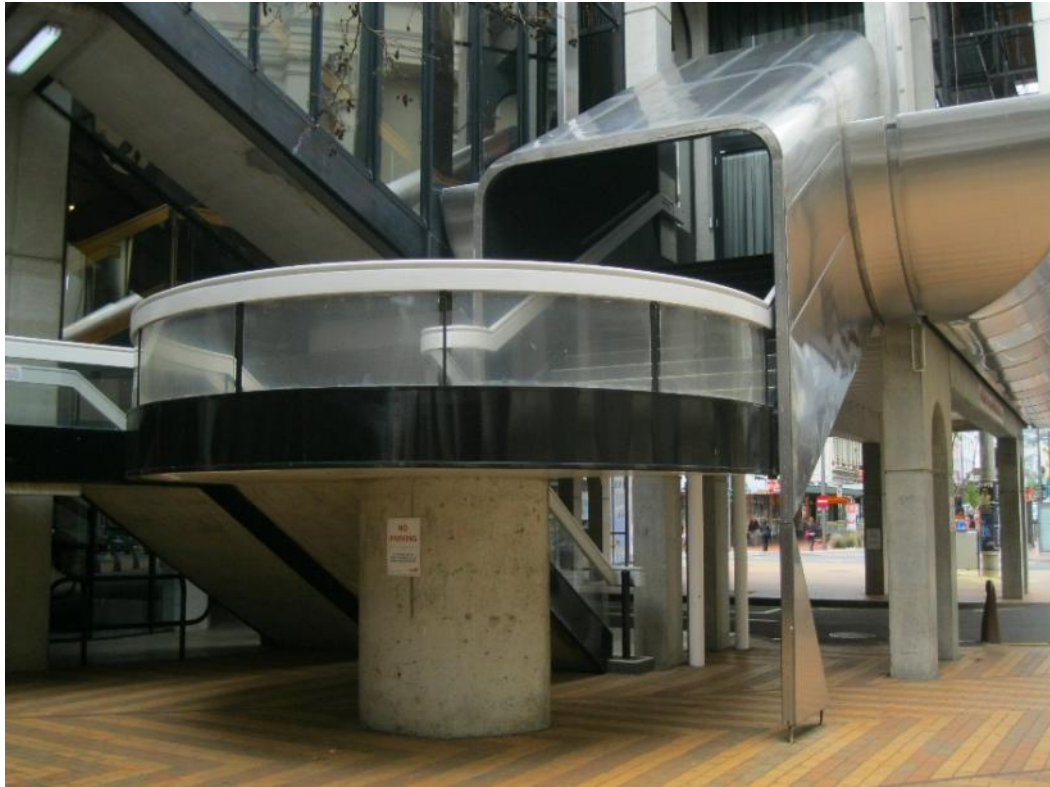
Figure 7-6: Stair 10

The corbel detail supporting the stair appears to be unreinforced, with no reinforcing details indicated on the structural drawings. While unseating of the stair flight is not expected below 34 %DBE, this supporting corbel detail is vulnerable to any damage that occurs and this may compromise gravity support of the upper stair flight. It is recommended that supplementary details are installed to secure this stair in the event the supporting corbel is damaged.

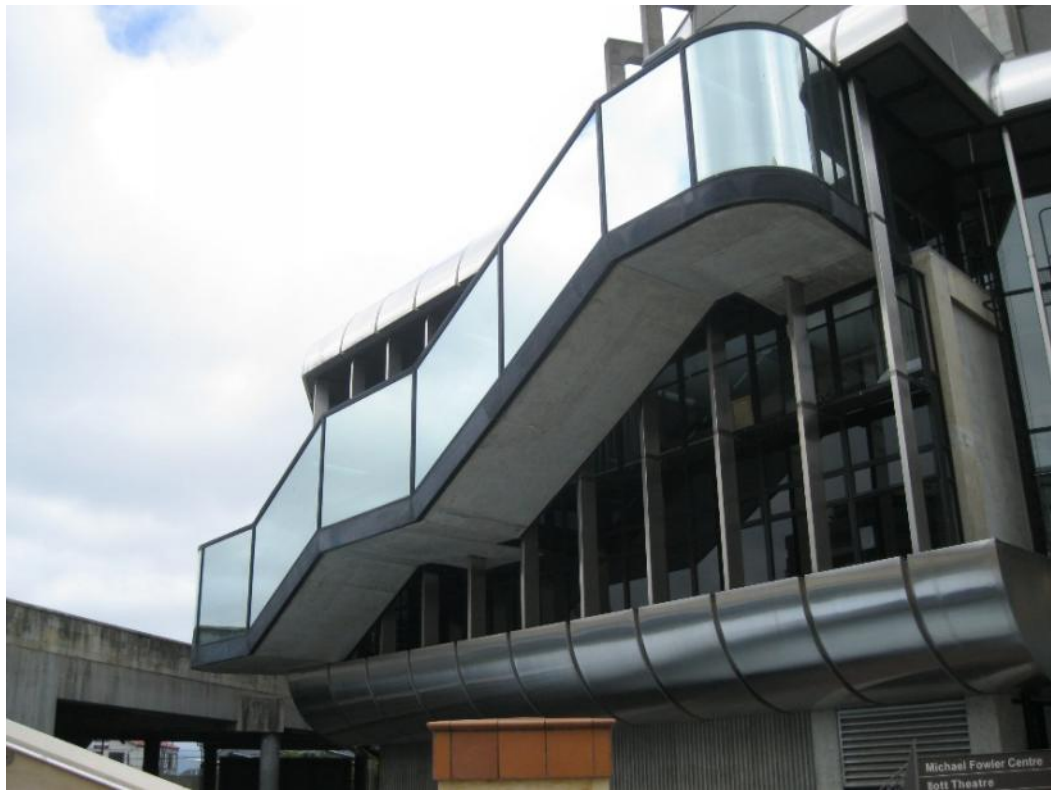
Figure 7-8: Stairwell 16

Assessment of the stairs to accommodate the effects of relative movement between the floor levels indicates that the ultimate limit state flexural capacity of the stair flights would be reached at about 15%NBS level of displacements. The stair flights can be expected to sustain displacements beyond this point but significant damage at each landing will occur at higher levels of earthquake loading which may hamper use of the stairs for egress following an earthquake. It is recommended that the stairs are structurally separated at each floor level, to allow for interstorey seismic displacements to occur without leading to damage to the stair flights.

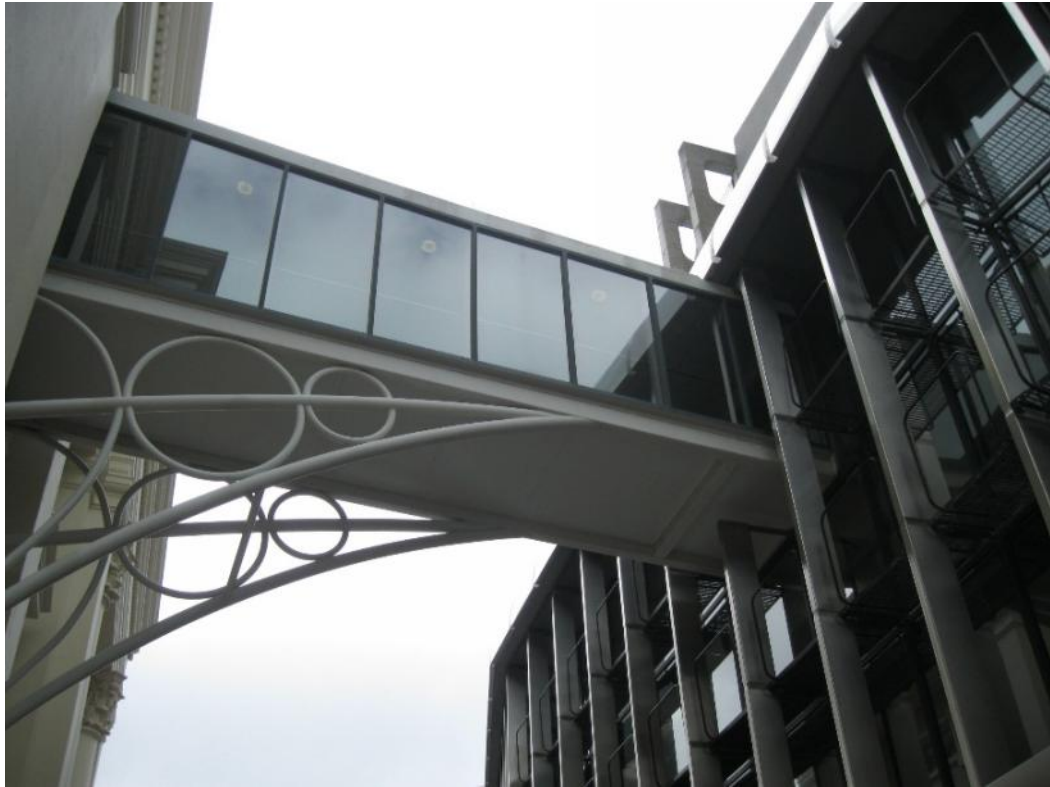
Figure 7-9: Town Hall Air Bridge

An access air bridge is provided from Level 4 (upper promenade), across to the Town Hall on the eastern end of the Michael Fowler Centre. The air bridge is fixed, cantilevering from the Town Hall, with no physical connection at the Michael Fowler Centre side. The air bridge penetrates through the glazed façade of the Michael Fowler Centre and non-structural damage to glazing, mullions and transoms is likely as combined seismic displacements of both buildings will exceed the available clearances.
