Invasive and Destructive Weathertightness Report

**Karori Community Hall, England Lane,
Karori, Wellington**

Wellington City Council

Date of Report July 2024

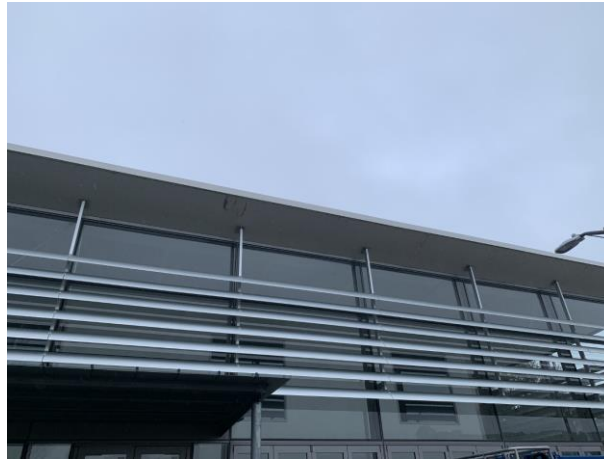
20.

- Lack of barge flashing deflection at the roof soffit junctions (Photographs 20-64).
- Exposed blockwork exterior walls, including at joinery openings, with no evidence of a sealer/protective coating (Photographs 65-161).
- A lack of vertical control joints to exposed blockwork exterior walls, with visible vertical cracking to mortar joints (Photographs 72-90 & 106-109, 112-115).
- Exterior ground finishing higher than the internal floor slab at the base of the curtain walling and at door thresholds (Photographs 162-195).
- Inadequately modified and fixed cavity closer at the base of the metal cladding (Photographs 196-200).
- Inadequate eaves flashing projection over the metal gutters (Photographs 201-210).
- Rippling of the internal gutter membrane - main roof (Photographs 223-228).

- Replacement of all barge flashings and soffit linings above the north and west elevations, including assessing the framing.
- Reinstallation of the two window joinery units and the metal egress door in the blockwork on the west elevation, including waterproofing.
