Shelly Bay, Shed 8 - Foundation Inspection			Inspection-43 – Rev 1
Date:	22/06/2020	Weather	Fine
Time:	11:15 Am	Job #	1000057
Tide:	Low @ 11:38 am	Inspectors	SELO, JIDE
Monitoring observations			
Void space A, refer attached Figure 1 for void location

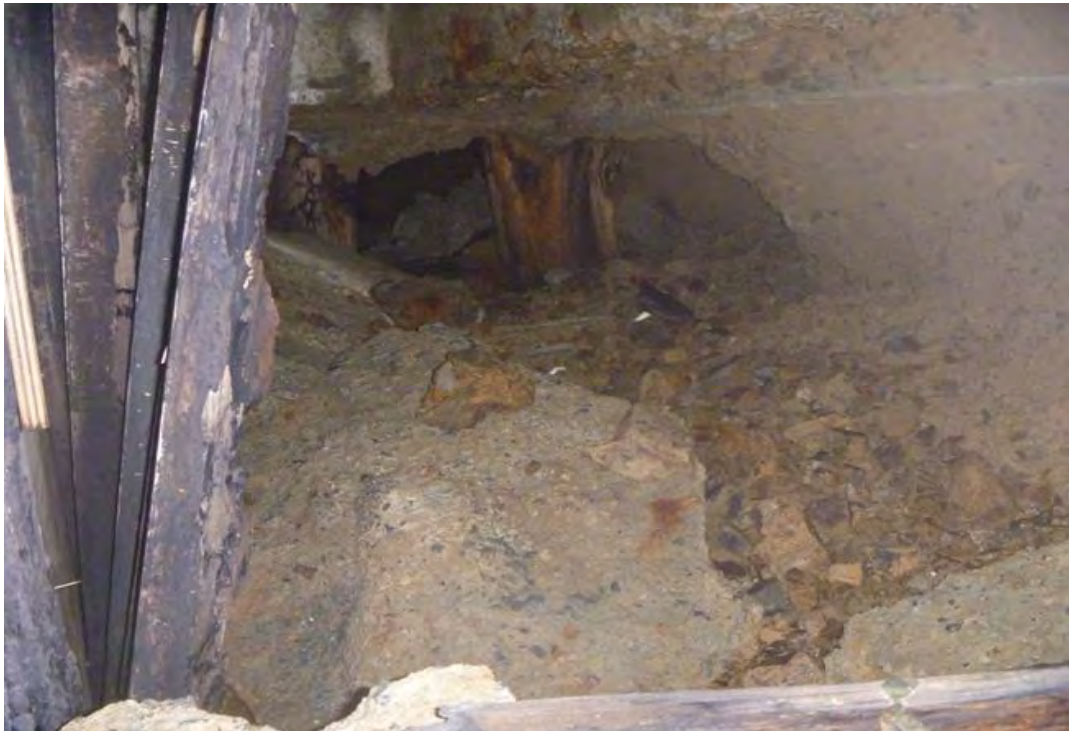
Item	Changes observed since previous visit	Observations and measurements	Photo ID
Void Depth	Unobserved	No longer observable as timber facing has been secured over damaged rails (06/10/2017). It is unlikely that the condition of the void has changed since last visual sighting during inspection on 05 September 2017.	-
Void Width	Unobserved	No longer observable as timber facing has been secured over damaged rails (06/10/2017). It is unlikely that the condition of the void has changed since last visual sighting during inspection on 05 September 2017.	-
Timber Piles	Unobserved	No longer observable as timber facing has been secured over damaged rails (06/10/2017). It is unlikely that the condition of the void has changed since last visual sighting during inspection on 05 September 2017. Rear pile can be observed looking north from Void A. Pile appears to be in a similar poor condition as previously observed. The pile is likely to be providing minimal support to the pile cap. The condition of the front pile is not observable but is likely to be similar to the rear pile.	17

Photograph 17 & 18: Photo 17 above taken 09/03/2020 looking north from Void A. Condition of timber acceptable relative to other piles. Ply facing installed over damaged timber railings so no longer observable from Void D-South. Photo 18 below taken 10/10/2019
