Asbestos Management Survey Report

Shelly Bay Complex
Shelly Bay Road
Wellington, 6022

Wellington City Council

Reference: W-01625

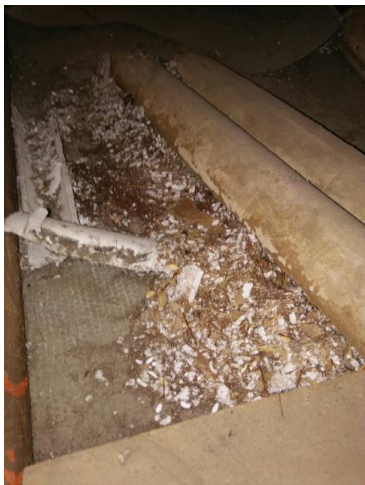
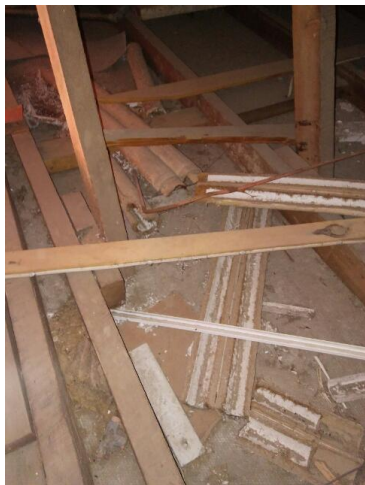
Location	Laundry Building, Ground Floor, 005, Roof Void	Sample Number	5 (S)

Item / Position	Pipe Lagging
		Material:	Insulation
		Extent	All
		Product Type	Thermal insulation (eg pipe and boiler lagging), sprayed asbestos, loose asbestos, asbestos mattresses and packing. 3
		Condition	High damage 3
		Surface Treatment	Unsealed 3
		Asbestos Type	Chrysotile 1
		Material Assessment	High 10
		Recommendation	Remove
		Comments:	Access has been restricted to the old boiler room, which is open to the roof void above.

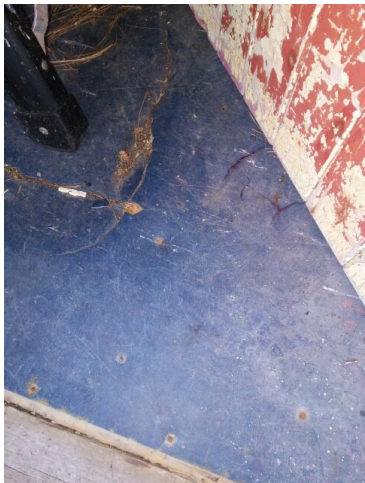
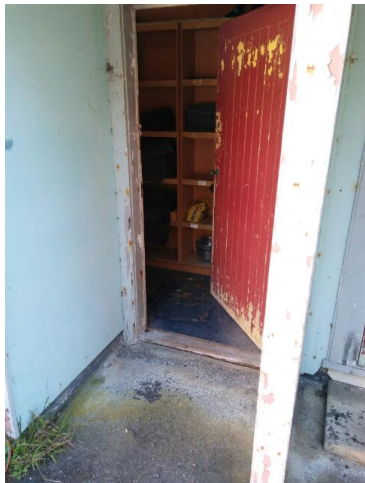
Location	Squash Courts, External, 024, Store Room	Sample Number	15 (S)

Item / Position	Vinyl Flooring - Blue
		Material:	Vinyl Products
		Extent	4m ²
		Product Type	N/A N/A
		Condition	N/A N/A
		Surface Treatment	N/A N/A
		Asbestos Type	NAD N/A
		Material Assessment	N/A 0
		Recommendation	No further action required
		Comments:

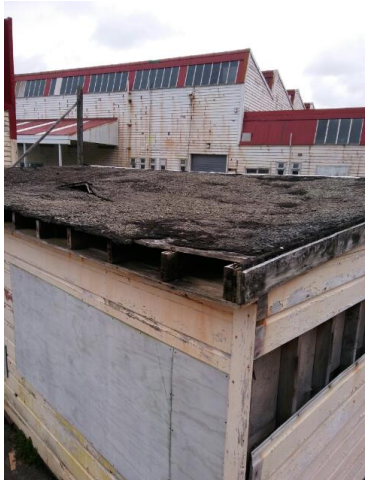
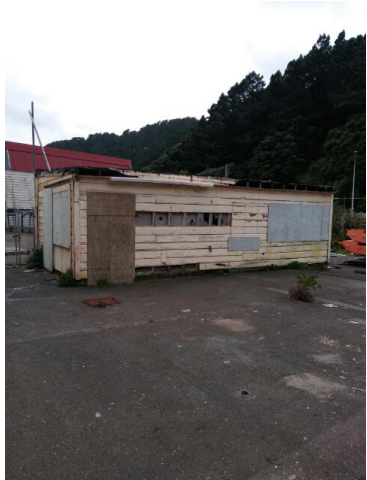
Location	Slipway Storage Building, External, 038, Roof		Sample Number	33 (S)

Item / Position	Bitumen Roofing		
	Material:	Bituminous Product		
	Extent	50m ²		
	Product Type	Asbestos reinforced composites etc.	1	
	Condition	High damage	3	
	Surface Treatment	Partially unsealed	2	
	Asbestos Type	Chrysotile	1	
	Material Assessment	Medium	7	
	Recommendation	Remove		
	Comments:	Building is structurally unsound, and roof is badly damaged. Restrict access until remediation can be conducted.

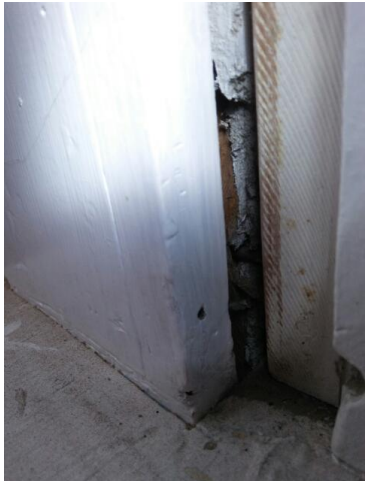
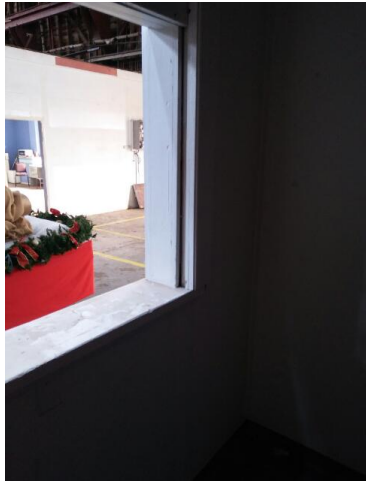
Location	Shed 8, Ground Floor, 051, Old Workshop Rooms		Sample Number	38 (S)

Item / Position	Wall & Ceiling Lining		
	Material:	Insulating Board		
	Extent	Unknown		
	Product Type	AIB, Millboards, other low-density insulation boards, asbestos textiles, gaskets, ropes and woven textiles, asbestos paper and felt	2	
	Condition	Low damage	1	
	Surface Treatment	Partially unsealed	2	
	Asbestos Type	Amosite / Chrysotile	2	
	Material Assessment	Medium	7	
	Recommendation	Manage and Label		
	Comments:	Walls are painted and it is therefore difficult to easily distinguish insulating boards from GIB. AIB wall linings are also concealed in places. Further intrusive inspection will be required to locate and delineate AIB extent. All walls should be presumed to conceal insulating boards until this can occur. Extent has been indicated on the provided drawings as far as could be determined.

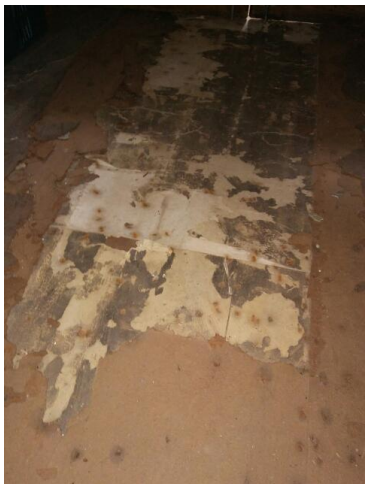
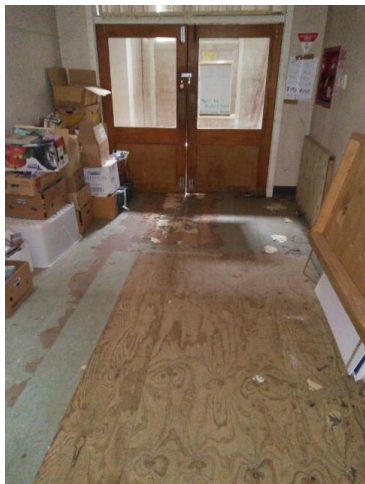
Location	Shed 8, Ground Floor, 065, South East Room		Sample Number	44 (S)

Item / Position	Vinyl Flooring			
	Material:	Paper Product			
	Extent	All			
	Product Type	N/A	N/A		
	Condition	N/A	N/A		
	Surface Treatment	N/A	N/A		
	Asbestos Type	NAD	N/A		
	Material Assessment	N/A	0		
	Recommendation	No further action required			
	Comments:

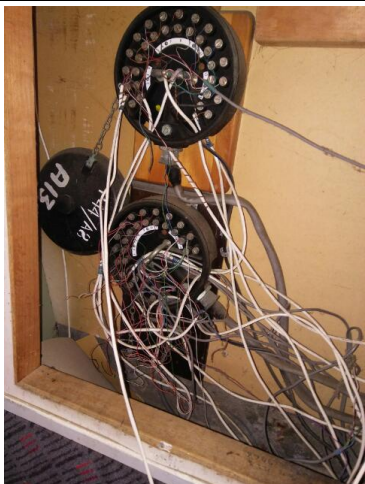
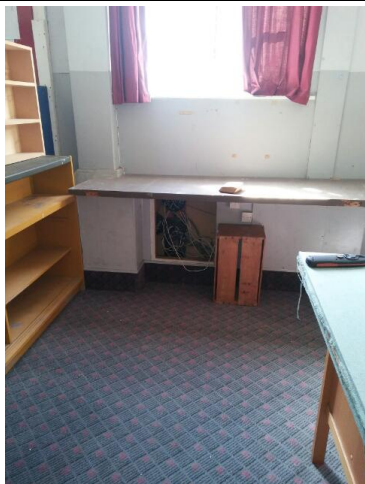
Location	Shed 8, Ground Floor, 063, Eastern Room		Sample Number	1 (X)

Item / Position	Electrical Fitting			
	Material:	PVC / Reinforced Plastics			
	Extent	1no			
	Product Type	Asbestos reinforced composites etc.	1		
	Condition	Good condition	0		
	Surface Treatment	Completely sealed	0		
	Asbestos Type	Presumed Asbestos	3		
	Material Assessment	Very Low	4		
	Recommendation	Manage and Label			
	Comments:

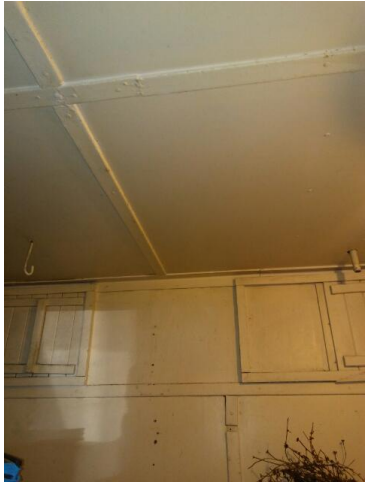
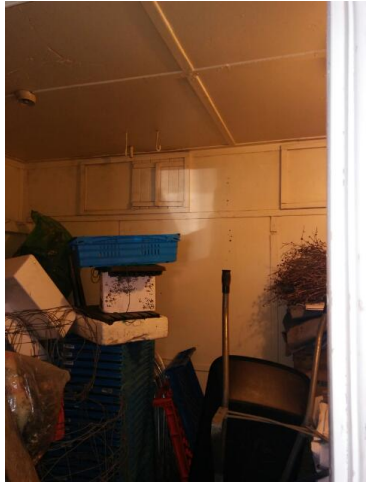
Location	Laundry Building, Ground Floor, 007, Drying Room		Sample Number	4 (X)

Item / Position	Wall and Ceiling Lining		
	Material:	Cement Product		
	Extent	50m ²		
	Product Type	Asbestos reinforced composites etc.	1	
	Condition	Low damage	1	
	Surface Treatment	Surface sealed	1	
	Asbestos Type	Amosite / Chrysotile	2	
	Material Assessment	Low	5	
	Recommendation	Manage and Label		
	Comments:

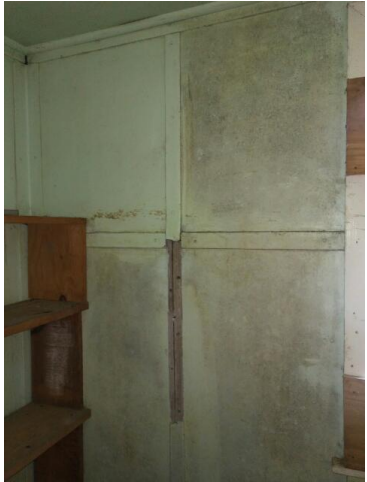
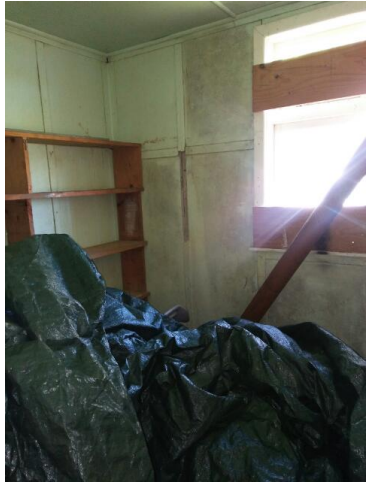
Location	Laundry Building, Ground Floor, 008, Store Room		Sample Number	4 (X)

Item / Position	Wall Lining		
	Material:	Cement Product		
	Extent	30m ²		
	Product Type	Asbestos reinforced composites etc.	1	
	Condition	Low damage	1	
	Surface Treatment	Surface sealed	1	
	Asbestos Type	Amosite / Chrysotile	2	
	Material Assessment	Low	5	
	Recommendation	Encapsulate, Label and Manage		
	Comments:

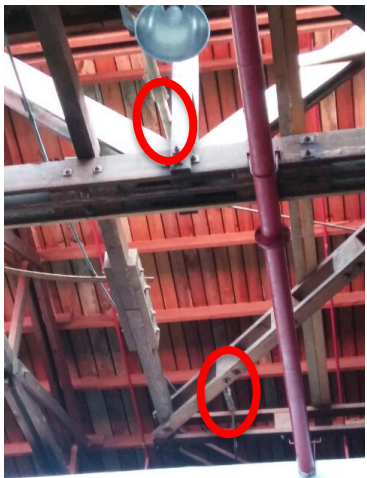
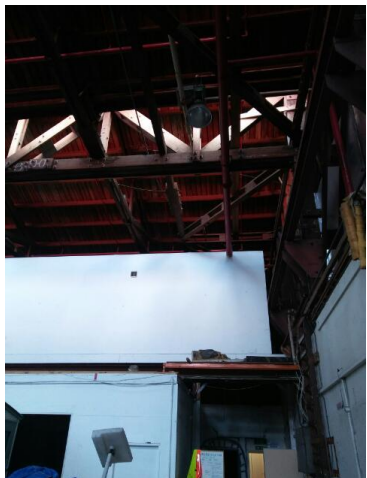
Location	Shed 8, Ground Floor, 057, Workshop Roof Structure		Sample Number	5 (X)

Item / Position	Pipe Lagging		
	Material:	Insulation		
	Extent	Unknown		
	Product Type	Thermal insulation (eg pipe and boiler lagging), sprayed asbestos, loose asbestos, asbestos mattresses and packing.	3	
	Condition	High damage	3	
	Surface Treatment	Unsealed	3	
	Asbestos Type	Chrysotile	1	
	Material Assessment	High	10	
	Recommendation	Remove		
	Comments:	Material was inspected via mezzanine ceiling void. It is unclear where the transition to non-asbestos lagging occurs, and all lagging should be presumed to contain asbestos as a precaution.

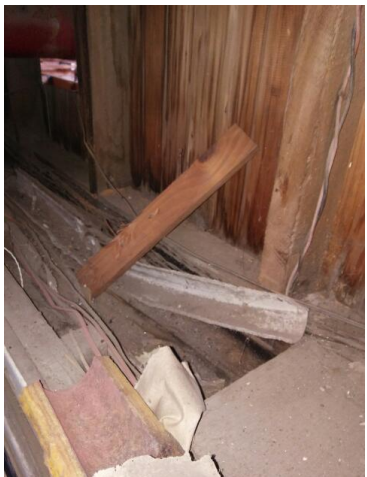
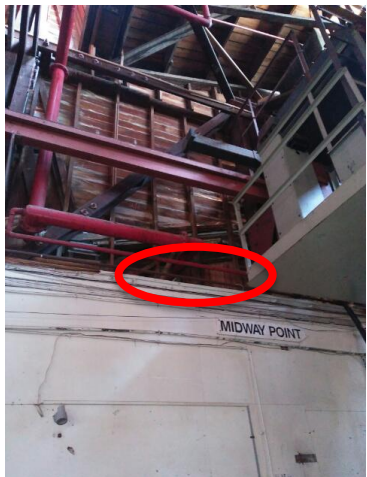
Location	Shed 8, Ground Floor, 060, Workshop		Sample Number	5 (X)

Item / Position	Pipe Lagging		
	Material:	Insulation		
	Extent	Unknown		
	Product Type	Thermal insulation (eg pipe and boiler lagging), sprayed asbestos, loose asbestos, asbestos mattresses and packing.	3	
	Condition	High damage	3	
	Surface Treatment	Unsealed	3	
	Asbestos Type	Chrysotile	1	
	Material Assessment	High	10	
	Recommendation	Remove		
	Comments:	Restrict access to ledge. Material may be present elsewhere in difficult to access areas.

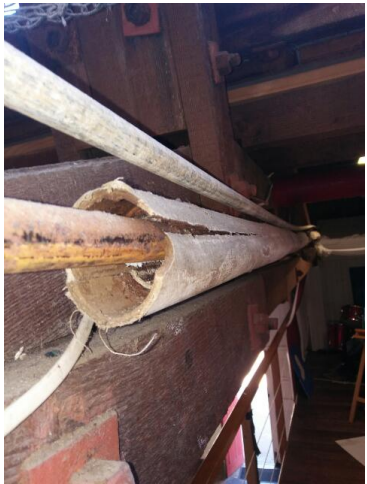
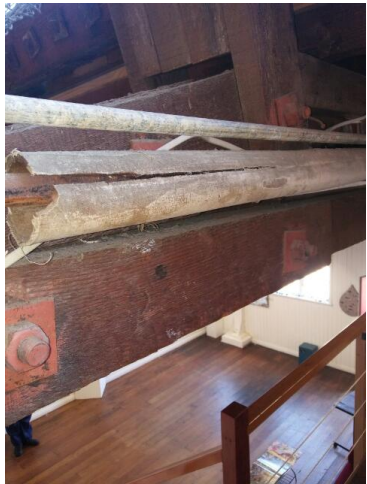
Location	Shed 8, Ground Floor, 068, Artist Tenancy Mezzanine		Sample Number	5 (X)

Item / Position	Pipe Lagging		
	Material:	Insulation		
	Extent	10lin m		
	Product Type	Thermal insulation (eg pipe and boiler lagging), sprayed asbestos, loose asbestos, asbestos mattresses and packing.	3	
	Condition	High damage	3	
	Surface Treatment	Unsealed	3	
	Asbestos Type	Chrysotile	1	
	Material Assessment	High	10	
	Recommendation	Remove		
	Comments:

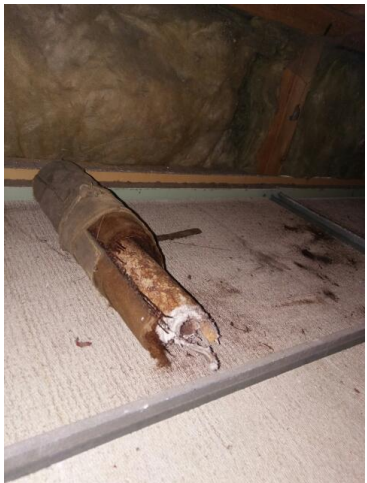
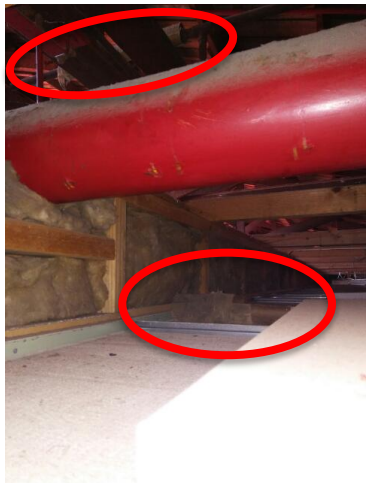
Location	Shed 8, 1st Floor, 056, Mezzanine Offices Ceiling Void		Sample Number	5 (X)

Item / Position	Pipe Lagging		
	Material:	Insulation		
	Extent	Unknown		
	Product Type	Thermal insulation (eg pipe and boiler lagging), sprayed asbestos, loose asbestos, asbestos mattresses and packing.	3	
	Condition	High damage	3	
	Surface Treatment	Unsealed	3	
	Asbestos Type	Chrysotile	1	
	Material Assessment	High	10	
	Recommendation	Remove		
	Comments:	Debris on top of ceiling tile, and partially intact lagging fixed to pipework above

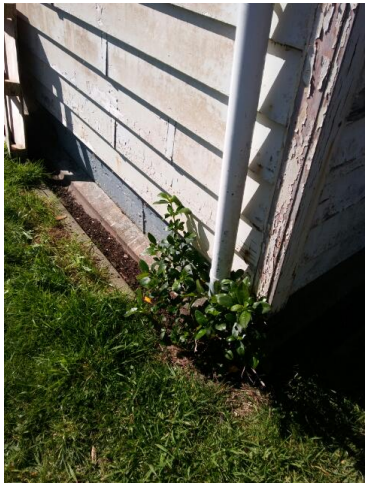
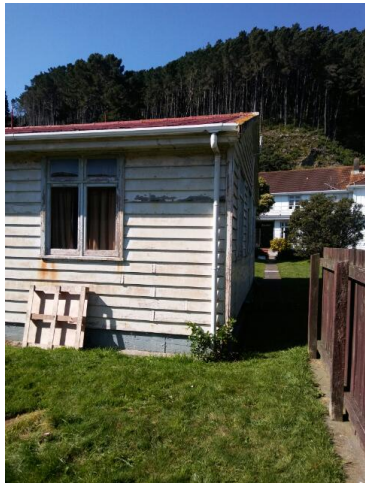
Location	Headquarters Building, External, 014, Drains		Sample Number	9 (X)

Item / Position	Debris		
	Material:	Suspected Asbestos		
	Extent	All		
	Product Type	Thermal insulation (eg pipe and boiler lagging), sprayed asbestos, loose asbestos, asbestos mattresses and packing.	3	
	Condition	High damage	3	
	Surface Treatment	Unsealed	3	
	Asbestos Type	Presumed Asbestos	3	
	Material Assessment	High	12	
	Recommendation	Remove		
	Comments:	Guttering and perimeter channels are full of soil and other debris. Run-off from the degrading roof is collecting in the drains and surrounding areas at ground level. Action should be taken to address drainage issues, and further testing and assessment will be required to inform soil contamination and remediation actions.

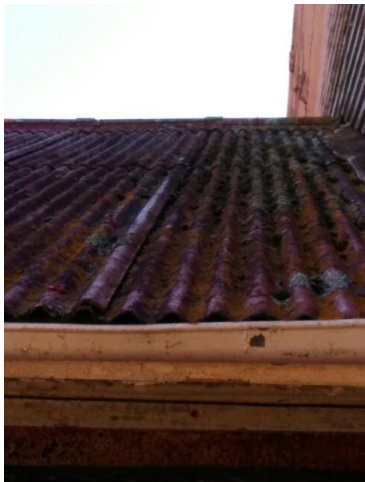
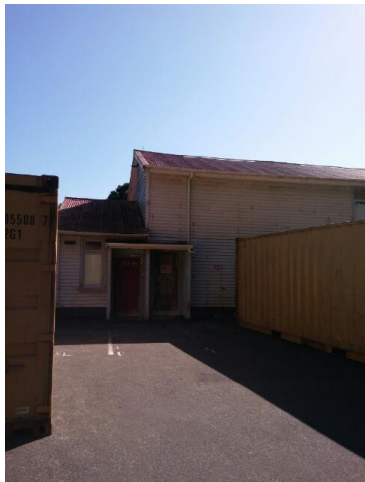
Location	Squash Courts, External, 018, Roof		Sample Number	9 (X)

Item / Position	Corrugated Cement Roofing		
	Material:	Cement Product		
	Extent	200m ²		
	Product Type	Asbestos reinforced composites etc.	1	
	Condition	Low damage	1	
	Surface Treatment	Surface sealed	1	
	Asbestos Type	Presumed Asbestos	3	
	Material Assessment	Low	6	
	Recommendation	Manage and Label		
Comments:

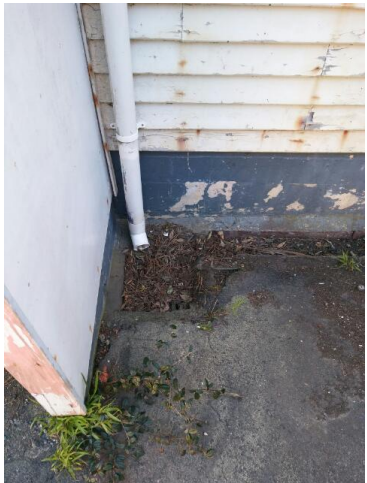
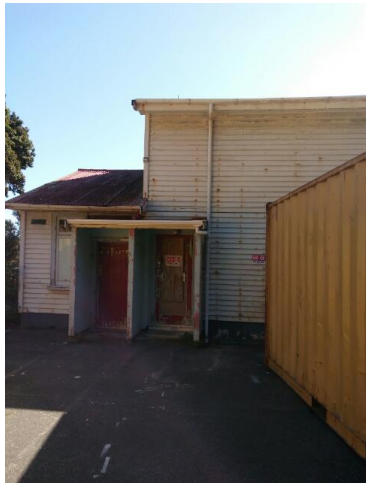
Location	Squash Courts, External, 019, Drains		Sample Number	9 (X)

Item / Position	Debris		
	Material:	Suspected Asbestos		
	Extent	All		
	Product Type	Thermal insulation (eg pipe and boiler lagging), sprayed asbestos, loose asbestos, asbestos mattresses and packing.	3	
	Condition	High damage	3	
	Surface Treatment	Unsealed	3	
	Asbestos Type	Presumed Asbestos	3	
	Material Assessment	High	12	
	Recommendation	Remove		
	Comments:	Guttering and perimeter channels are full of soil and other debris. Run-off from the degrading roof is collecting in the drains and surrounding areas at ground level. Action should be taken to address drainage issues, and further testing and assessment will be required to inform soil contamination and remediation actions.

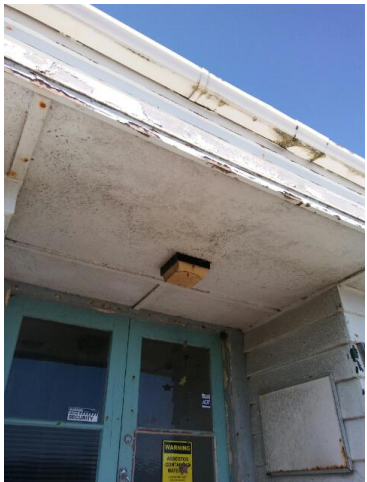
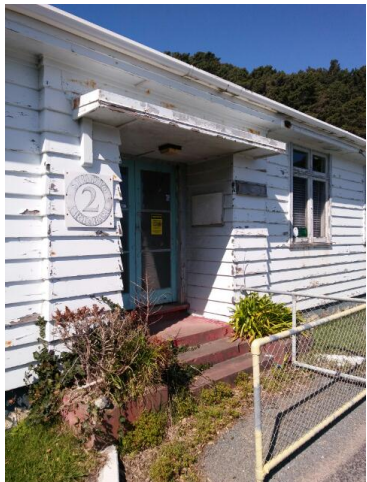
Location	Headquarters Building, External, 016, West Entrance		Sample Number	11 (X)

Item / Position	Soffit		
	Material:	Cement Product		
	Extent	3m ²		
	Product Type	Asbestos reinforced composites etc.	1	
	Condition	Low damage	1	
	Surface Treatment	Surface sealed	1	
	Asbestos Type	Presumed Asbestos	3	
	Material Assessment	Low	6	
	Recommendation	Manage and Label		
Comments:

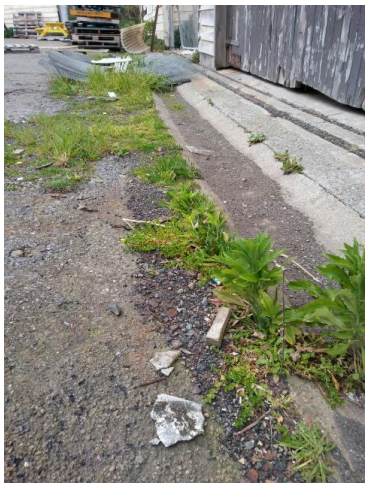
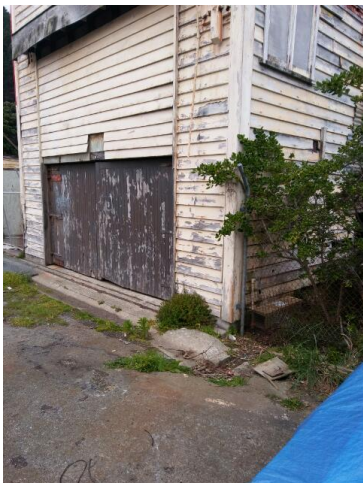
Location	Shipwrights Building, External, 045, Perimeter		Sample Number	36 (X)

Item / Position	Debris and Run-off		
	Material:	Cement Product		
	Extent	All		
	Product Type	Asbestos reinforced composites etc.	1	
	Condition	High damage	3	
	Surface Treatment	Unsealed	3	
	Asbestos Type	Presumed Asbestos	3	
	Material Assessment	High	10	
	Recommendation	Remove		
	Comments:	Access to building perimeter was limited, however visible surface debris is present. Run-off from the roof is uncontrolled along the western edge. Recommend handpick of debris. Restrict access until further testing and assessment of soil contamination is undertaken.

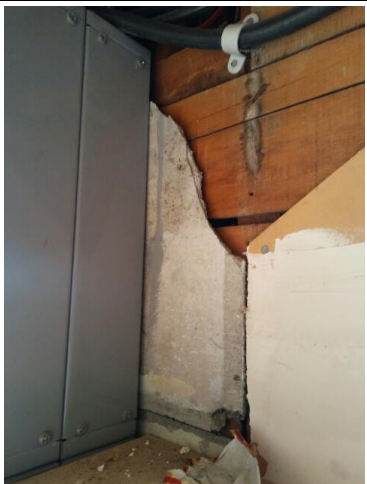
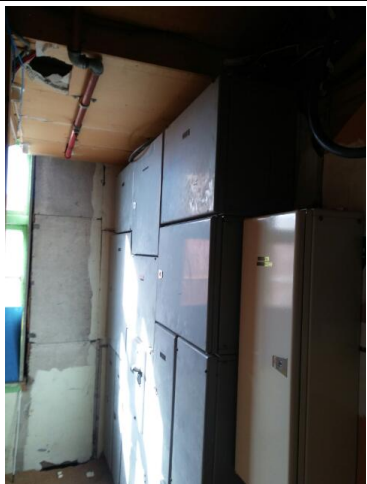
Location	Shed 8, Ground Floor, 053, Switchboard Room		Sample Number	39 (X)

Item / Position	Wall and Ceiling Lining		
	Material:	Cement Product		
	Extent	40m ²		
	Product Type	Asbestos reinforced composites etc.	1	
	Condition	High damage	3	
	Surface Treatment	Partially unsealed	2	
	Asbestos Type	Presumed Asbestos	3	
	Material Assessment	Medium	9	
	Recommendation	Remove		
	Comments:	Restrict access until remediation can be conducted

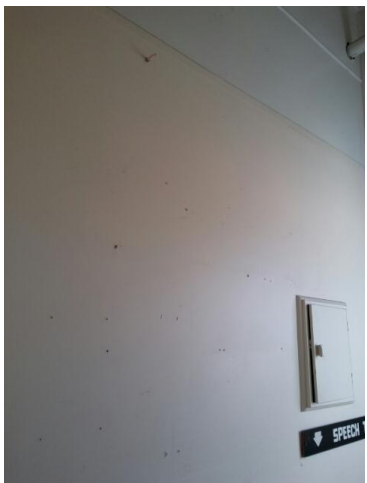
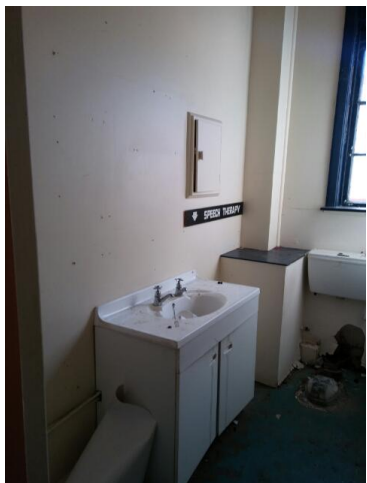
Location	Shed 8, Ground Floor, 054, Toilet		Sample Number	39 (X)

Item / Position	Wall Lining		
	Material:	Cement Product		
	Extent	10m ²		
	Product Type	Asbestos reinforced composites etc.	1	
	Condition	Good condition	0	
	Surface Treatment	Surface sealed	1	
	Asbestos Type	Presumed Asbestos	3	
	Material Assessment	Low	5	
	Recommendation	Manage and Label		
	Comments:	Cement board lining is concealed (accessible via adjacent switchboard room at time of survey)

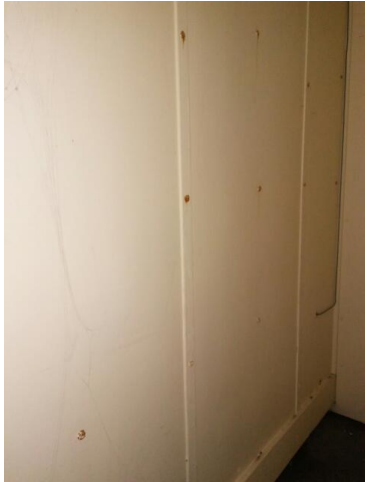
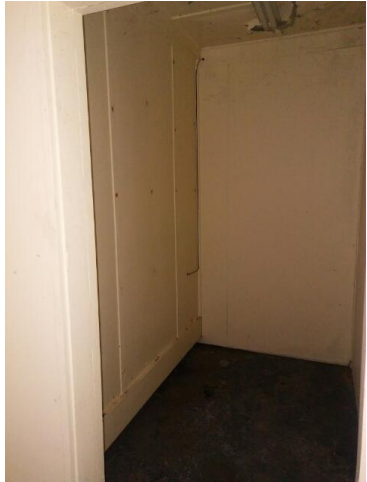
Location	Guard Hut, Ground Floor, 001, Interior		Sample Number	BS023704 (X)

Item / Position	Wall Lining			
	Material:	Cement Product			
	Extent	12m ²			
	Product Type	Asbestos reinforced composites etc.	1		
	Condition	Low damage	1		
	Surface Treatment	Surface sealed	1		
	Asbestos Type	Presumed Asbestos	3		
	Material Assessment	Low	6		
	Recommendation	Manage and Label			
	Comments:

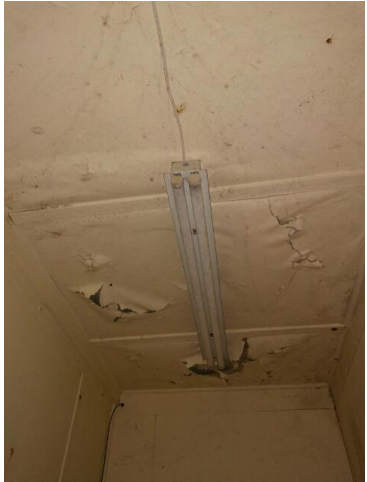
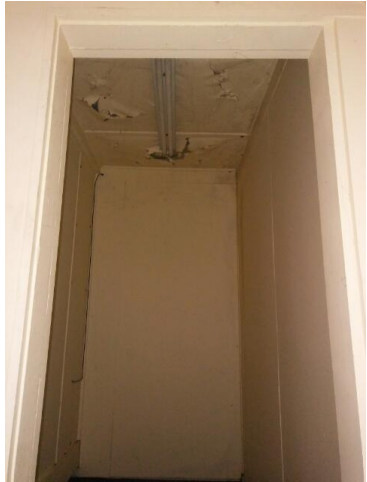
Location	Guard Hut, Ground Floor, 001, Interior		Sample Number	BS023704 (X)

Item / Position	Ceiling Lining			
	Material:	Cement Product			
	Extent	4m ²			
	Product Type	Asbestos reinforced composites etc.	1		
	Condition	Low damage	1		
	Surface Treatment	Surface sealed	1		
	Asbestos Type	Amosite / Crocidolite / Chrysotile	3		
	Material Assessment	Low	6		
	Recommendation	Manage and Label			
	Comments:

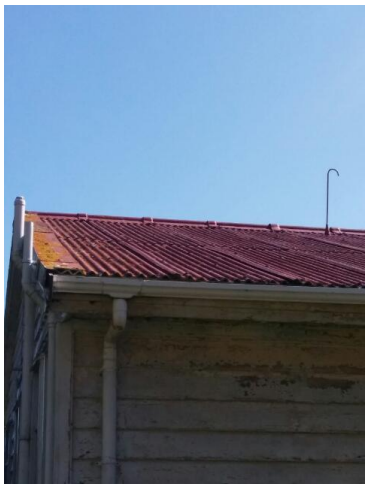
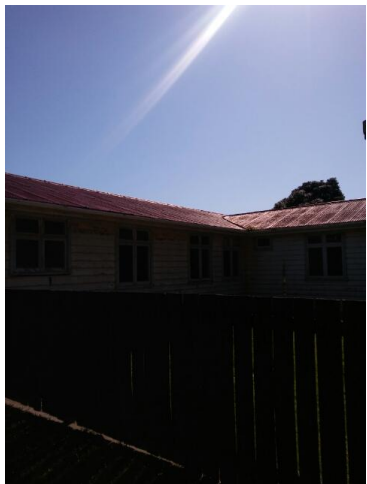
Location	Headquarters Building, External, 012, Roof		Sample Number	9 (SP)

Item / Position	Corrugated Cement Roofing		
	Material:	Cement Product		
	Extent	1000m ²		
	Product Type	Asbestos reinforced composites etc.	1	
	Condition	Low damage	1	
	Surface Treatment	Surface sealed	1	
	Asbestos Type	Presumed Asbestos	3	
	Material Assessment	Low	6	
	Recommendation	Manage and Label		
	Comments:

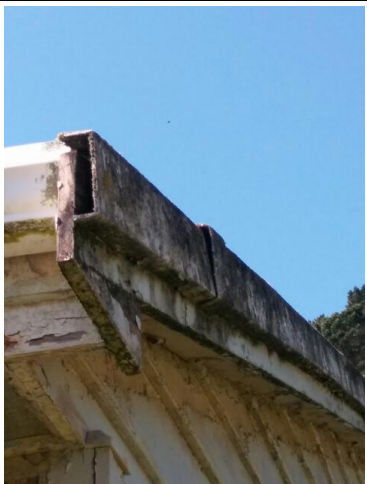
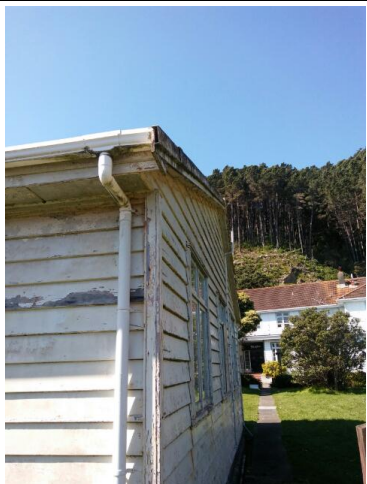
Location	Headquarters Building, External, 012, Roof		Sample Number	10 (SP)

Item / Position	Flashing & Ridge Capping		
	Material:	Cement Product		
	Extent	All		
	Product Type	Asbestos reinforced composites etc.	1	
	Condition	Low damage	1	
	Surface Treatment	Surface sealed	1	
	Asbestos Type	Presumed Asbestos	3	
	Material Assessment	Low	6	
	Recommendation	Manage and Label		
	Comments:

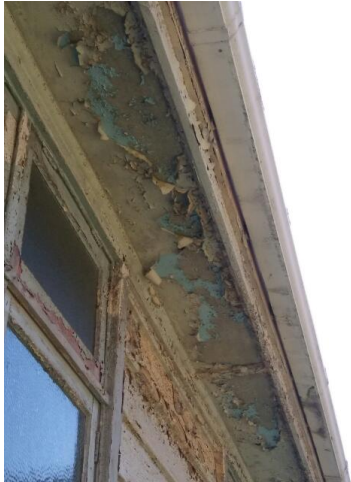
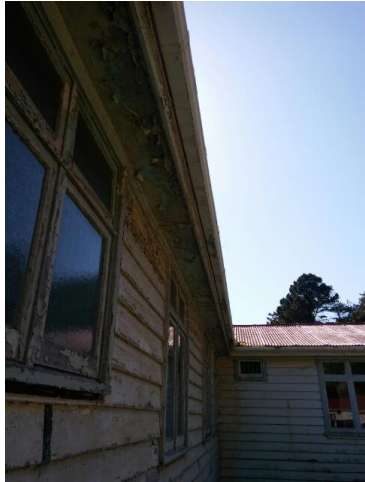
Location	Headquarters Building, External, 013, Eaves	Sample Number	11 (SP)

Item / Position	Soffits
		Material:	Cement Product
		Extent	60lin m
		Product Type	Asbestos reinforced composites etc. 1
		Condition	Low damage 1
		Surface Treatment	Surface sealed 1
		Asbestos Type	Presumed Asbestos 3
		Material Assessment	Low 6
		Recommendation	Manage and Label
		Comments:

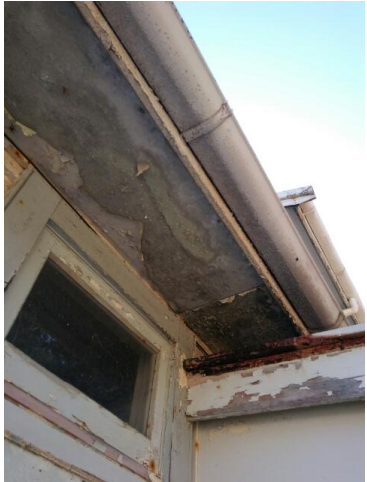
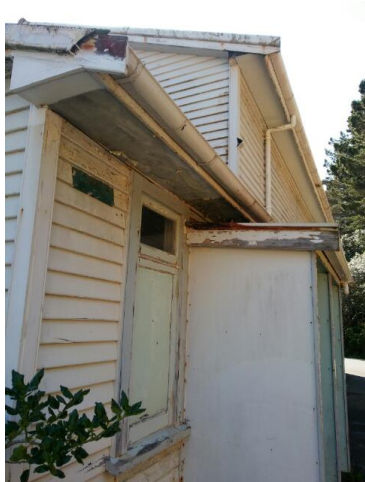
Location	Squash Courts, External, 020, Lower Roof	Sample Number	12 (SP)

Item / Position	Soffits
		Material:	Cement Product
		Extent	6lin m
		Product Type	Asbestos reinforced composites etc. 1
		Condition	Medium damage 2
		Surface Treatment	Partially unsealed 2
		Asbestos Type	Presumed Asbestos 3
		Material Assessment	Medium 8
		Recommendation	Manage and Label
		Comments:	Both sides of building

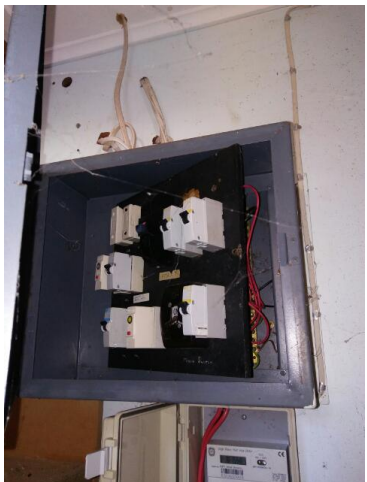
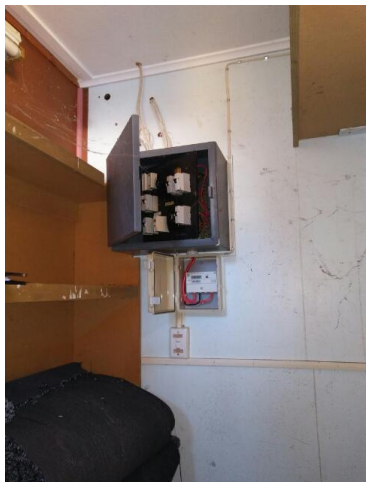
Location	Squash Courts, External, 022, Store Room		Sample Number	13 (SP)

Item / Position	Switchboard		
	Material:	Bituminous Product		
	Extent	1no		
	Product Type	Asbestos reinforced composites etc.	1	
	Condition	Low damage	1	
	Surface Treatment	Completely sealed	0	
	Asbestos Type	Chrysotile	1	
	Material Assessment	Very Low	3	
	Recommendation	Manage and Label		
	Comments:

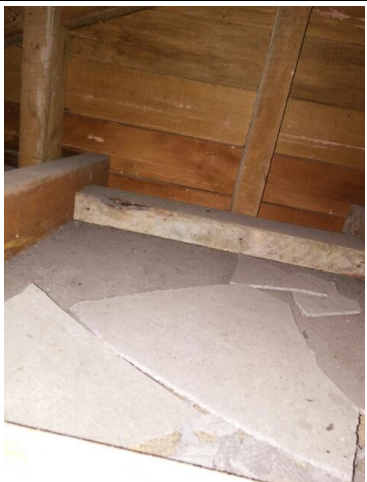
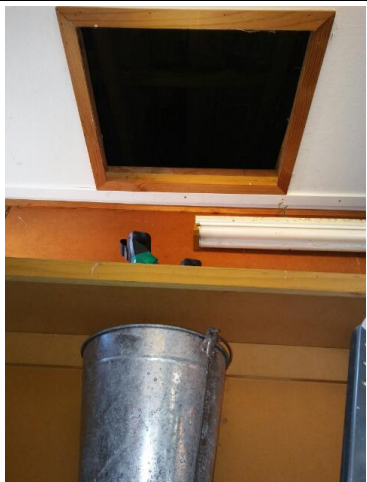
Location	Squash Courts, External, 023, Lower Ceiling Void		Sample Number	14 (SP)

Item / Position	Cement Boards		
	Material:	Cement Product		
	Extent	30m ²		
	Product Type	Asbestos reinforced composites etc.	1	
	Condition	Medium damage	2	
	Surface Treatment	Partially unsealed	2	
	Asbestos Type	Presumed Asbestos	3	
	Material Assessment	Medium	8	
	Recommendation	Manage and Label		
	Comments:	Restrict access, do not penetrate ceiling from below

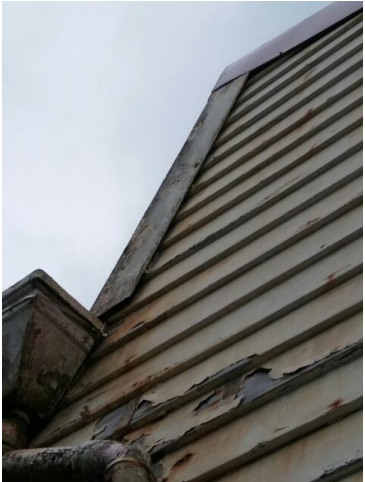
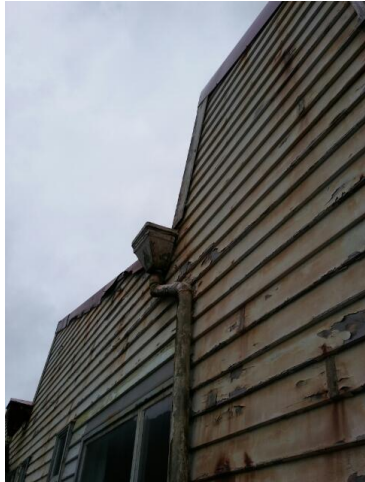
Location	Shed 8, External, 031, Roof		Sample Number	21 (SP)

Item / Position	Cement Flashing		
	Material:	Cement Product		
	Extent	All		
	Product Type	Asbestos reinforced composites etc.	1	
	Condition	Medium damage	2	
	Surface Treatment	Partially unsealed	2	
	Asbestos Type	Presumed Asbestos	3	
	Material Assessment	Medium	8	
	Recommendation	Manage and Label		
	Comments:	Some sections have been replaced

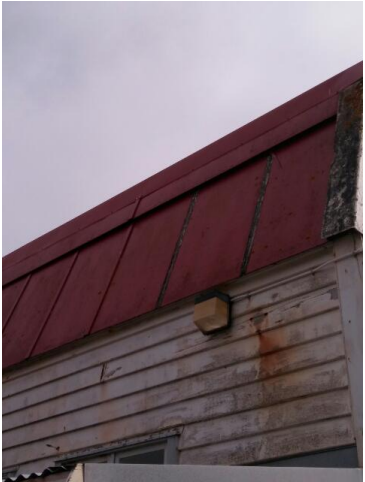
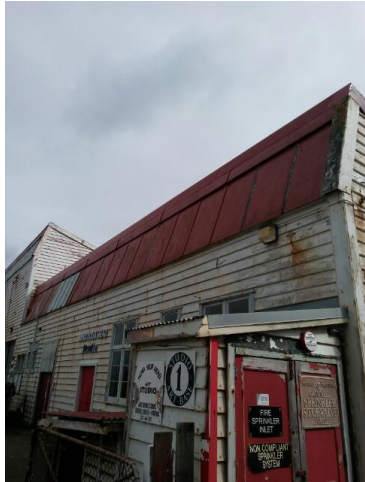
Location	Shed 8, External, 031, Roof		Sample Number	22 (SP)

Item / Position	Flat Sheet Cement Boards		
	Material:	Cement Product		
	Extent	All		
	Product Type	Asbestos reinforced composites etc.	1	
	Condition	Low damage	1	
	Surface Treatment	Surface sealed	1	
	Asbestos Type	Presumed Asbestos	3	
	Material Assessment	Low	6	
	Recommendation	Manage and Label		
	Comments:

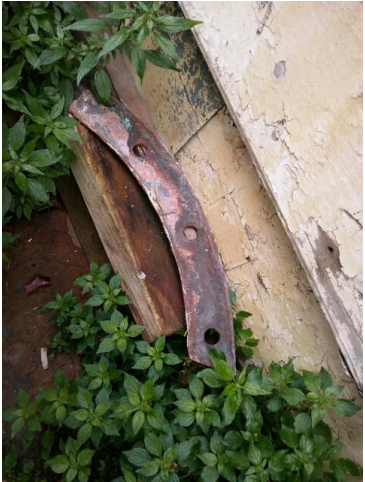
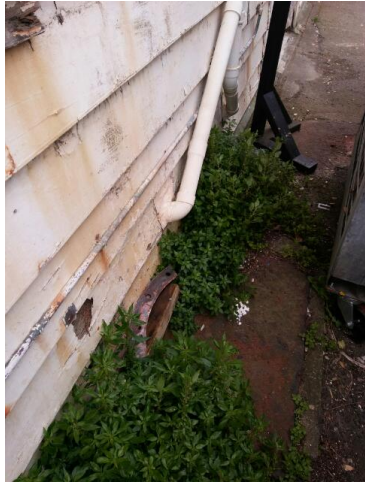
Location	Shed 8, External, 033, South Perimeter		Sample Number	26 (SP)

Item / Position	Gasket Debris		
	Material:	Gaskets (compressed)		
	Extent	1no		
	Product Type	N/A	N/A	
	Condition	N/A	N/A	
	Surface Treatment	N/A	N/A	
	Asbestos Type	Removed	N/A	
	Material Assessment	N/A	0	
	Recommendation	No further action required		
	Comments:	This item was removed by the surveyor at the time of the survey.

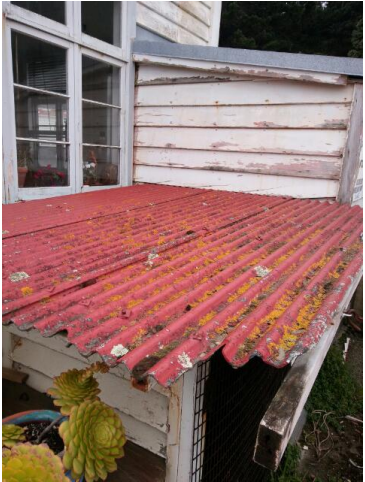
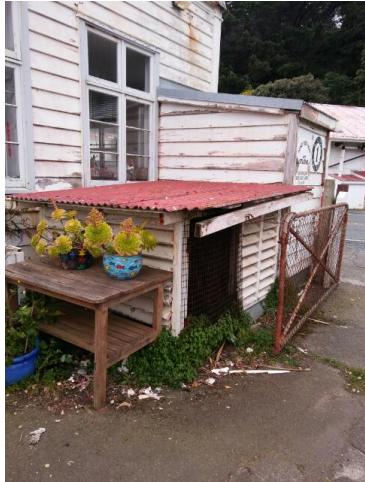
Location	Shed 8, External, 033, South Perimeter		Sample Number	29 (SP)

Item / Position	Corrugated Cement Roofing		
	Material:	Cement Product		
	Extent	5m ²		
	Product Type	Asbestos reinforced composites etc.	1	
	Condition	Medium damage	2	
	Surface Treatment	Partially unsealed	2	
	Asbestos Type	Presumed Asbestos	3	
	Material Assessment	Medium	8	
	Recommendation	Remove		
	Comments:	Roof is degrading and removal is recommended due to accessibility

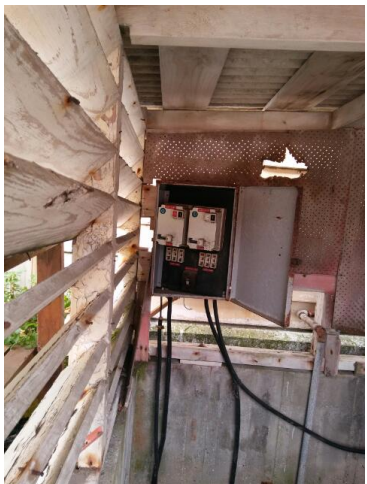
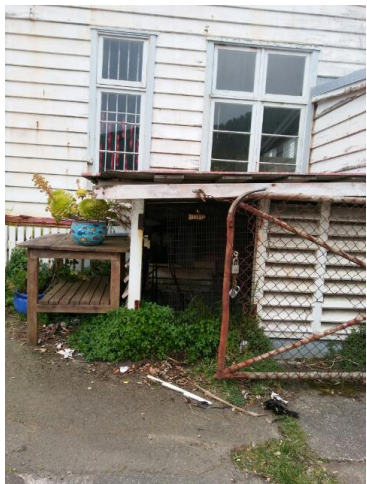
Location	Shed 8, External, 033, South Perimeter		Sample Number	30 (SP)

Item / Position	Switchboard		
	Material:	Bituminous Product		
	Extent	1no		
	Product Type	Asbestos reinforced composites etc.	1	
	Condition	Good condition	0	
	Surface Treatment	Completely sealed	0	
	Asbestos Type	Chrysotile	1	
	Material Assessment	Very Low	2	
	Recommendation	Manage and Label		
Comments:

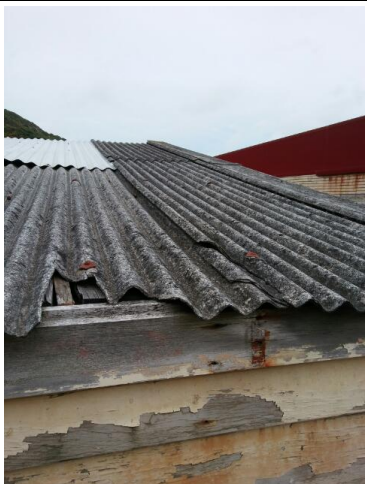
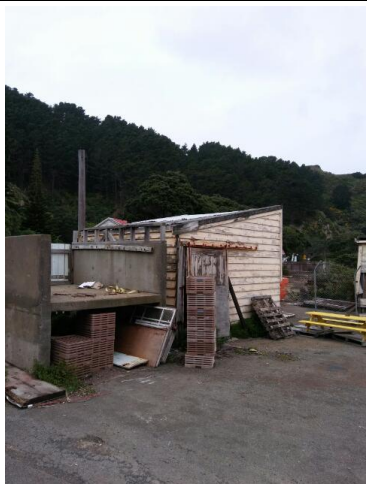
Location	Winding House, External, 036, Roof		Sample Number	31 (SP)

Item / Position	Corrugated Cement Roof and Flashing		
	Material:	Cement Product		
	Extent	20m ²		
	Product Type	Asbestos reinforced composites etc.	1	
	Condition	Medium damage	2	
	Surface Treatment	Partially unsealed	2	
	Asbestos Type	Presumed Asbestos	3	
	Material Assessment	Medium	8	
	Recommendation	Remove		
Comments:	Restrict access. Removal will be required when site plans are confirmed.

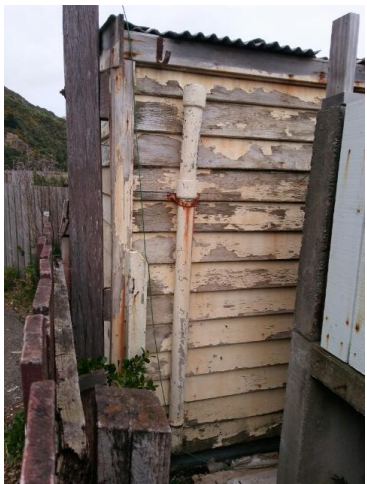
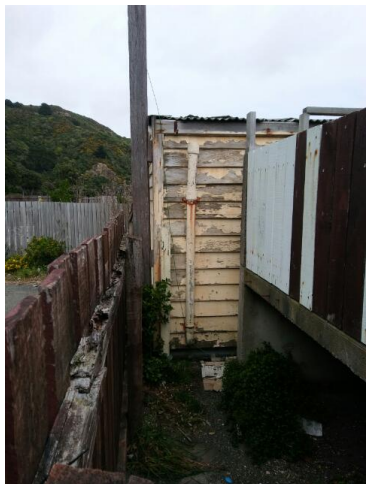
Location		Winding House, External, 038, North Wall		Sample Number	32 (SP)

Item / Position	Cement Pipe			
	Material:	Cement Product			
	Extent	1no			
	Product Type	Asbestos reinforced composites etc.	1		
	Condition	Low damage	1		
	Surface Treatment	Partially unsealed	2		
	Asbestos Type	Presumed Asbestos	3		
	Material Assessment	Medium	7		
	Recommendation	Remove			
	Comments:	Manage & Label until removal can occur

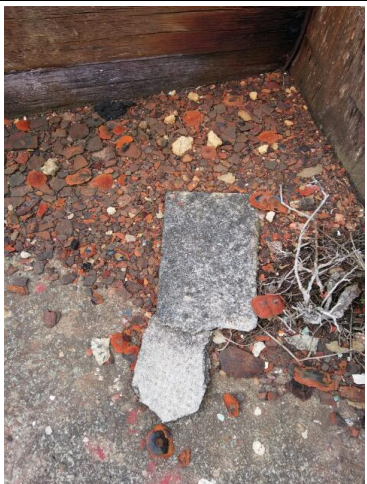
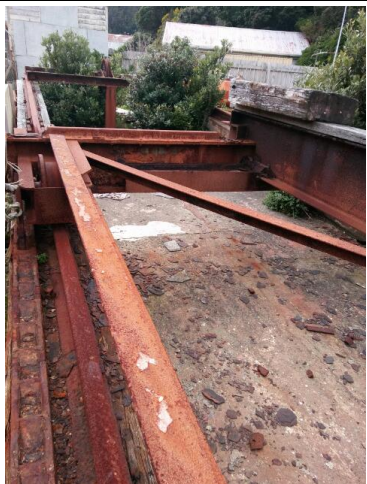
Location		Slipway Storage Building, External, 041, Slipway		Sample Number	35 (SP)

Item / Position	Cement Debris			
	Material:	Cement Product			
	Extent	All			
	Product Type	Asbestos reinforced composites etc.	1		
	Condition	High damage	3		
	Surface Treatment	Partially unsealed	2		
	Asbestos Type	Presumed Asbestos	3		
	Material Assessment	Medium	9		
	Recommendation	Remove			
	Comments:	Surface debris scattered over slipway area. Recommend grid handpick.

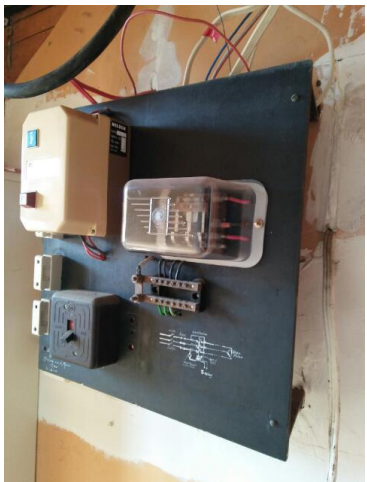
Location	Shed 8, Ground Floor, 053, Switchboard Room		Sample Number	41 (SP)

Item / Position	Switchboard		
	Material:	Bituminous Product		
	Extent	2no		
	Product Type	Asbestos reinforced composites etc.	1	
	Condition	Good condition	0	
	Surface Treatment	Surface sealed	1	
	Asbestos Type	Chrysotile	1	
	Material Assessment	Very Low	3	
	Recommendation	Manage and Label		
	Comments:	A second switchboard is present in the adjacent room

Ground Floor	053 / Switchboard Room	Switchboard - Bituminous Product	2no	Good condition	Surface sealed	SP041	Chrysotile	3	Manage and Label
1st Floor	031 / Roof	Guttering - Cement Product	All	Medium damage	Partially unsealed	SP042	Presumed Asbestos	8	Manage and Label
Ground Floor	060 / Workshop	Switchboard - Bituminous Product	1no	Good condition	Completely sealed	SP043	Chrysotile	2	Manage and Label
External	033 / South Perimeter	Window Panel - Cement Product	2no	Low damage	Surface sealed	P027	Amosite / Crocidolite / Chrysotile	6	Manage and Label
External	033 / South Perimeter	Loose Cement Boards - Cement Product	All	Low damage	Surface sealed	P028	Presumed Asbestos	6	Manage and Label
Ground Floor	059 / Toilet	Cladding and Partitions - Cement Product	50m ²	Low damage	Surface sealed	PSBS022 365	Chrysotile	4	Manage and Label

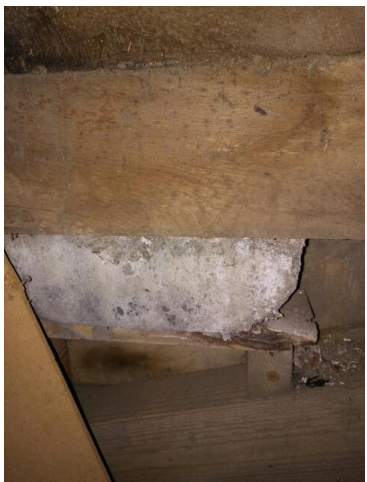
Location	Shed 8, 1st Floor, 031, Roof		Sample Number	42 (SP)

Item / Position	Guttering		
	Material:	Cement Product		
	Extent	All		
	Product Type	Asbestos reinforced composites etc.	1	
	Condition	Medium damage	2	
	Surface Treatment	Partially unsealed	2	
	Asbestos Type	Presumed Asbestos	3	
	Material Assessment	Medium	8	
	Recommendation	Manage and Label		
	Comments:	Item documented where exposed to mezzanine offices interior. Recommend encapsulating and enclosing in this location if offices are to be reoccupied.

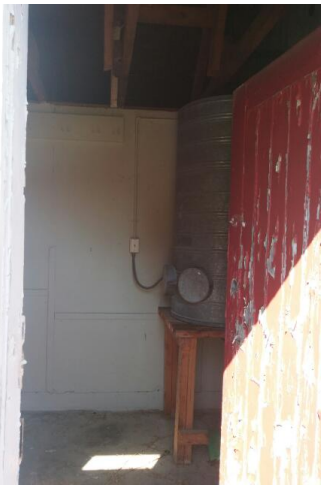
Location	Laundry Building, Ground Floor, 004, Boiler Room		Sample Number	3 (P)

Item / Position	Hot Water Cylinder		
	Material:	Suspected Asbestos		
	Extent	1no		
	Product Type	Thermal insulation (eg pipe and boiler lagging), sprayed asbestos, loose asbestos, asbestos mattresses and packing.	3	
	Condition	Good condition	0	
	Surface Treatment	Completely sealed	0	
	Asbestos Type	Presumed Asbestos	3	
	Material Assessment	Low	6	
	Recommendation	Manage and Label		
	Comments:	Hot Water Cylinders can contain a variety of ACMs including insulation, gaskets, wiring and reinforced plastics. As it is not usually possible to fully inspect the internals, HWCs should be presumed to contain asbestos as a precaution, unless proven otherwise.

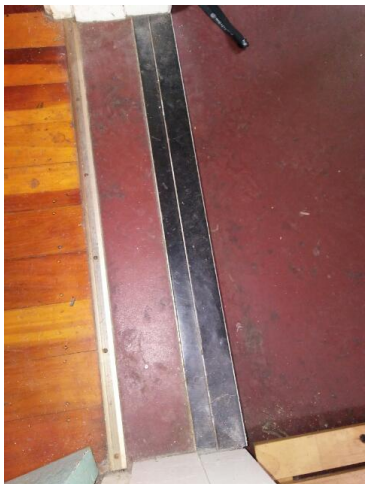
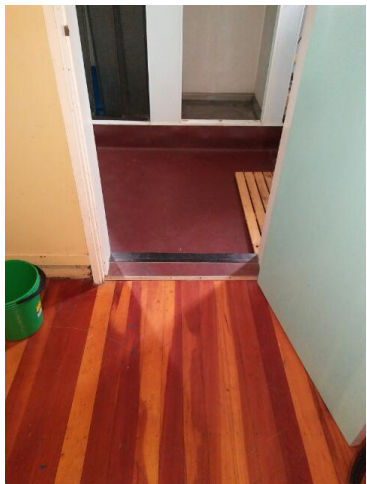
Location	Squash Courts, Ground Floor, 033, Showers		Sample Number	25 (P)

Item / Position	Edge Strip		
	Material:	Vinyl Products		
	Extent	1no		
	Product Type	Asbestos reinforced composites etc.	1	
	Condition	Good condition	0	
	Surface Treatment	Completely sealed	0	
	Asbestos Type	Presumed Asbestos	3	
	Material Assessment	Very Low	4	
	Recommendation	Manage and Label		
Comments:

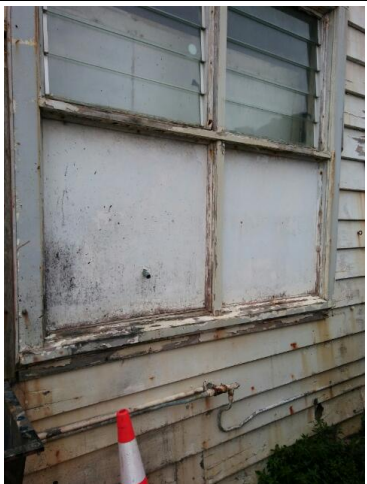
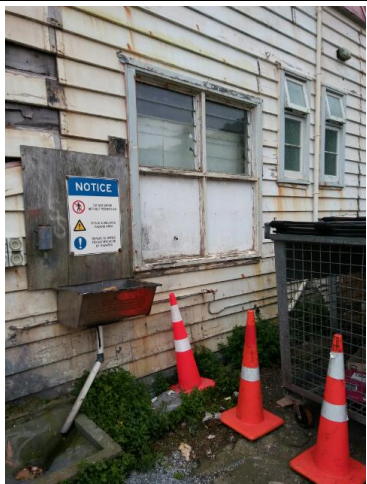
Location	Shed 8, External, 033, South Perimeter		Sample Number	27 (P)

Item / Position	Window Panel		
	Material:	Cement Product		
	Extent	2no		
	Product Type	Asbestos reinforced composites etc.	1	
	Condition	Low damage	1	
	Surface Treatment	Surface sealed	1	
	Asbestos Type	Amosite / Crocidolite / Chrysotile	3	
	Material Assessment	Low	6	
	Recommendation	Manage and Label		
Comments:

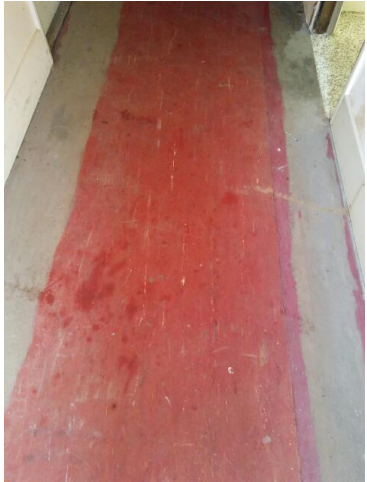
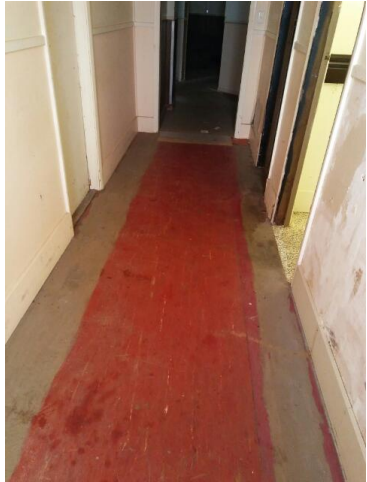
Location	Shed 8, Ground Floor, 046, North Hallway		Sample Number	BS022359 (PS)

Item / Position	Cement Board		
	Material:	Cement Product		
	Extent	2no		
	Product Type	Asbestos reinforced composites etc.	1	
	Condition	Low damage	1	
	Surface Treatment	Surface sealed	1	
	Asbestos Type	Presumed Asbestos	3	
	Material Assessment	Low	6	
	Recommendation	Manage and Label		
	Comments:	Sample prior to disturbance or dispose of as asbestos waste as a precaution.

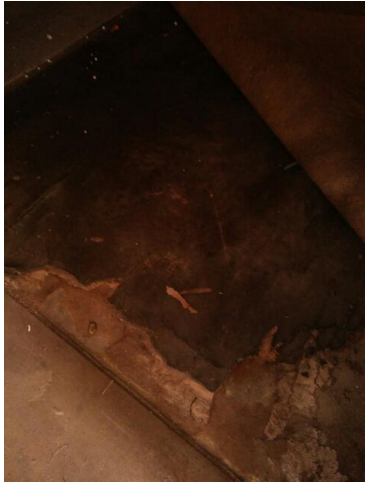
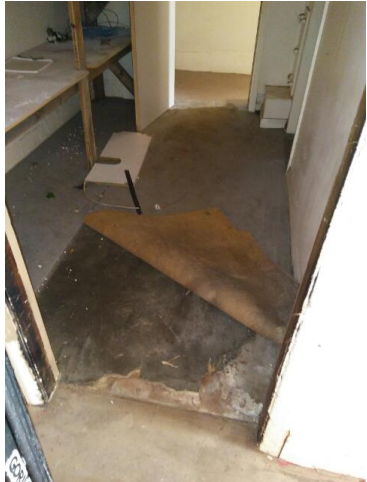
Location	Shed 8, Ground Floor, 047, Room 8		Sample Number	BS022361 (PS)

Item / Position	Vinyl Flooring			
	Material:	Vinyl Products			
	Extent	10m ²			
	Product Type	N/A	N/A		
	Condition	N/A	N/A		
	Surface Treatment	N/A	N/A		
	Asbestos Type	NAD	N/A		
	Material Assessment	N/A	0		
	Recommendation	No further action required			
	Comments:

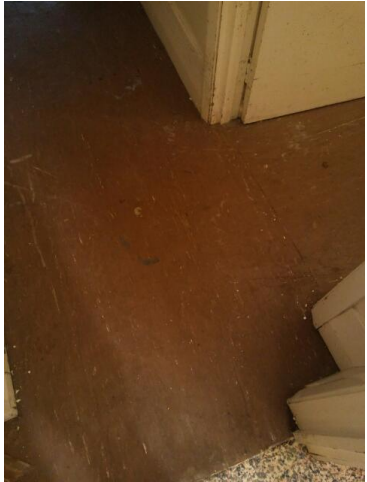
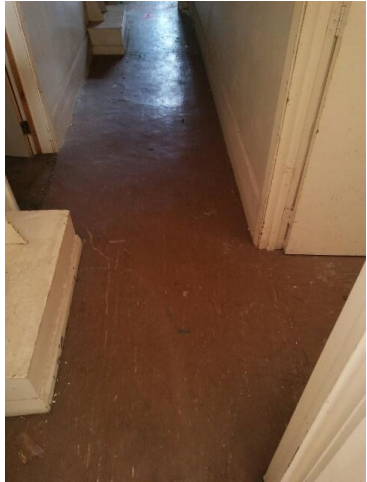
Location	Shed 8, Ground Floor, 048, Room 14		Sample Number	BS022362 (PS)

Item / Position	Vinyl Flooring			
	Material:	Vinyl Products			
	Extent	10m ²			
	Product Type	N/A	N/A		
	Condition	N/A	N/A		
	Surface Treatment	N/A	N/A		
	Asbestos Type	NAD	N/A		
	Material Assessment	N/A	0		
	Recommendation	No further action required			
	Comments:	Under carpet

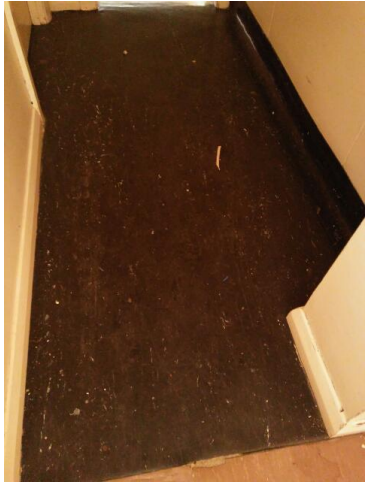
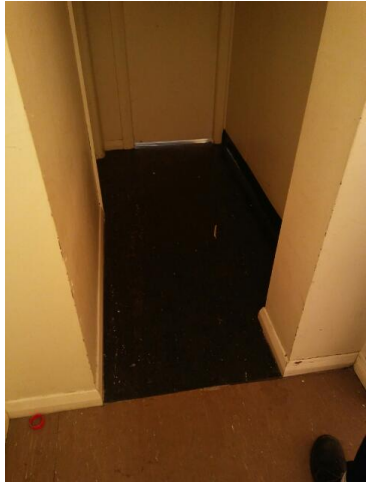
Location	Shed 8, Ground Floor, 049, Room 14		Sample Number	BS022363 (PS)

Item / Position	Vinyl Flooring - Brown			
	Material:	Vinyl Products			
	Extent	20m ²			
	Product Type	N/A			N/A
	Condition	N/A			N/A
	Surface Treatment	N/A			N/A
	Asbestos Type	NAD			N/A
	Material Assessment	N/A			0
	Recommendation	No further action required			
	Comments:

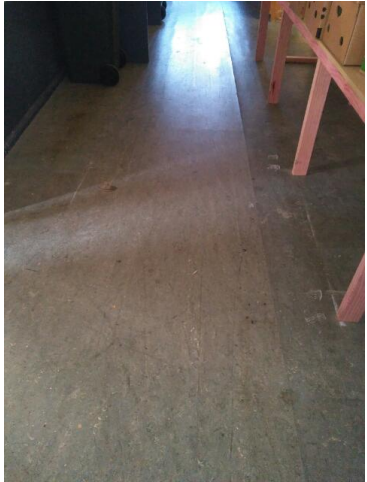
Location		Shed 8, Ground Floor, 062, Eastern Corridor		Sample Number	BS022368 (PS)

Item / Position	Wall and Ceiling Linings			
	Material:	Cement Product			
	Extent	100m ²			
	Product Type	Asbestos reinforced composites etc.	1		
	Condition	Low damage	1		
	Surface Treatment	Surface sealed	1		
	Asbestos Type	Chrysotile	1		
	Material Assessment	Very Low	4		
	Recommendation	Manage and Label			
	Comments:

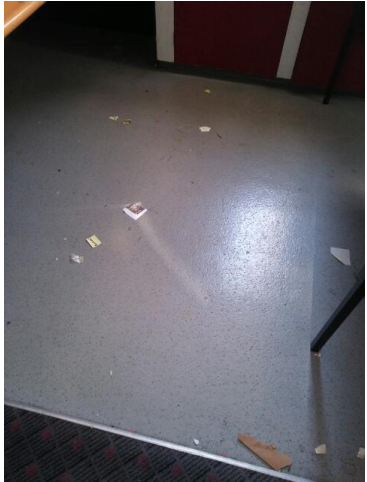
Location		Shed 8, Ground Floor, 064, Eastern Room Kitchenette		Sample Number	BS022369 (PS)

Item / Position	Vinyl Flooring		
		Material:	Vinyl Products		
		Extent	100m ²		
		Product Type	N/A	N/A	
		Condition	N/A	N/A	
		Surface Treatment	N/A	N/A	
		Asbestos Type	NAD	N/A	
		Material Assessment	N/A	0	
		Recommendation	No further action required		
		Comments:

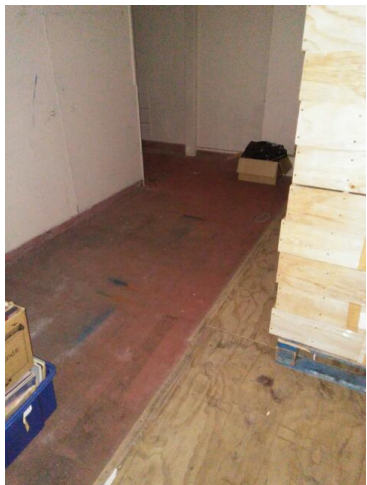
Location	Shed 8, Ground Floor, 065, South East Room		Sample Number	BS022370 (PS)

Item / Position	Vinyl Flooring		
		Material:	Vinyl Products		
		Extent	8m ²		
		Product Type	N/A	N/A	
		Condition	N/A	N/A	
		Surface Treatment	N/A	N/A	
		Asbestos Type	NAD	N/A	
		Material Assessment	N/A	0	
		Recommendation	No further action required		
		Comments:

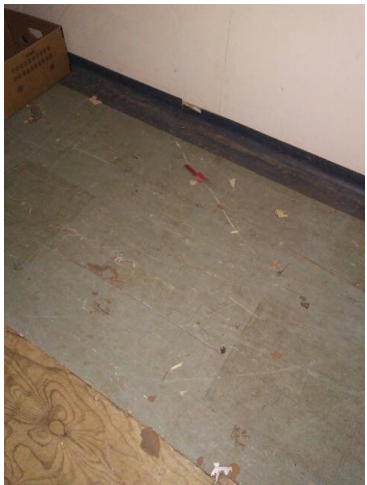
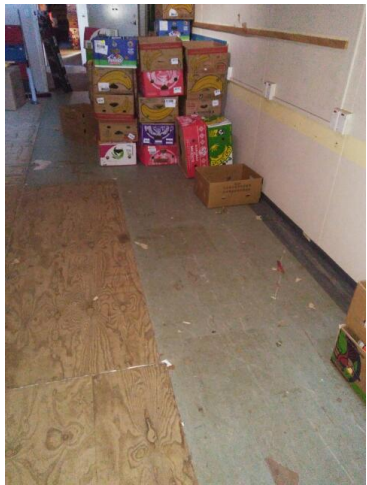
Location	Shed 8, Ground Floor, 065, South East Room		Sample Number	BS022371 (PS)

Item / Position	Red Vinyl Flooring			
	Material:	Vinyl Products			
	Extent	Unknown			
	Product Type	Asbestos reinforced composites etc.	1		
	Condition	Medium damage	2		
	Surface Treatment	Surface sealed	1		
	Asbestos Type	Chrysotile	1		
	Material Assessment	Low	5		
	Recommendation	Manage and Label			
	Comments:	Full extent is unclear and material may extend under more recent floor coverings

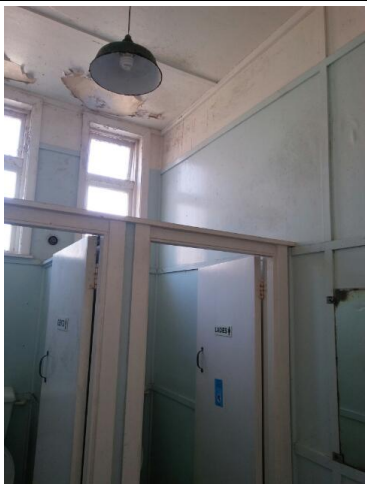
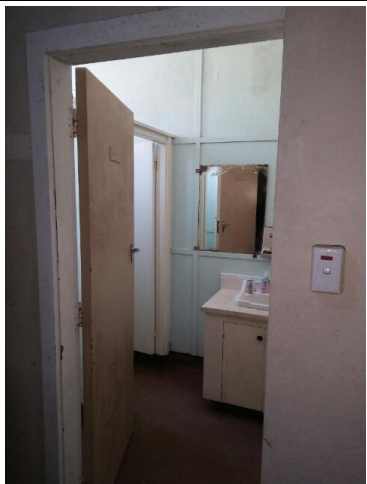
Location		Shed 8, Ground Floor, 066, Toilet		Sample Number	BS022372 (PS)

Item / Position	Aqua Vinyl Flooring			
	Material:	Vinyl Products			
	Extent	All			
	Product Type	N/A	N/A		
	Condition	N/A	N/A		
	Surface Treatment	N/A	N/A		
	Asbestos Type	NAD	N/A		
	Material Assessment	N/A	0		
	Recommendation	No further action required			
	Comments:
