Asbestos Management Survey Report

Shelly Bay Complex
Shelly Bay Road
Wellington, 6022

Wellington City Council

Reference: W-01625

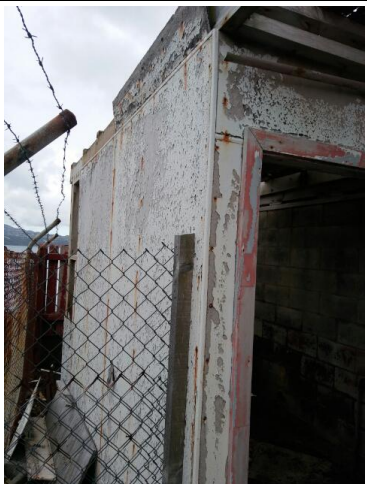
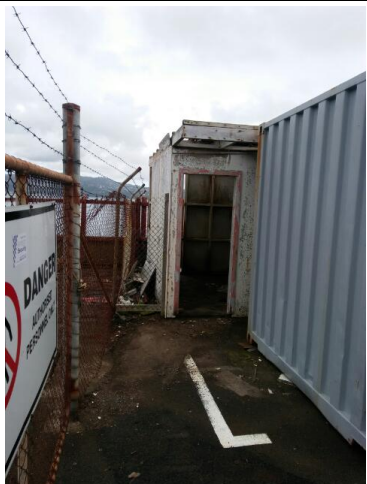
Location		North Yard Bunker, External, 027, West Extension		Sample Number	BS022374 (PS)

Item / Position	Wall, Ceiling Linings & Partitions		
		Material:	Cement Product		
		Extent	50m ²		
		Product Type	Asbestos reinforced composites etc.	1	
		Condition	Low damage	1	
		Surface Treatment	Completely sealed	0	
		Asbestos Type	Chrysotile	1	
		Material Assessment	Very Low	3	
		Recommendation	Manage and Label		
		Comments:

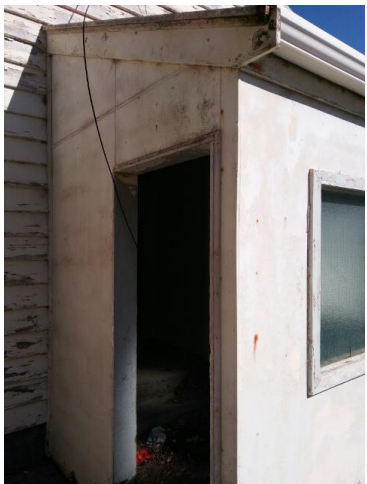
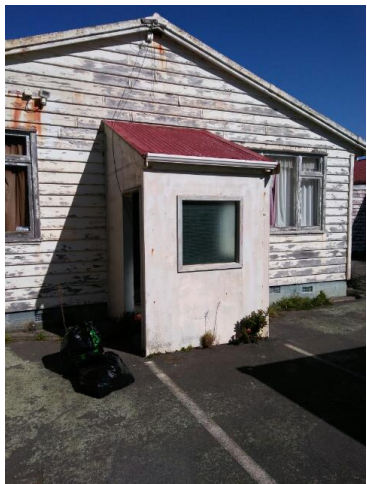
Location	Headquarters Building, External, 017, North Wall		Sample Number	BS022375 (PS)

Item / Position	Cladding		
		Material:	Cement Product		
		Extent	12m ²		
		Product Type	Asbestos reinforced composites etc.	1	
		Condition	High damage	3	
		Surface Treatment	Partially unsealed	2	
		Asbestos Type	Chrysotile	1	
		Material Assessment	Medium	7	
		Recommendation	Remove		
		Comments:	Restrict access until material can be removed

PS-BS022374 – Cladding
 (Cladding is severely degraded. Restrict access until removal can be undertaken)

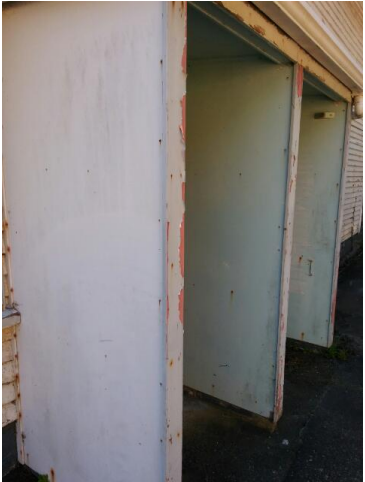
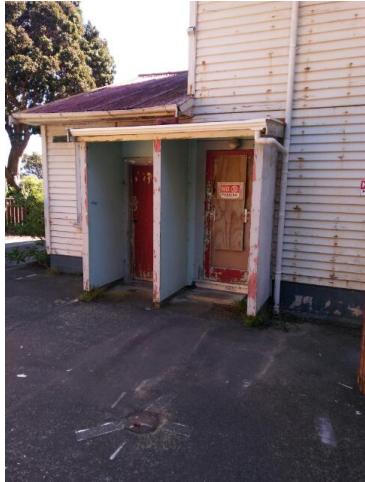
Location	Squash Courts, External, 021, East Porch	Sample Number	BS023703 (PS)

Item / Position	Porch Cladding and Soffit			
	Material:	Cement Product			
	Extent	12m ²			
	Product Type	Asbestos reinforced composites etc.	1		
	Condition	Low damage	1		
	Surface Treatment	Surface sealed	1		
	Asbestos Type	Chrysotile	1		
	Material Assessment	Very Low	4		
	Recommendation	Manage and Label			
	Comments:	Cladding is external and internal to porch

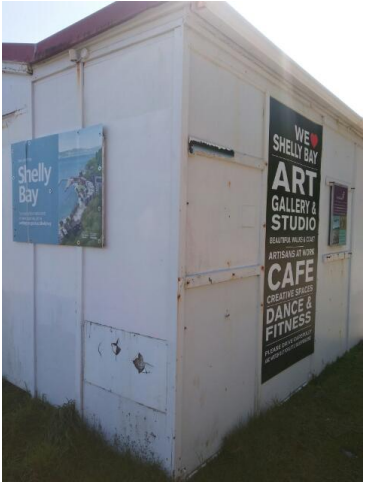
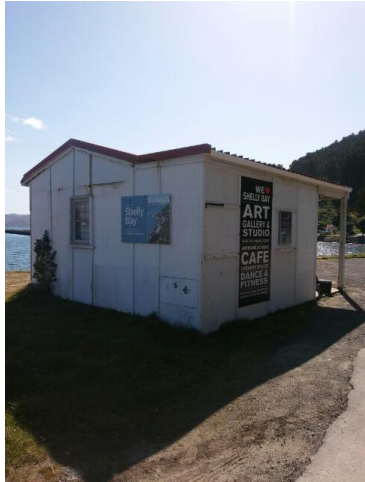
Location	Guard Hut, External, 003, Walls	Sample Number	BS023704 (PS)

Item / Position	Lining	
	Material:	Cement Product	
	Extent	12m ²	
	Product Type	Asbestos reinforced composites etc.	1
	Condition	Low damage	1
	Surface Treatment	Surface sealed	1
	Asbestos Type	Amosite / Chrysotile	2
	Material Assessment	Low	5
	Recommendation	Manage and Label	
Comments:

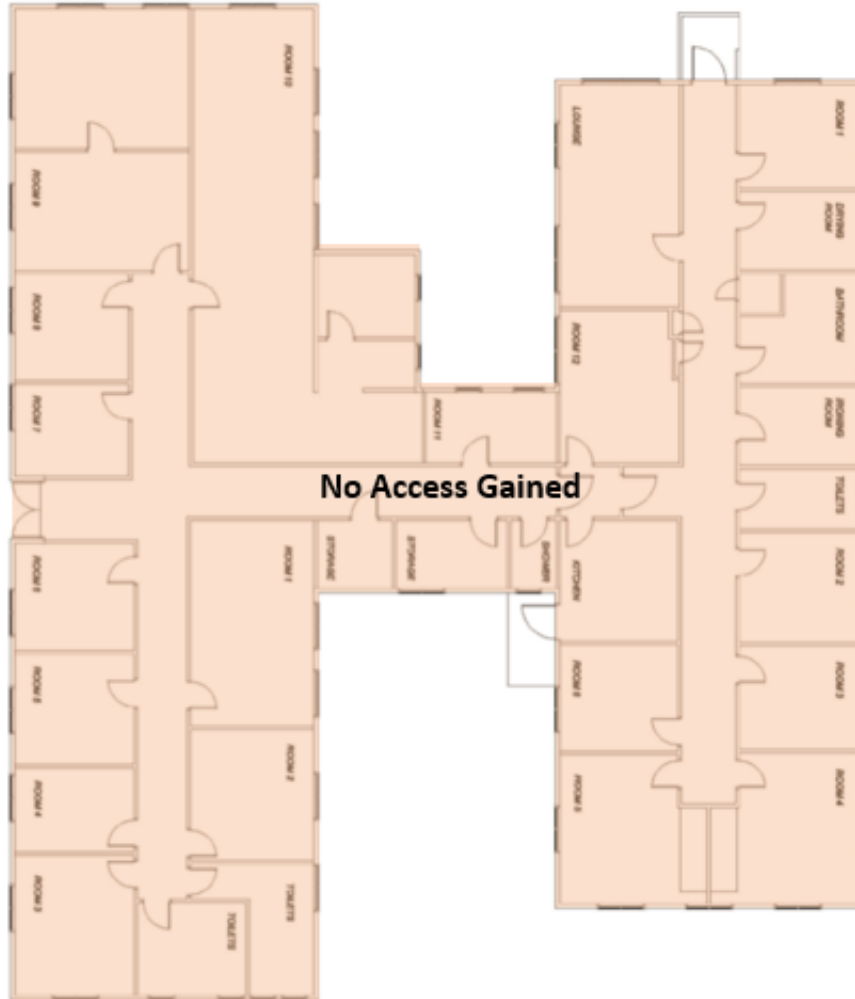
Shelly Bay – Headquarters Building – Internal

No Access Gained

No Access Gained to headquarters building interior due to safety concerns. **AIB panels behind heaters** are known to be present as a result of previous testing conducted by a third party (Refer Certificates – Sample BS022377).

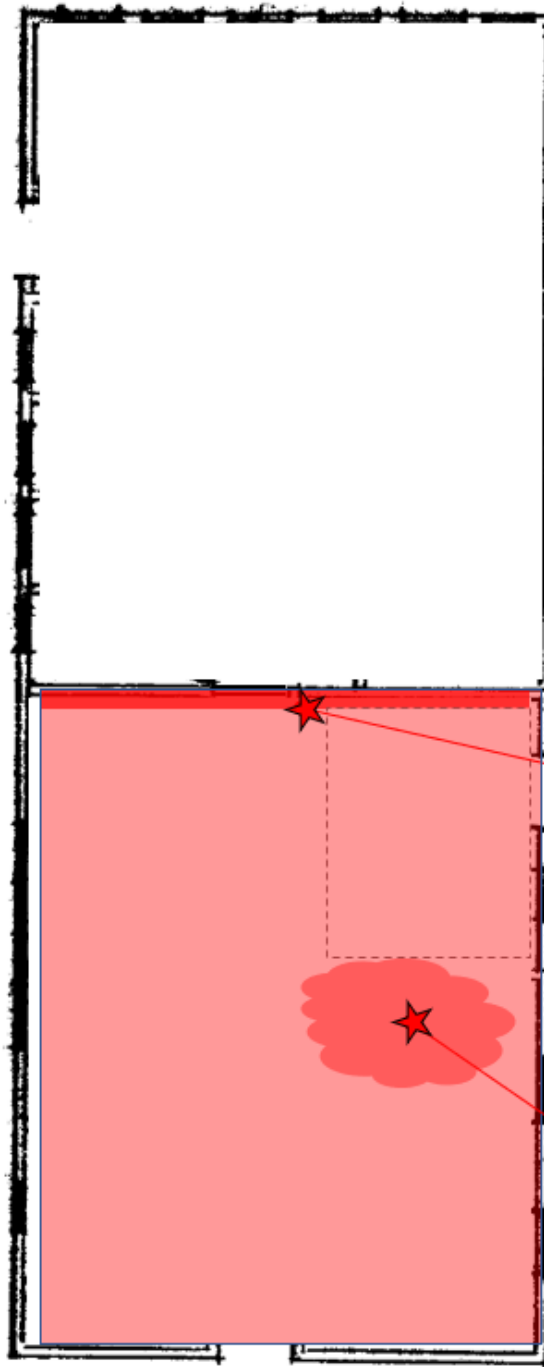
X004 – Wall Lining
(Extends from room below to form internal gable)

S005 – Pipe Lagging Debris
(Treat entire eastern extent of void as contaminated)
