Maintenance Plan Report

WELLINGTON SCOTTISH ATHLETICS
CLUB

Prince of Wales Park, Salisbury Terrace,
Mt Cook, Wellington 6021

17/01/2023
WSA22-01

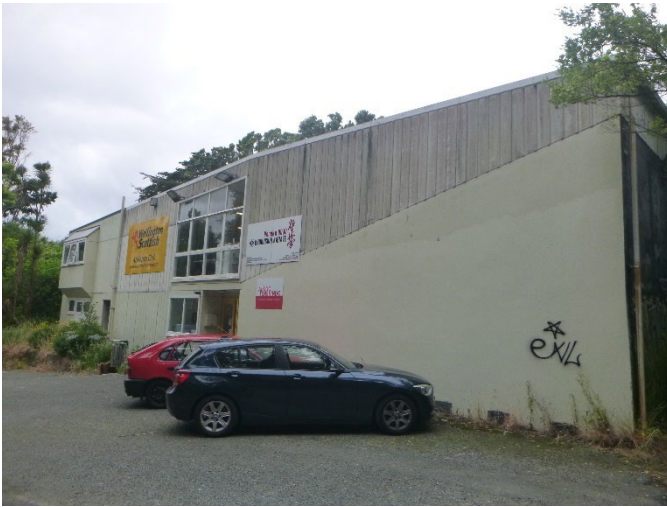
Photograph 1

Overview of front (northwest) elevation.

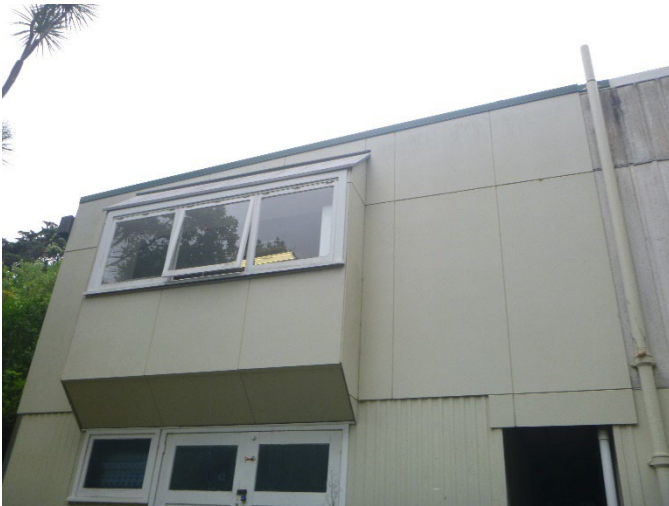
Photograph 4

Partial view of kitchen window (first floor addition).

3.10.4		Windows	Painted timber windows.	Generally in reasonable condition, but localised impact damage to timber framing and decorative finishes consistent with intended use.	Allow to wash down, prepare and repaint.	P	4m2	110	440	8 years							440				440

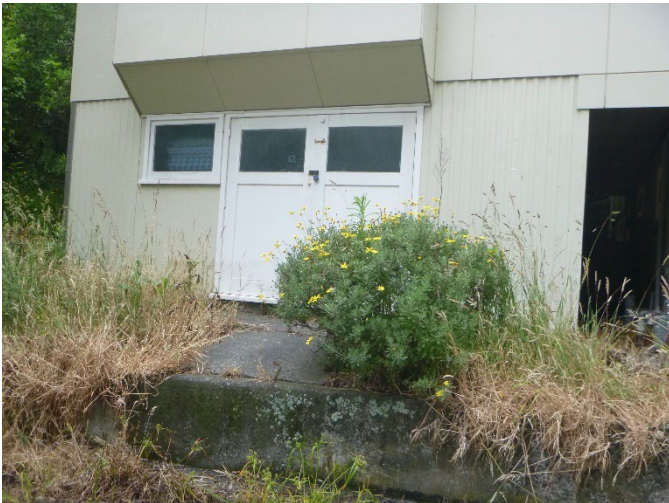
Photograph 5

Entrance to ground floor storage area below kitchen.

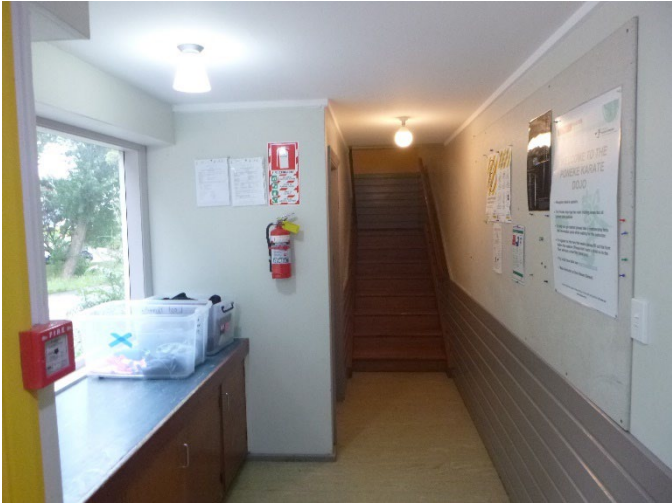
Photograph 19

Ground floor entrance corridor.

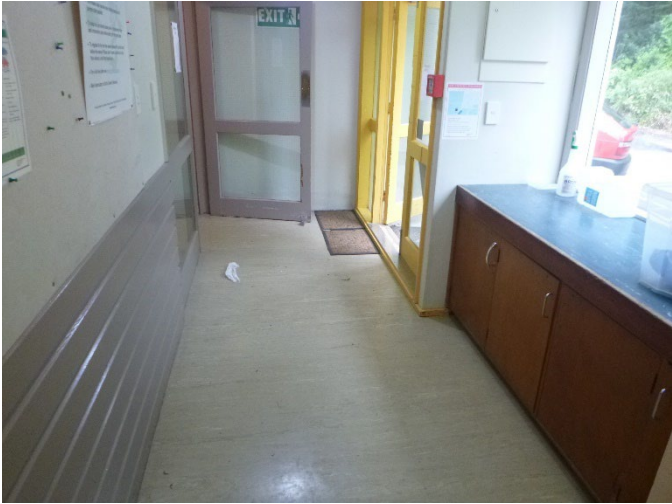
Photograph 20

Ground floor entrance corridor.

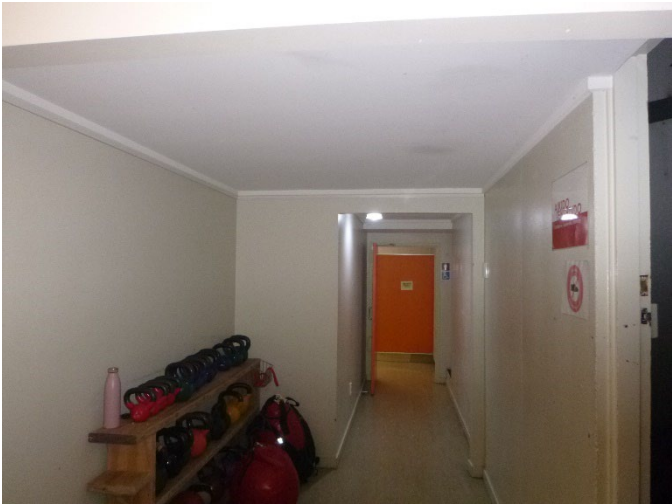
Photograph 21

Ground floor entrance corridor leading to WCs.

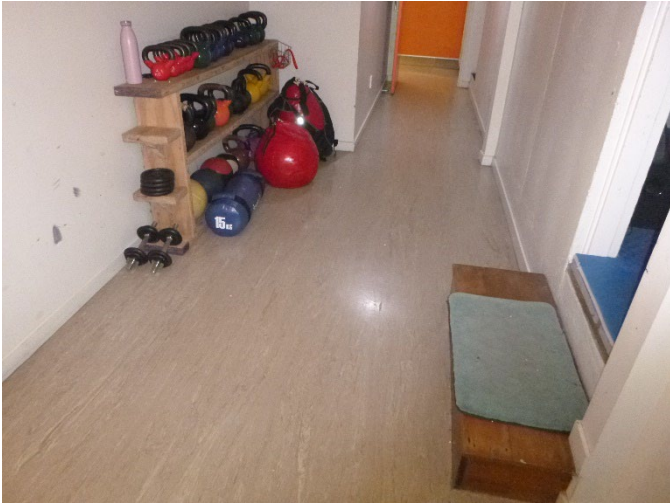
Photograph 22

Ground floor entrance corridor leading to WCs.

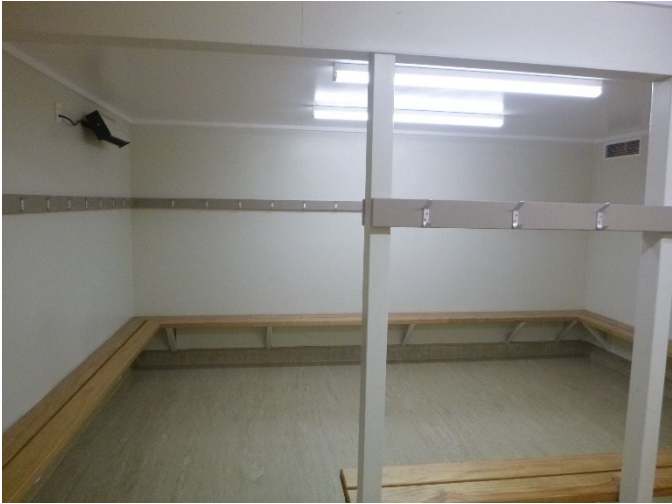
Photograph 29

Partial view of female changing room.

5.1.6		Wall mounted electric heater (Female)	Skope wall mounted heater located in the female changing area.	Older units, in reasonable condition.	Plan for replacement in the next 3 years.	P	2No.	675	1350	6 yearly			1,350						1,350		2,700

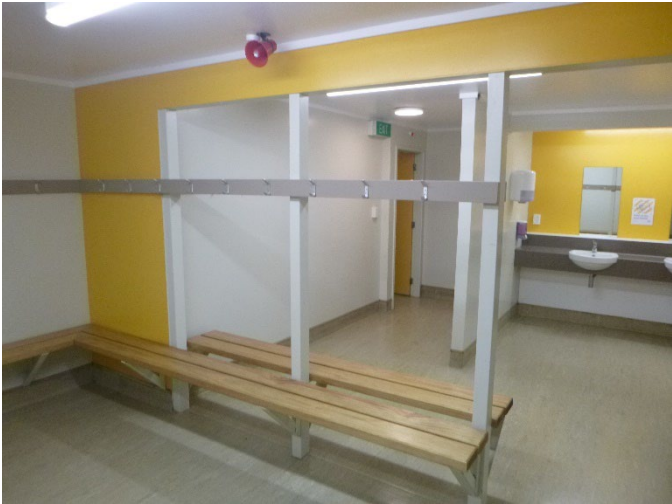
Photograph 30

Partial view of female changing room.

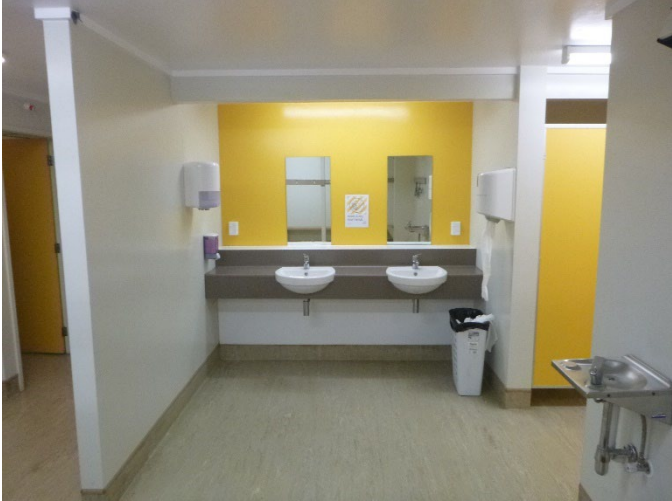
Photograph 31

Partial view of female changing room.

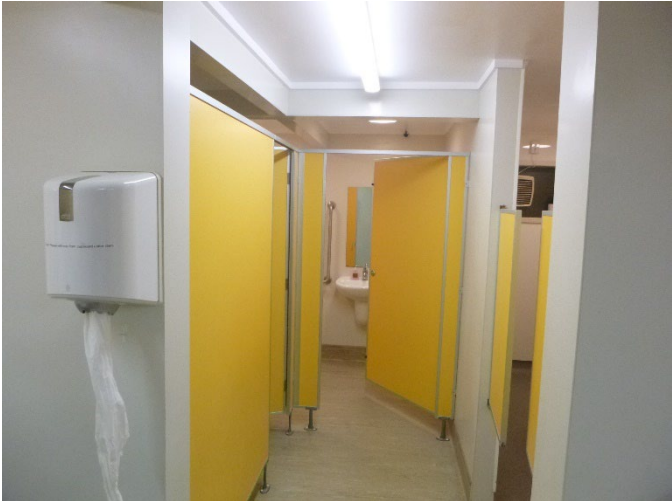
Photograph 32

Partial view of female changing room.

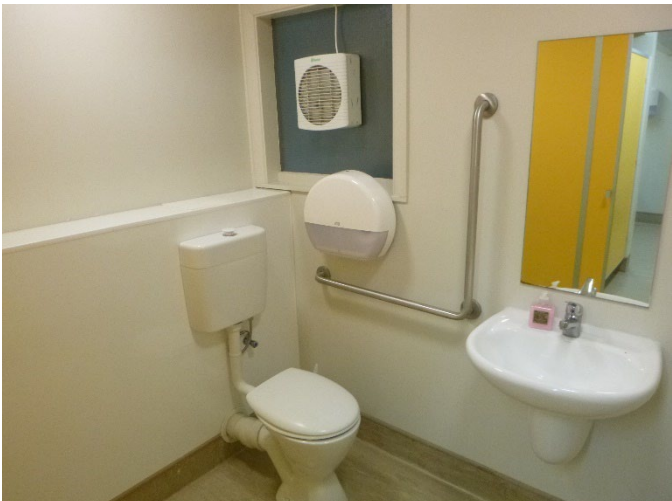
Photograph 33

Partial view of female changing room.

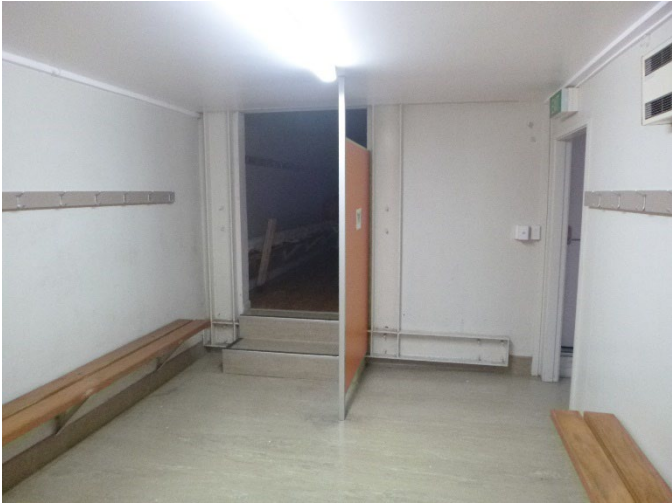
Photograph 34

Partial view of male changing room.

5.1.5		Wall mounted electric heater (Male)	Skope wall mounted heater located in the male changing area.	Older unit, in reasonable condition.	Plan for replacement in the next 3 years.	P	1No.	675	675	6 yearly			675						675		1,350

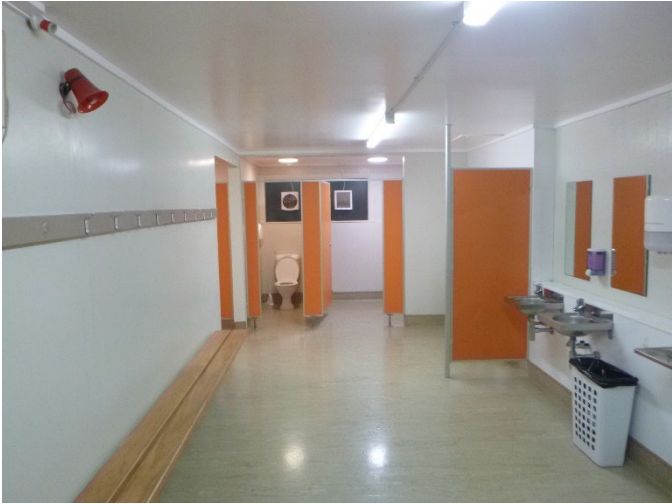
Photograph 35

Partial view of male changing room.

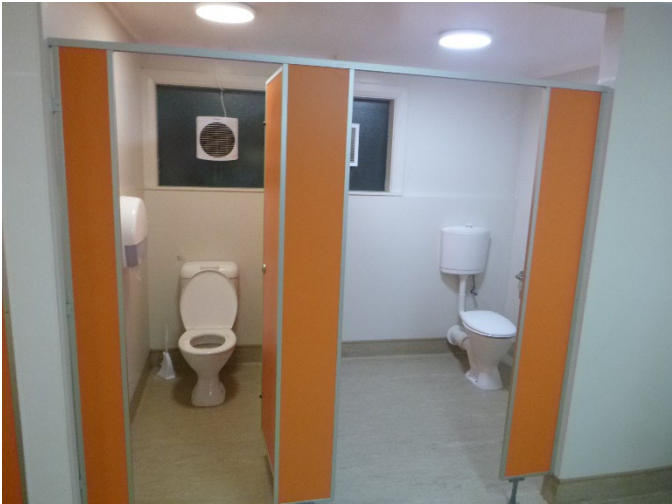
Photograph 36

Partial view of male changing room.

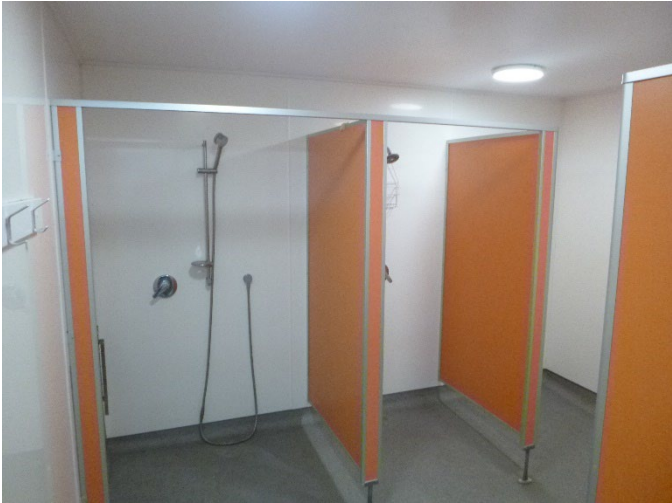
Photograph 37

Partial view of male changing room.

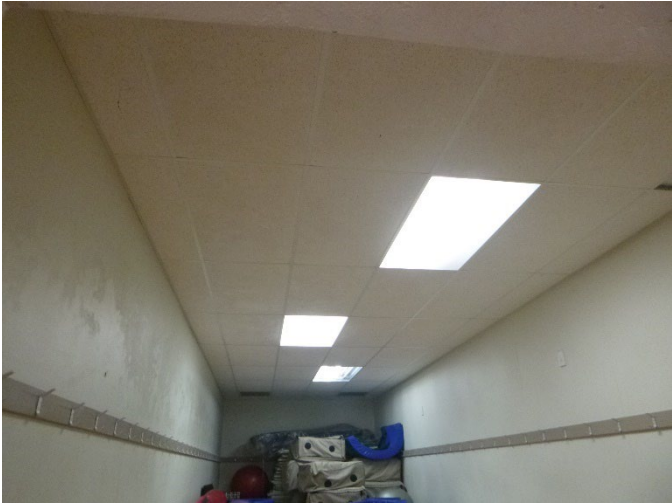
Photograph 38

Storage area beyond male changing room (former squash court)

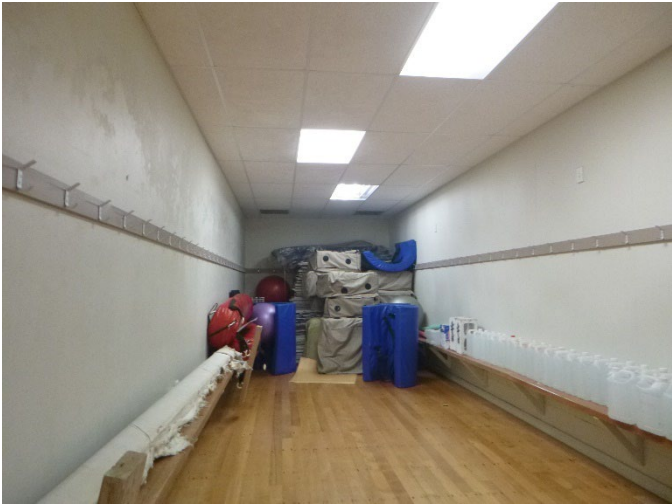
Photograph 39

Storage area beyond male changing room (former squash court)

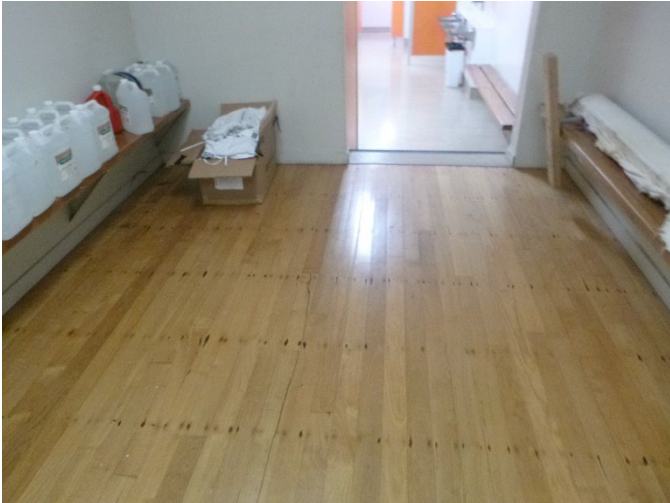
Photograph 40

Storage area beyond male changing room
(former squash court)

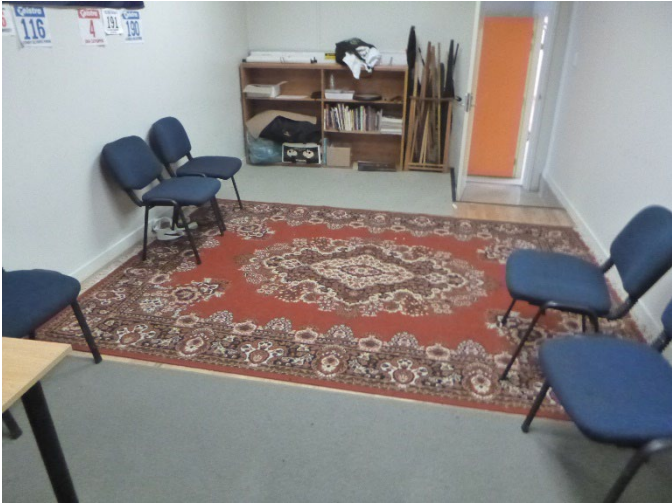
Photograph 43

Storage area beyond male changing room (former squash court)

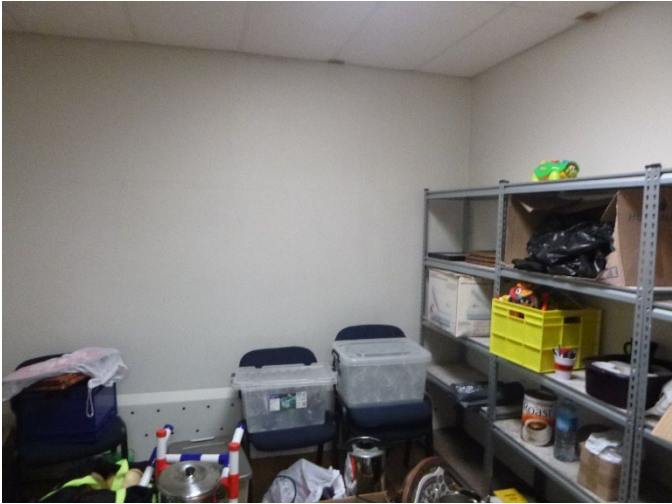
Photograph 44

Storage area beyond male changing room (former squash court)

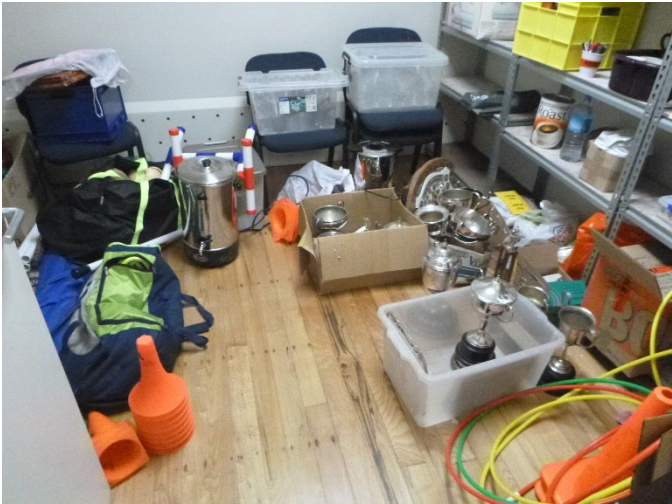
Photograph 45

Storage area beyond male changing room (former squash court)

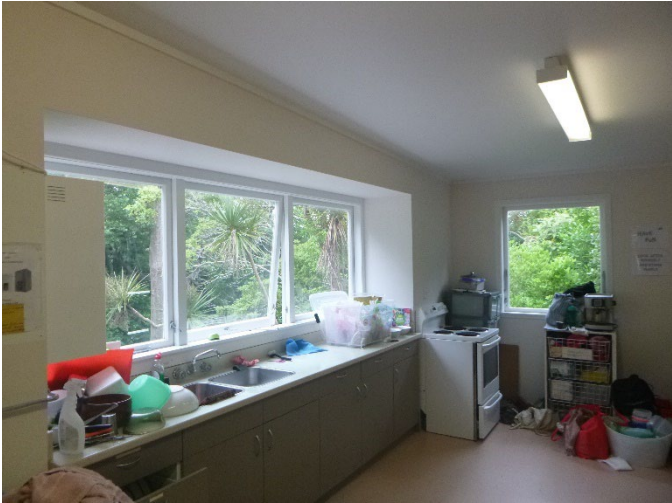
Photograph 46

Partial view of first floor kitchen area.

3.10.7		Joinery	Built-in timber cabinetry. Kitchen worktops, base units and appliances.	Generally in good condition, with minor surface abrasion consistent with normal wear.	Allow to wash down, prepare and repaint.	P	1No.	7500	7500	8 years							7,500				7,500
4	GROUNDS

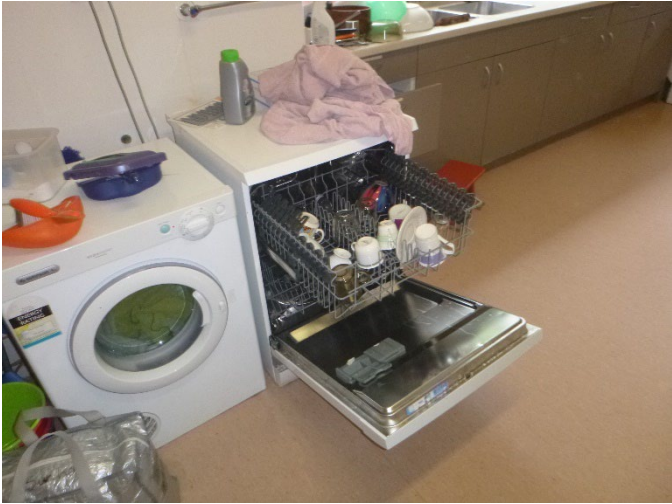
Photograph 47

Partial view of first floor kitchen area.

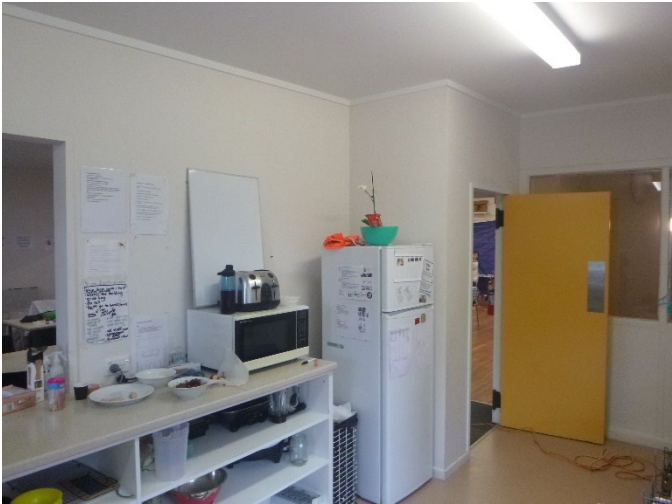
Photograph 48

Partial view of first floor kitchen area.

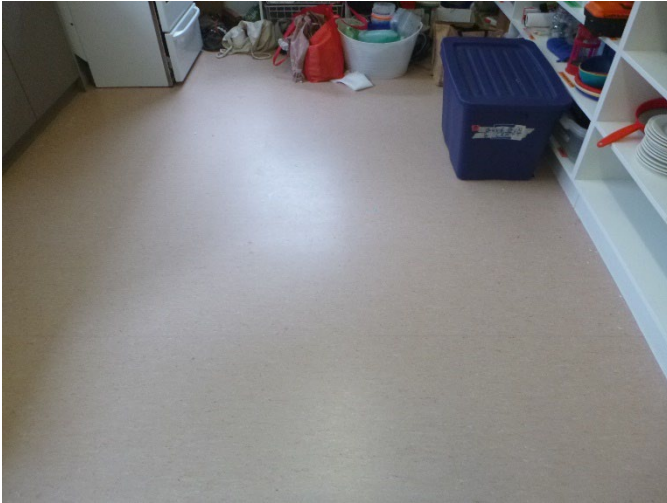
Photograph 49

Partial view of first floor kitchen area.

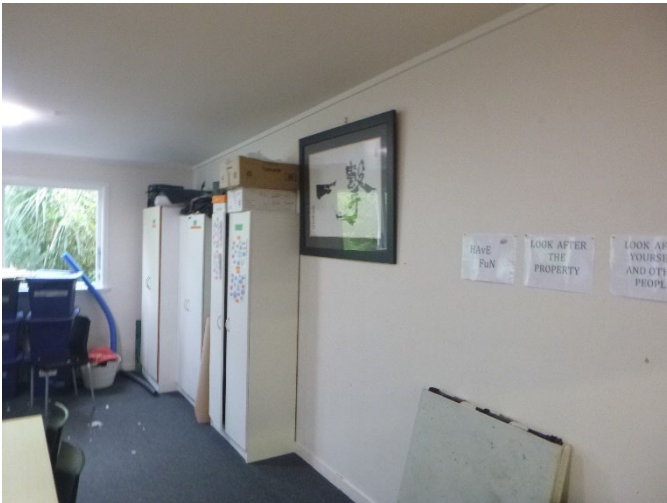
Photograph 50

Partial view of first floor area adjacent to kitchen.

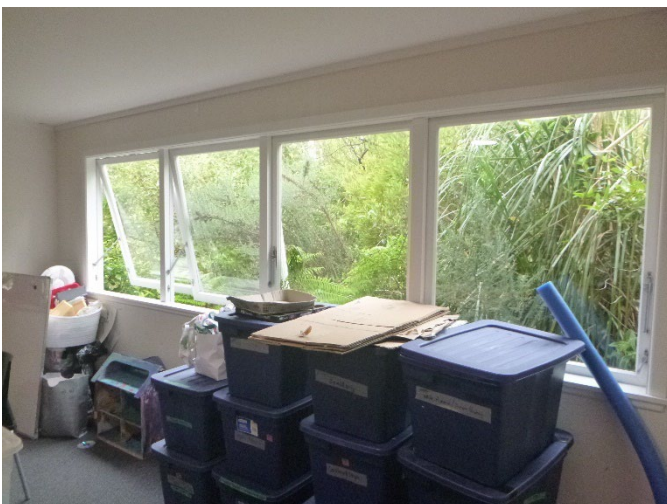
Photograph 51

Partial view of first floor area adjacent to kitchen.

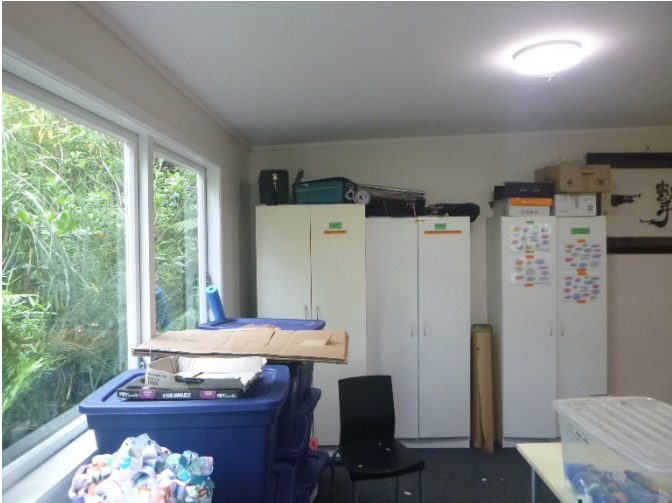
Photograph 52

Partial view of first floor area adjacent to kitchen.

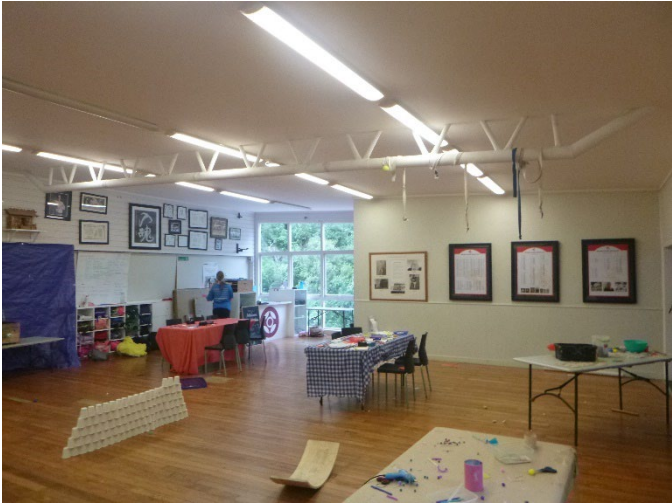
Photograph 56

Overview of the first floor hall looking towards the front elevation (car park).

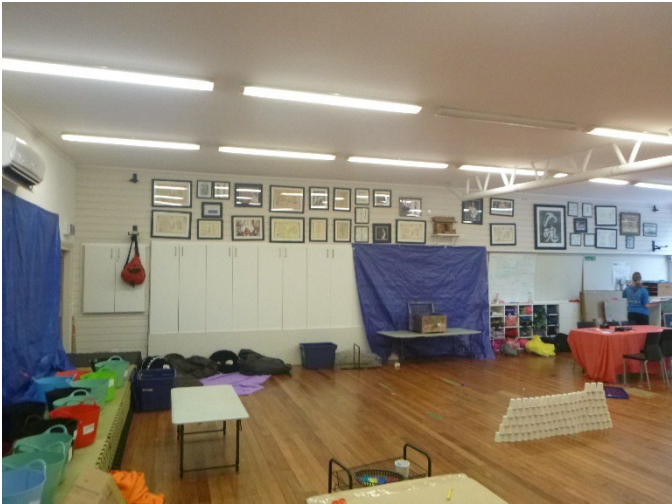
Photograph 57

Overview of the first floor hall.

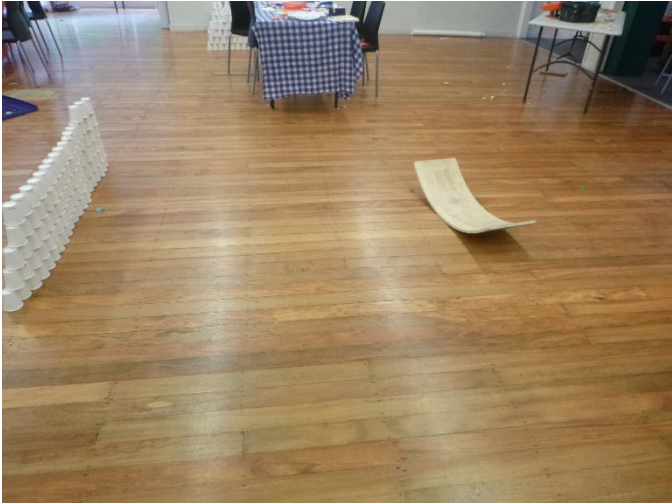
Photograph 58

Partial view of the floor to the first floor hall.

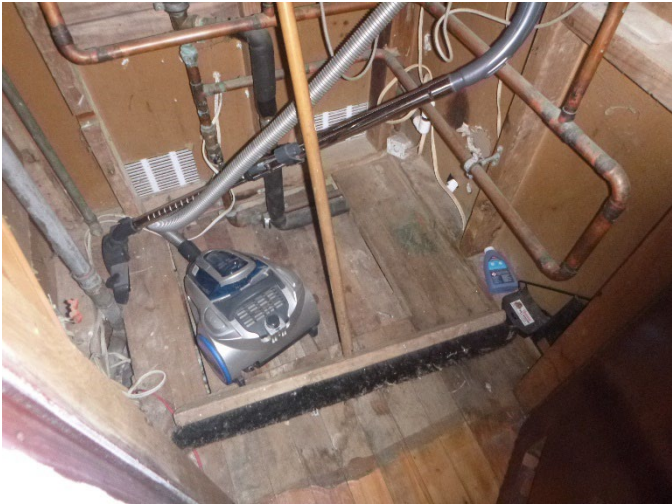
Photograph 60

First floor store cupboard.

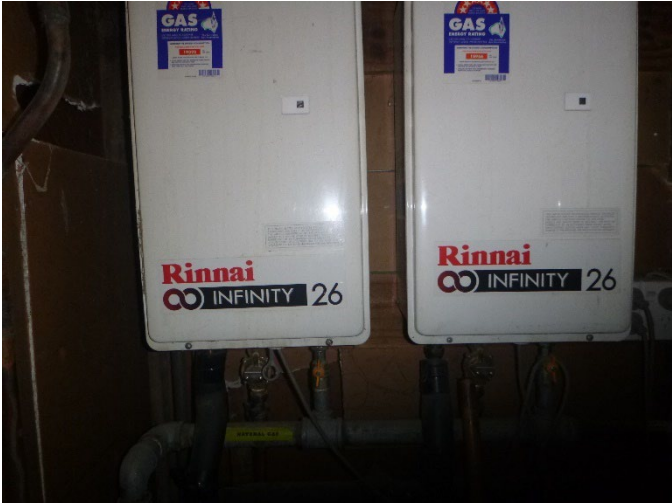
Photograph 61

Water heaters in the first floor cupboard.

5.1.8		Water heaters	Rinnai Infinity 26 (x2) Rinnai Infinity XR26i (x1)	Reasonable operational condition, but age unknown.	Plan for replacement in the next 5 years.	P	3No.	3,000	9,000	8 yearly			9,000								9,000

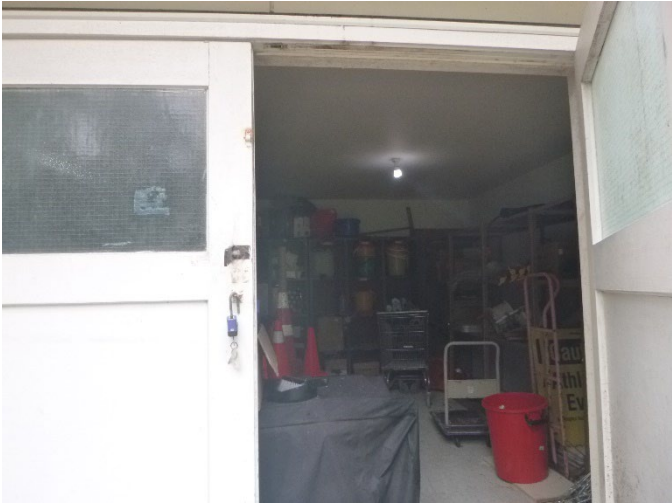
Photograph 62

External entrance to the ground floor store area. See also photograph 5.

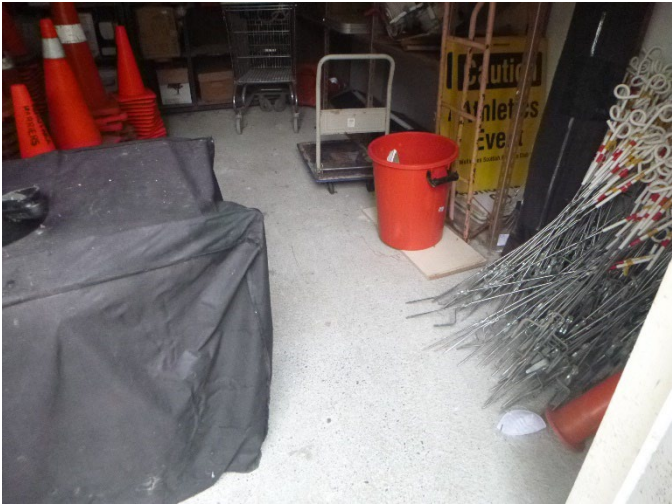
Photograph 63

Partial view of ground floor storage area.

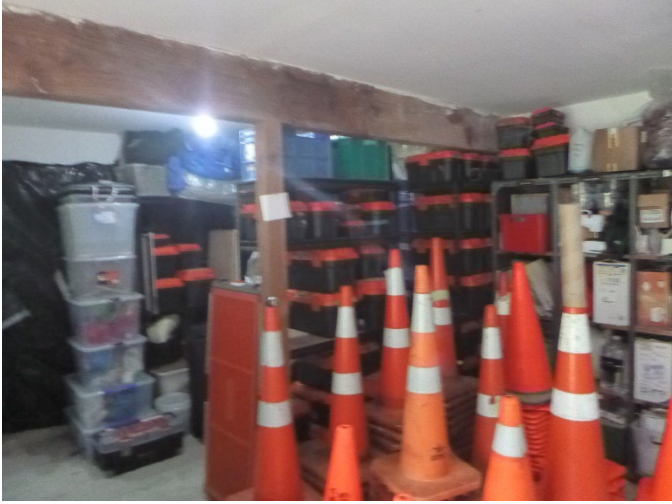
Photograph 64

Partial view of ground floor storage area.

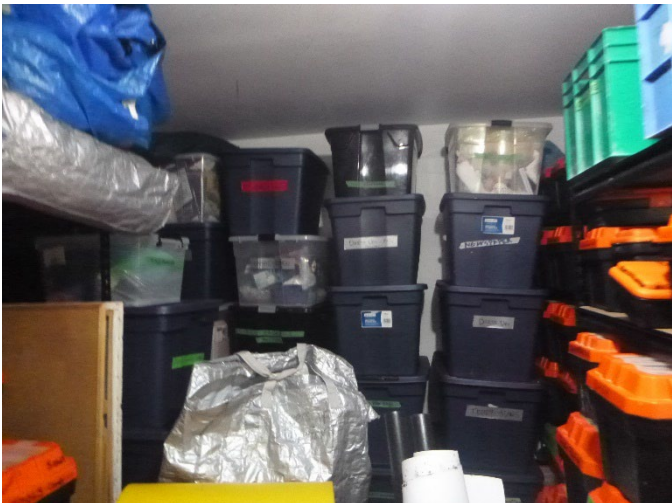
Photograph 65

Partial view of ground floor storage area.

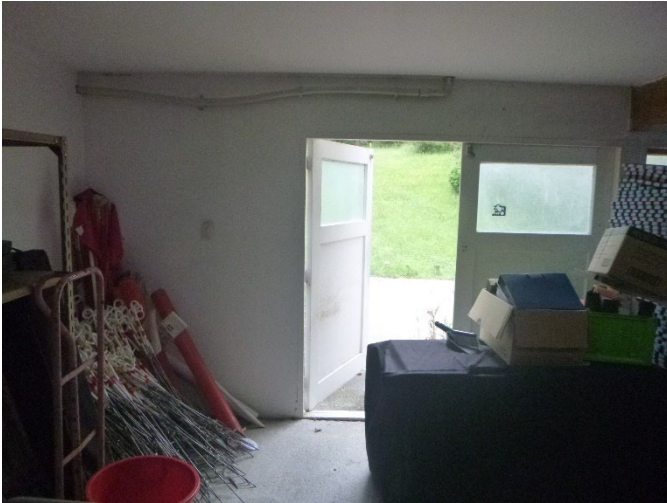
Photograph 66

Partial view of ground floor storage area.

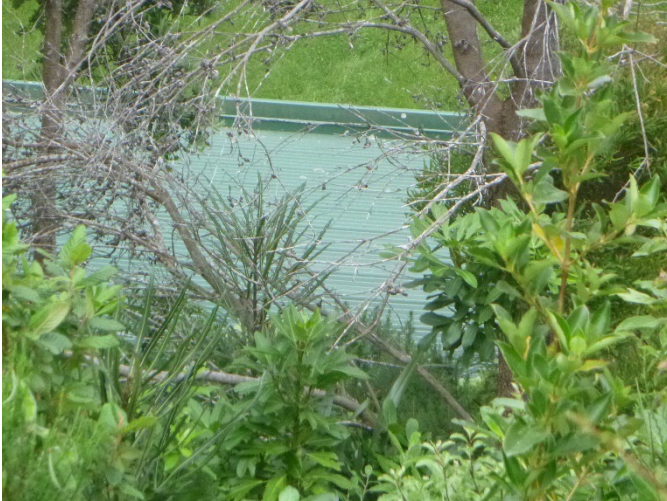
Photograph 69

Close up of photograph 68, note vegetation growth to gutters.

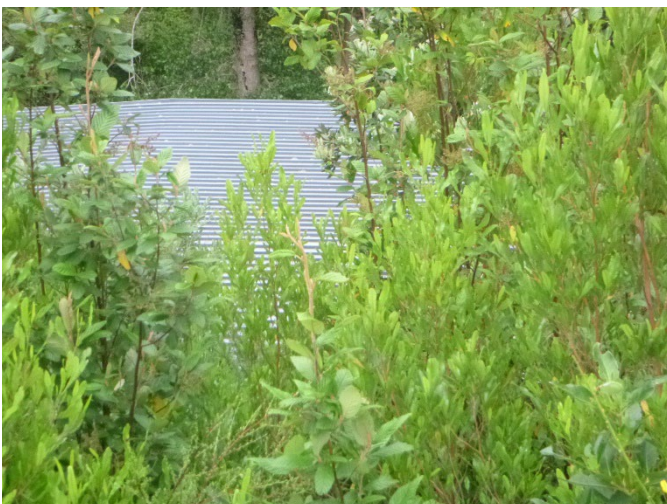
Photograph 71

Partial view of the junction between the original and additional roof area taken from the walkway above and behind the building. Note, some vegetation noted around the rainwater spreader.
